# The April 27, 2014 Windstorm

## Summary

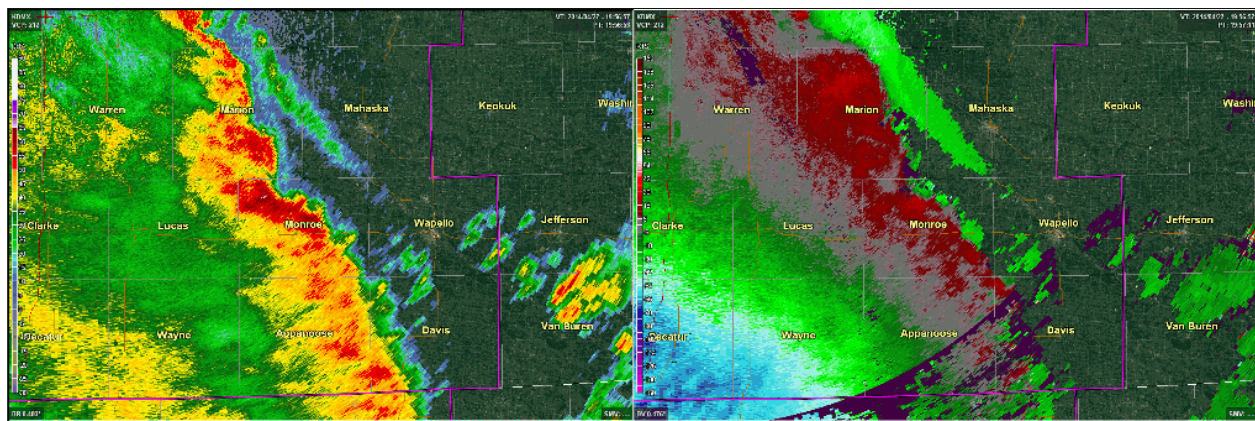
**Radar loop from 2:24pm to 3:36pm CDT on April 27 as the line of thunderstorms raced through southeastern Iowa. The left image is base reflectivity and the right image is base velocity. Note that the radar did a poor job sampling the velocity since the wind vectors were normal to the radar beam. The two areas of higher wind speeds match the damage tracks reasonably well.**

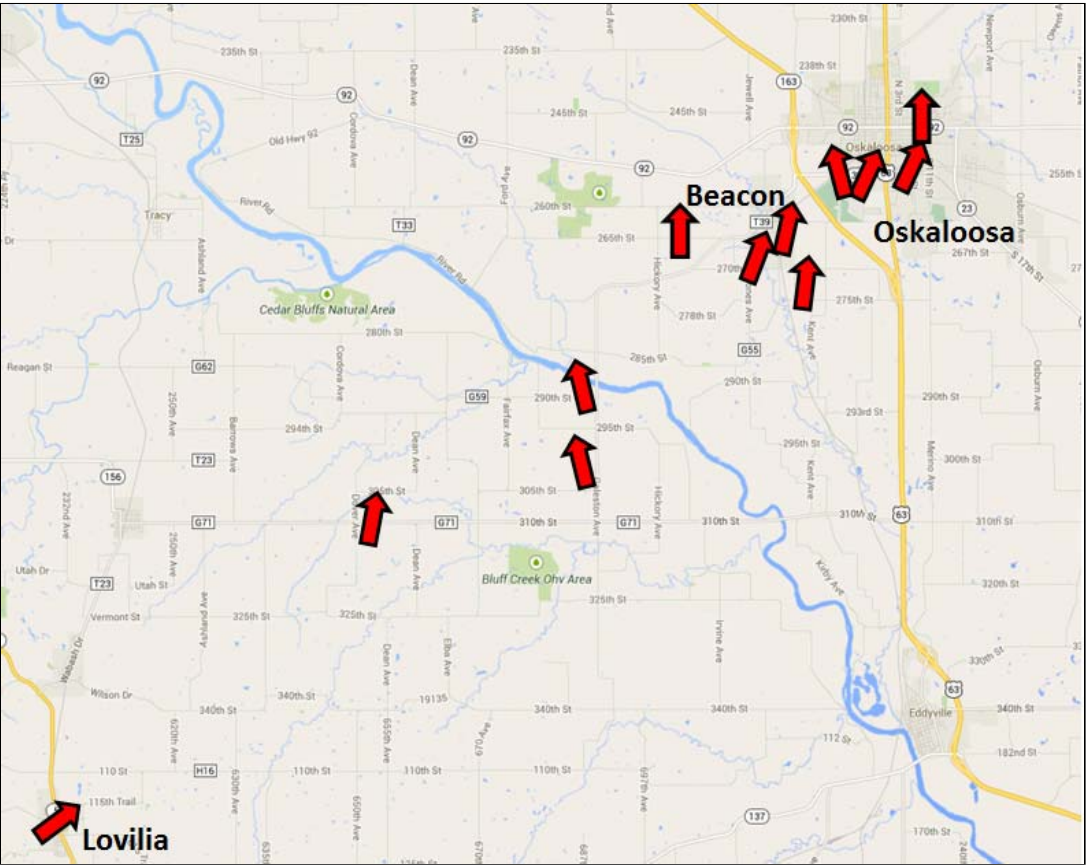
The survey in the city of Oskaloosa revealed that while the strongest winds occurred along a fairly narrow path less than a mile wide, the damage along this line was rather sporadic with no clear, tight path that would be indicative of a tornado. Large trees, a number of which were hollow or had weaker root systems, were snapped or uprooted with many houses sustaining damage from the falling trees. The trees all fell either to the north or northeast, with trees in Edmundson Park falling in a slightly divergent pattern (northwest on the west side of the park, northeast on the east side). Straight-line winds or a localized downburst were also the culprit for removing the roof of the Oskaloosa Family Medical Center. The roof peeled off in one piece and draped neatly over the north side of the building, with no twisting motion or dismemberment that would be seen in a tornado. The lack of any tree or structural damage surrounding the building points to a lower wind speed than might otherwise be inferred by this degree of damage and also infers that the winds may have exploited a weakness in the roof design.

A similar damage pattern was found through the southern portion of Beacon, just southwest of Oskaloosa. Once again, debris over a several mile wide swath was all blown north to northeast with no sign of any tornadic convergence. The snapped power lines west of town were some of the most severe damage in the area, but there is some uncertainty as to whether flying debris got tangled in the lines and compromised the poles (photos of the downed poles show field tiling wrapped around the wires). The damage became more sporadic the further one went southwest of Beacon, with all of the downed trees pointing generally north to northeast. The survey team investigated a report of a tornado in Lovilia but found little to no damage in town and no evidence that would correspond to a tornado. The environment that afternoon was conducive for the formation of low, menacing scud clouds that could have easily been mistaken for a tornado. It is believed that this is what was observed, rather than a tornado.

**Map of the damage trail found by the survey team from Lovilia to Oskaloosa. The red arrows indicate the direction the debris flew or trees fell.**

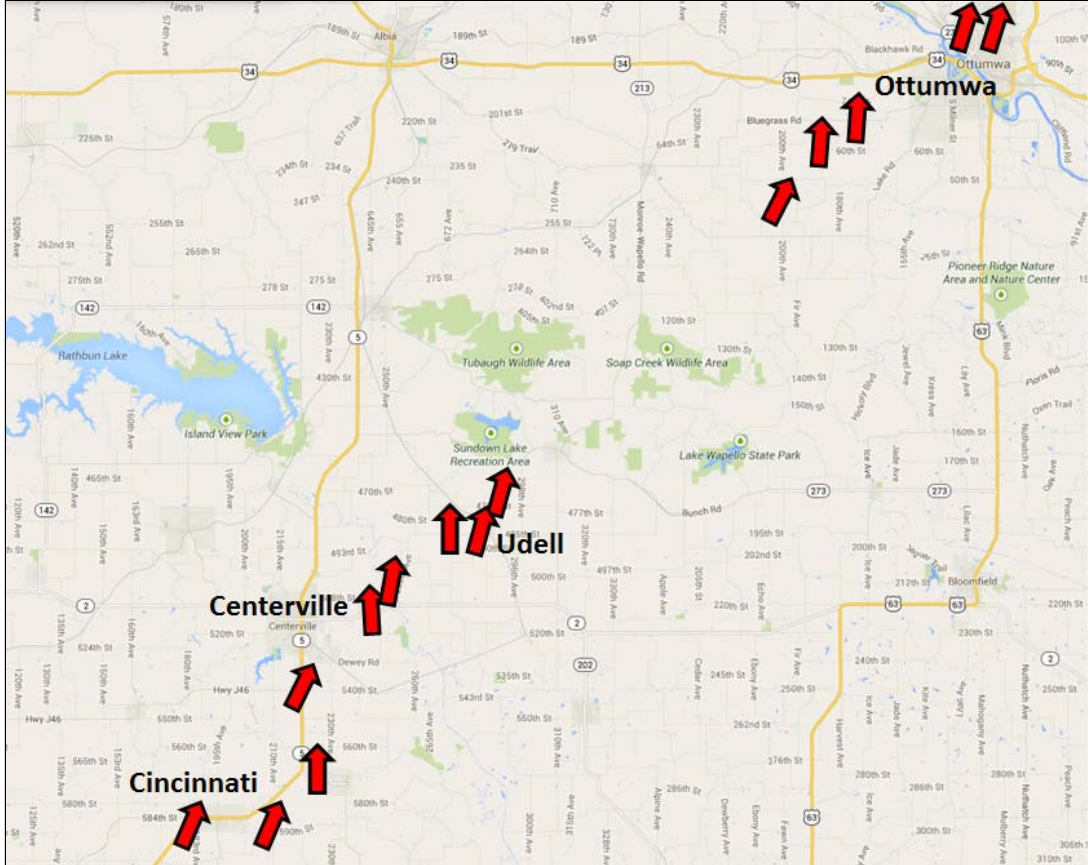
The trail of damage from Cincinnati to northwest Ottumwa was intermittent and broad at best with all of the damage oriented north to northeast (see map below). Old trees and either weak or susceptible outbuildings were the primary targets. One horse barn east of Cincinnati was open to the south and had half of its roof peeled off and deposited 50 yards due north, almost intact. A nearby shed with garage doors facing south had the doors blown in and the roof blown across the street and into a tree due north. The roof was relatively intact. Again, this pattern is very consistent with straight-line winds since there was no convergent debris trail and the buildings failed on their exposed southern sides, which is where the straight-line winds would have been coming from.

**Map of the damage trail found by the survey team from Cincinnati to Ottumwa. The red arrows indicate the direction the debris flew or trees fell.**

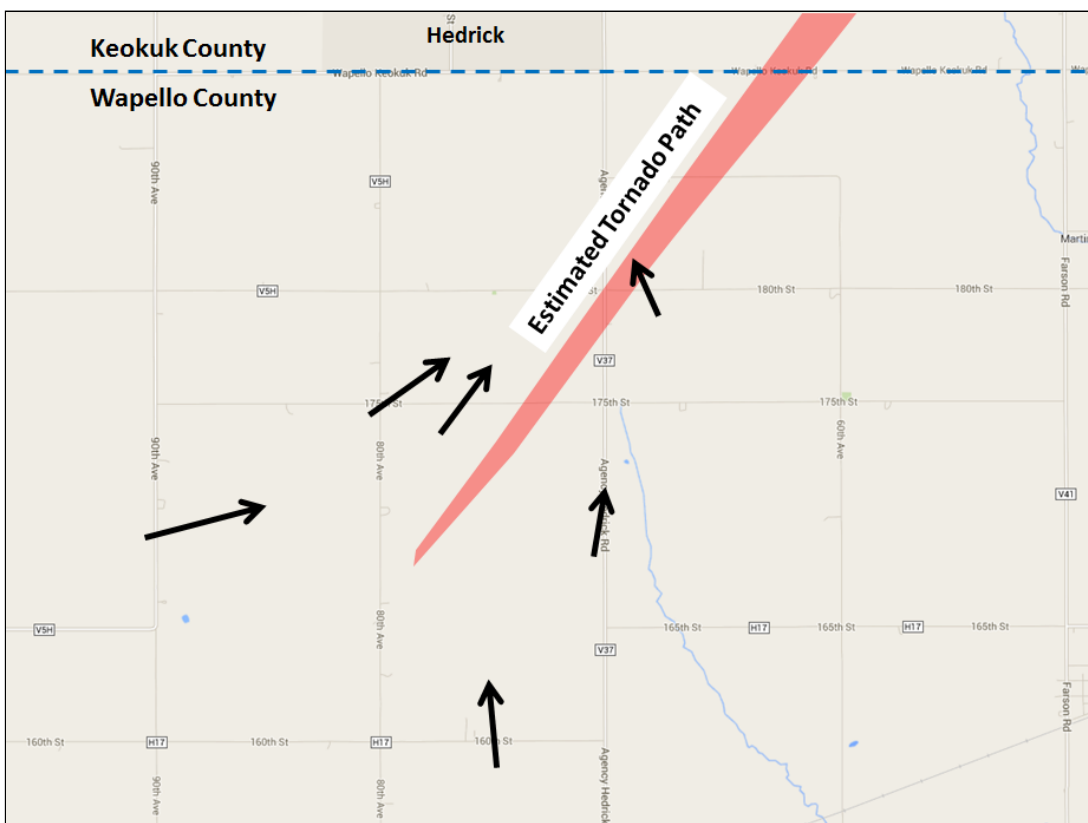
A damage trail was reacquired in far northern Wapello County which possessed several characteristics not observed throughout the survey up to that point, most notably an increase in the concentration of damage and a broad convergent pattern to the debris fields. This was especially noticeable on the southern fringe of the damage with the debris blown just west of due north, while a mile and a half to the northwest, part of a machine shed and a tractor trailer were blown 200-300 yards ENE. To the NE of this point, a grain bin and sections of a hog barn were ripped off and blown in a more NE fashion. Another mile to the NE, two power line poles were bent to the northwest. These wind vectors are plotted on the map below, along with an estimated tornado track based on these fields and an extrapolation of a stronger circulation track that formed as the storm moved into Keokuk County. The derived wind field is missing a strong westward or southward component that would have more firmly solidified the presence of a tornado. However, due to the storm's high rate of speed of 60 mph and the fact that the tornado was embedded in southwesterly straight-line winds of 60-70 mph may have masked this pattern.

**Map of the wind damage patterns near the forming tornado and the estimated tornado path.**
