## **Marathon F1-F2 Tornado Friday Morning, August 25<sup>th</sup> 2005 Survey Report**

### **Summary**

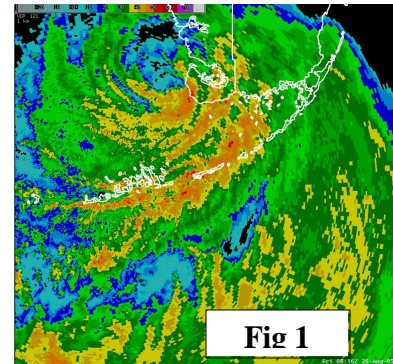
During the time of the tornado, the center of Hurricane Katrina was located approximately 40 miles north northwest of Marathon. A rain band, oriented east northeast to west south west, stretched from Florida Bay, across Marathon, and just south of the lower keys (Fig 1). A thorough post storm analysis of Key West Doppler radar could not find a tornadic signature. The individual cells within the rain band were moving towards the north northeast at near 50 knots, and the general movement of the rain band was towards the northeast at near 35 knots.

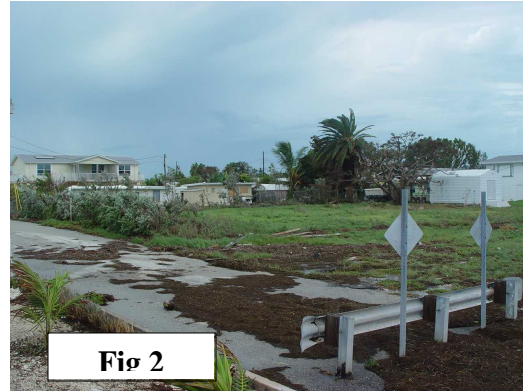
It is believed the tornado began as a waterspout, coming ashore at the eastern corner of 73<sup>rd</sup> Street Ocean and the waterfront, which is currently an empty lot(s) (Fig 2). The tornado then began to track to the north northwest. Flattening a line of bushes and stripping a tree of foliage at the north end of the lot. A one story rectangular residence, approximately 500 square feet, located at the north end of the lot (seen approximately left center in Figure2) had four of six windows blown out. A trailer on 74<sup>th</sup> Street Ocean, just east of the above structure, suffered substantial damage to the siding and skirt. The two houses north of the trailer received damage to the rear of their properties, including several trees downed, fences knocked down, and a substantial gazebo destroyed. One of the residents reported a cast iron table breaking a window and crashing into their house. They do not know from where the table originated.

At this point in the survey, the damage was similar to what would be expected with a convective downburst or strong F0 tornado. The width of the damage path was very narrow, maybe only 20 yards wide.

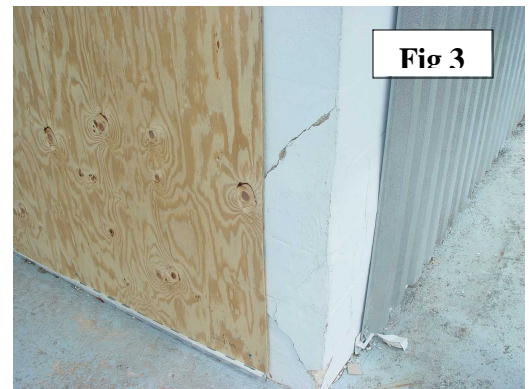
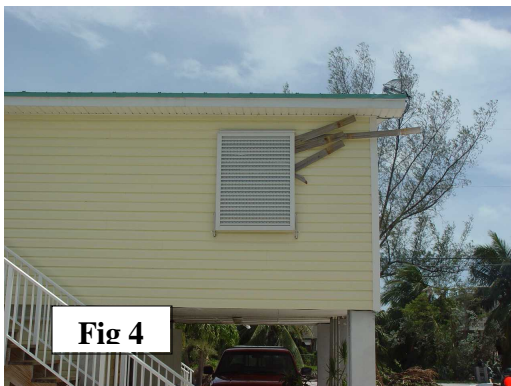
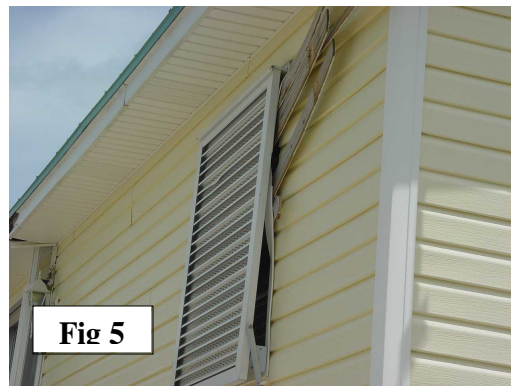
From 74<sup>th</sup> Street Ocean through W 75<sup>th</sup> Street Ocean, the tornado appeared to intensify somewhat. More missile damage was evident, and there was substantial damage to at least two houses, as well as one trailer severely damaged. Power lines were downed, and at least one utility pole snapped. A house on 74<sup>th</sup> Street Ocean, belonging to Mike Card (see witness testimony) was twisted on its foundation, causing the masonry to crack at all four corners of the house (Fig 3). Additionally, the shutters were ripped off one of Mr. Card's windows, and the window shattered (Fig 3). Across the canal, at 944 W 75<sup>th</sup> Street (see witness testimony), the porch was destroyed, and several fence boards, of an unknown origin, embedded between the window frame and the siding of the house (shattering the window). The shutter was closed when this occurred (Figures 4 and 5).

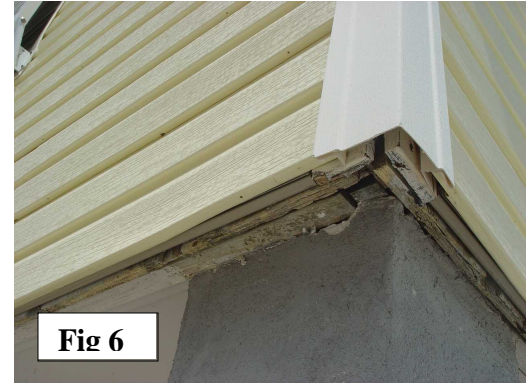
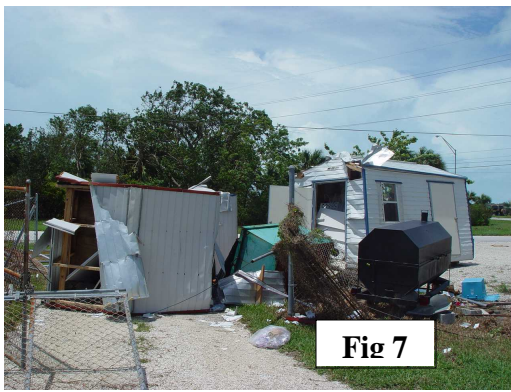
The porch of this residence was also destroyed, with the aluminum roof and all siding and screens removed. Several of the planks which comprised the porch floor were also missing. After interviewing the resident, it was discovered that the house had been shifted on its pilings; either pushed or lifted and dropped (Figure 6). Later, independent of this survey, it was discovered that the roof had been separated from the walls. Given the missile damage and the structural damage evident, it appeared that the tornado had reached F1 intensity during this portion of the path. The path width at this point also appears to have expanded, as best could be determined, reaching approximately 50 yards.

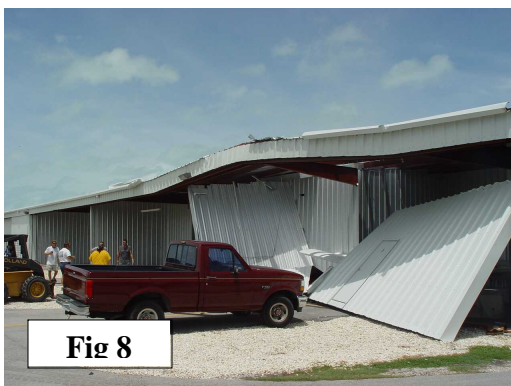
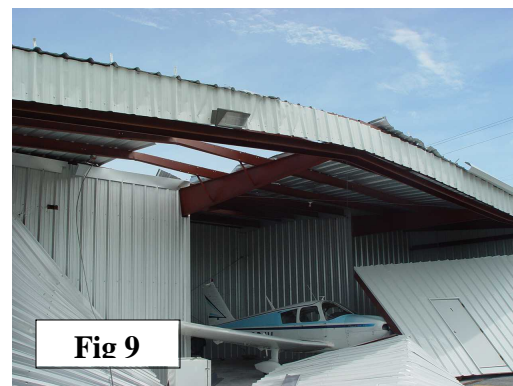
The tornado crossed the Overseas Highway and damaged several hangers at the Marathon Airport. The recently built hangers, which according to one witness on scene where built to withstand category five winds, suffered minor to substantial damage, with the western most hanger receiving heavy damage. This hanger had all but one of its doors damaged and toppled, roof damage, and three large steel I-beams bent (figures 8 and 9). Estimated wind to cause this type of damage, and to bend the I-bean infrastructure, are near 120 mph. This would be consistent with a weak F2 tornado.

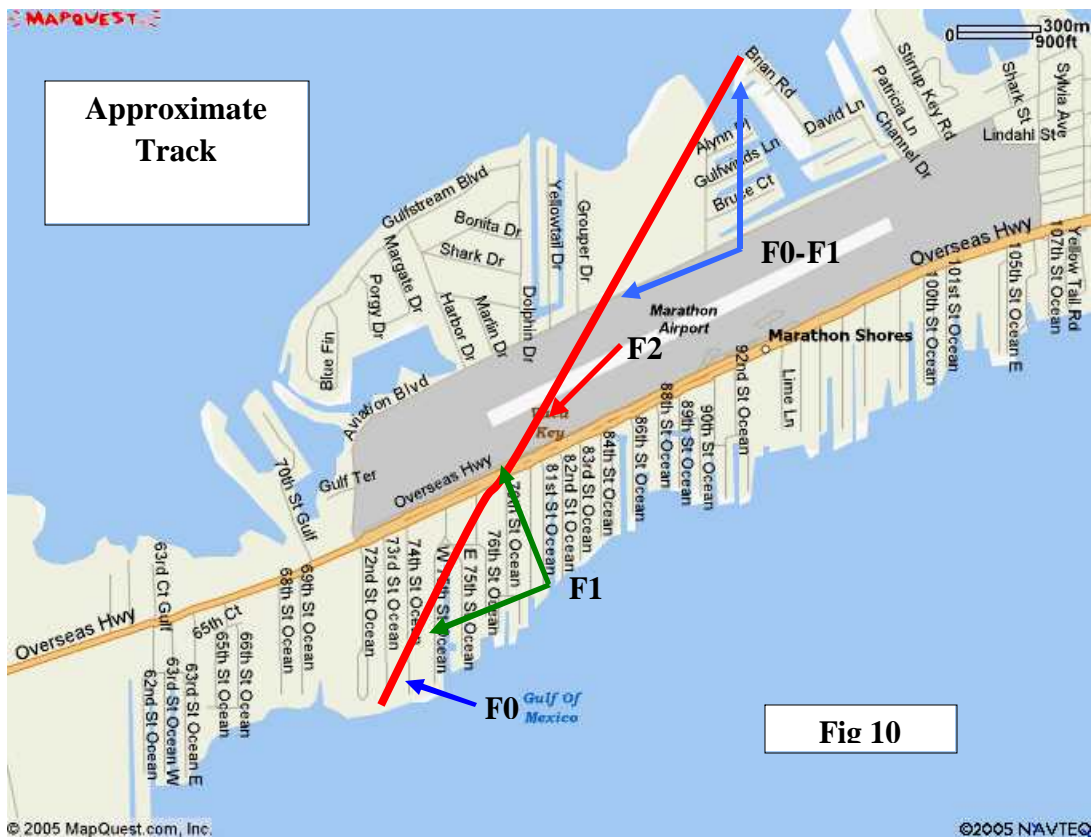
A very discrete, narrow track was uncovered during the survey ( Figure 10) . Damage, if any, outside of the tornado track was minimal, and could be explained as a result of the ambient tropical storm force winds. At times along the path, strong F1 to weak F2 damage was apparent. The debris field was very convergent, with some debris deposited along the track traceable to points of origin as far as 1,200 feet away. Given the convergent debris field, missile damage, long track, and the apparent strengthening of the tornado from 74<sup>th</sup> Street Ocean to the Marathon Airport, a convectively induced downburst was ruled out as a cause of the damage. However, some type of shear zone, such as a gust front along a convective downburst, could certainly have been the larger scale mechanism that spawned the tornado. Some of the witness testimony might also support this, with reports along the Ocean side reporting a loud boom and pressure change which would be consistent with a downburst, with witness further along the track describing an increasing noise, or roaring sound. After consultation with Jon Rizzo, the Warning Coordination Meteorologist at NWS Key West, survey team member Andy Devanas concluded that the event was a F1 tornado, with a limited area of F2 damage.
