Bow Echo Event

July 10th, 2003

Dupo, Illinois Tornado

Caseyville, Illinois Tornado

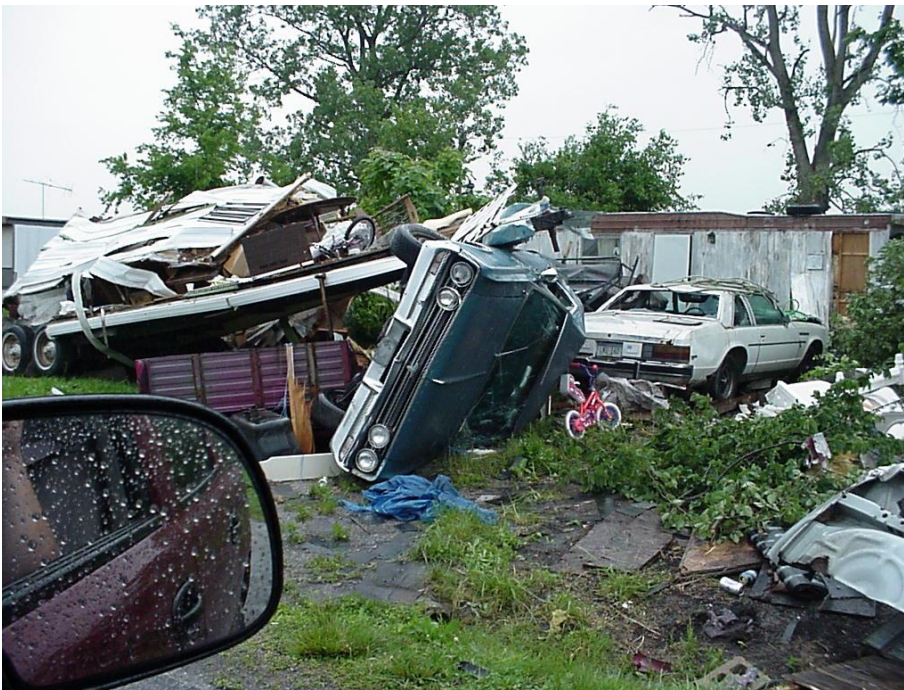
Vehicles overturned and destroyed 1/6 mile east of Black Lane (Caseyville, IL)

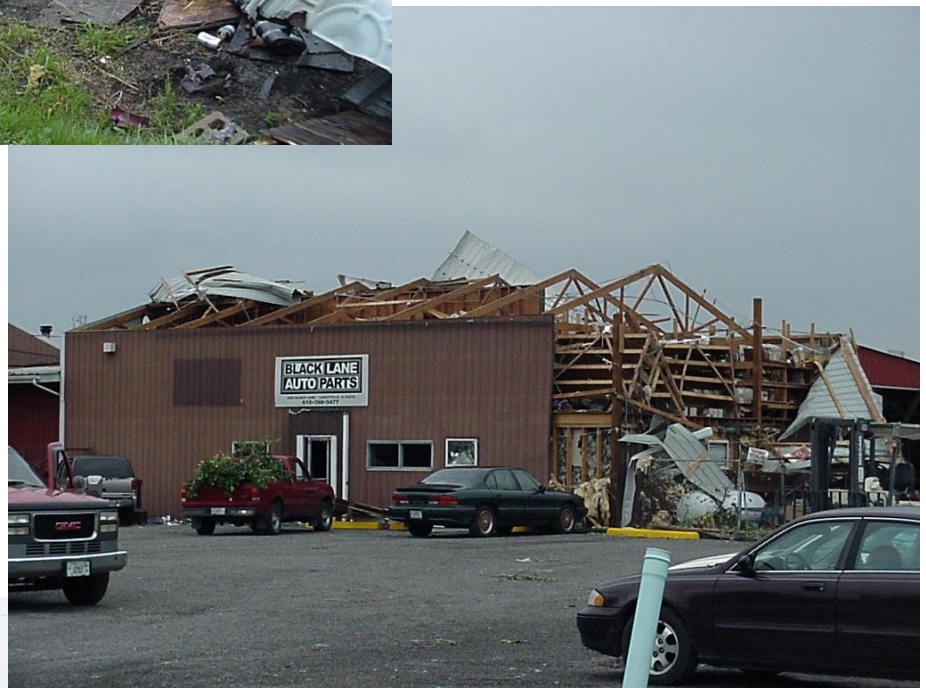
Roof of a large machine shed located on the east side of Black Lane severely damaged (Caseyville, IL)

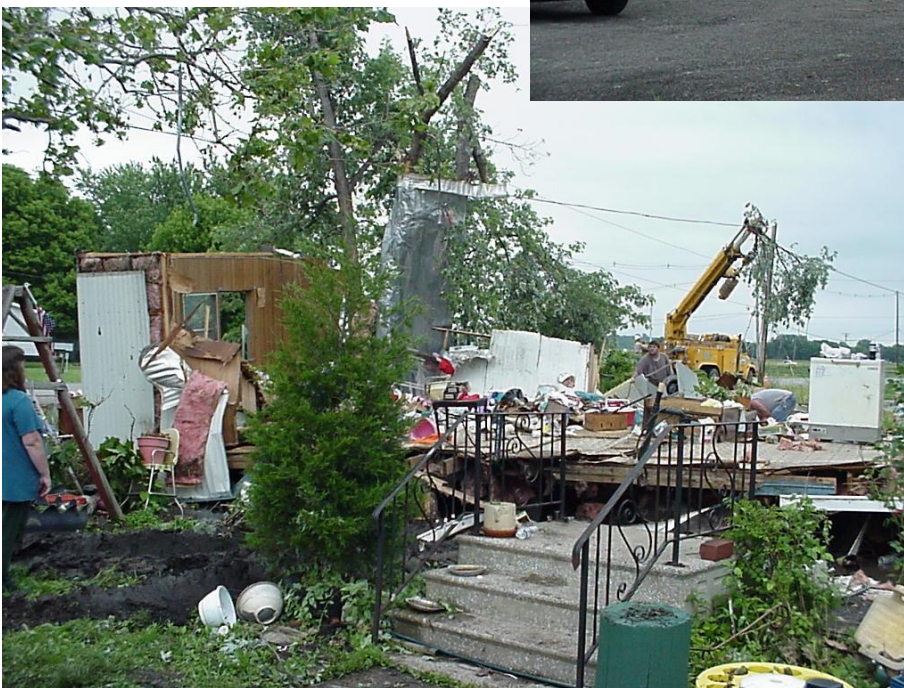
Damage to one of the three house trailers between 85th and Black Lane (Caseyville, IL)

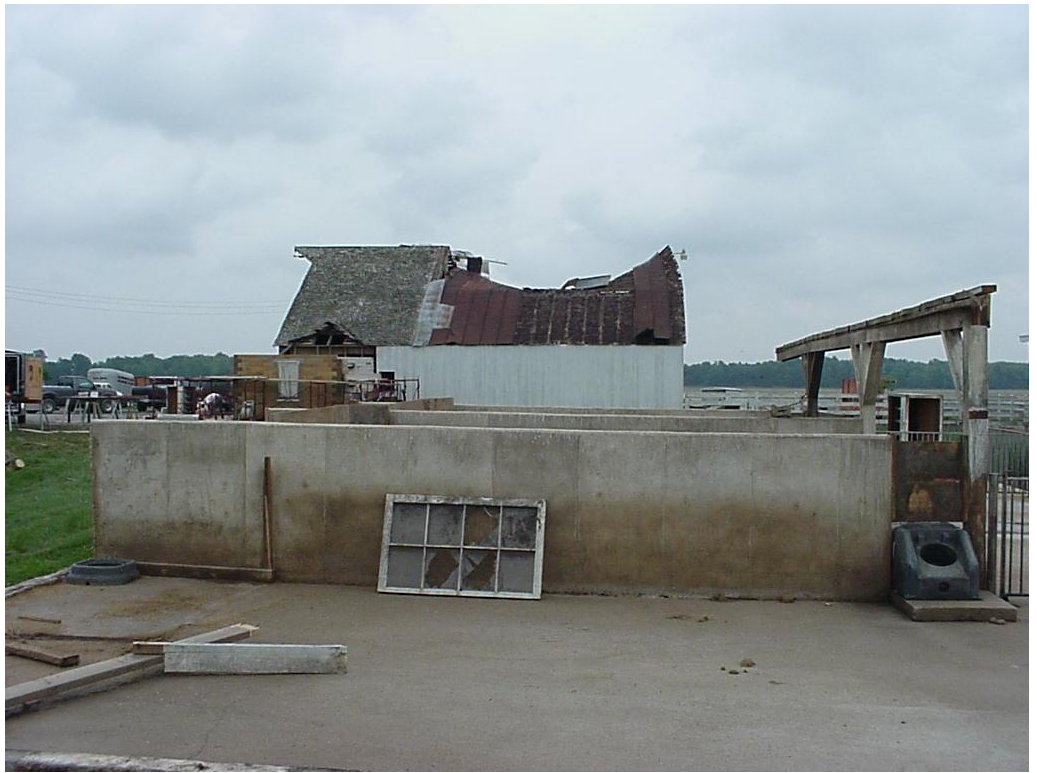
Another tornado caused brief damage to a farmstead over south-central Clinton County Illinois. The tornado occurred 4 miles south of Germantown , Illinois at 6:30 PM CDT. The farmstead was located in the Santa Fe flood plain along and north of the Kaskaskia River. A barn, machine shed, and silo sustained the greatest degree of damage while there was minor damage to the farm home. Debris from the farmstead was thrown 200 yards to 1/4 mile to the northeast. The tornadic damage track was 40 yards wide and 1.25 miles long. The tornadic damage was rated F0.

Damage to a barn and hog barn on the farmstead 4 miles south of Germantown (Clinton County, Illinois)

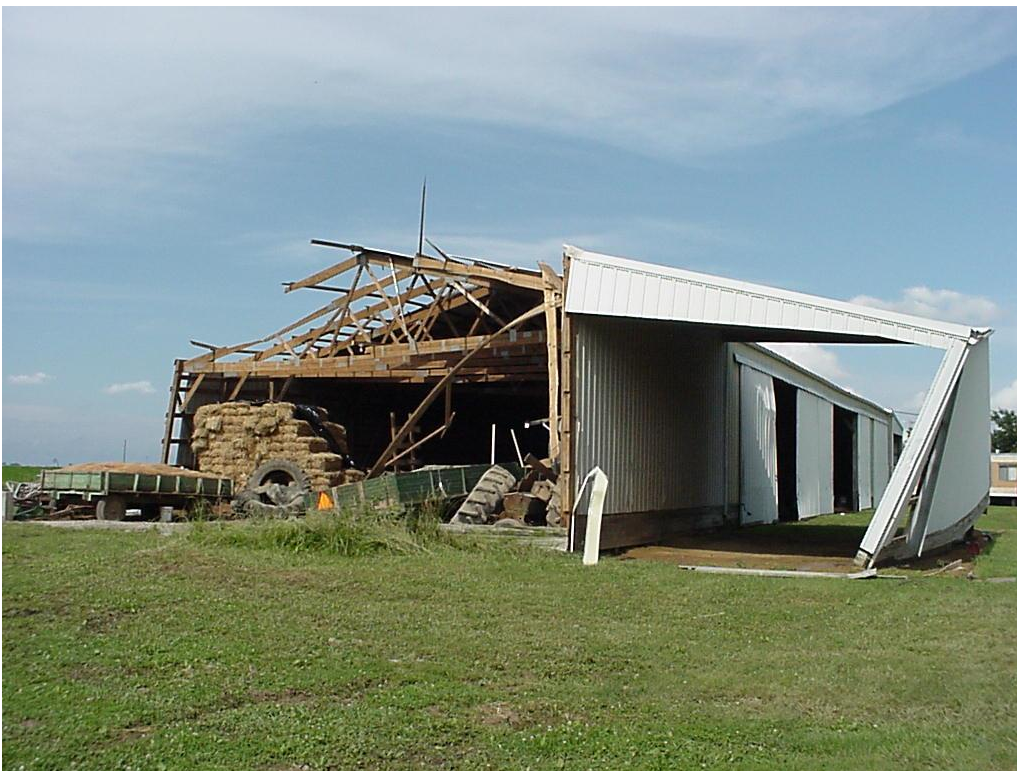
The bow echo system on June 10, 2003 spawned another tornado over parts of west-central Washington county Illinois. This tornadic damage track was relatively long (14 miles in length) compared to the other tornadic damage tracks on this day. Twelve machine sheds, barns, homes, other type of out-buildings sustained varying degrees of damage while numerous trees were along the tornado's path were either severed or uprooted. Debris at several locations along the damage path were driven into the ground 1 to 2 feet deep at 45 to 60 degree angles. A satellite tornadic damage track was observed approximately 100 yards north of the primary track approximately 1 mile south of Addieville, Illinois. The damage track of the satellite tornado was 1/4 mile long and 20 yards wide. In contrast to the other tornadoes on this day, this tornado occurred south of the apex of the bow echo. The tornado initially touched down at 635 PM CDT. The width of the damage track varied from 40 to 60 yards while the total length of the damage track was 7.0 miles. The damage was rated F1 intensity.

Damage to a machine shed on the west side of a farmstead 2.2 miles west of Plum Hill, Illinois just south of Highway 15
