Storm Survey for Severe Weather Event May 22-26, 2014

A damage assessment was conducted on Tuesday, May 27, 2014 by National Weather Service Midland, TX meteorologists. The survey was conducted in areas that reported widespread damage from either straight line winds or from a tornado. In addition, there were numerous reports of large hail where car windows were destroyed, mainly in Eddy County, New Mexico during this event. It appears that the greatest amount of hail, some of it the size of baseballs was in the White City and Carlsbad area. Based on NWS warnings and calls from WFO Midland, several outdoor activities were cancelled at Carlsbad Caverns National Park; with the National Park being evacuated before the thunderstorms arrived. This potentially saved significant amount of damage to vehicles. A damage survey was not conducted in this area due to the lack of any widespread structural damage. Vehicle damage was from vehicles travelling through the area.

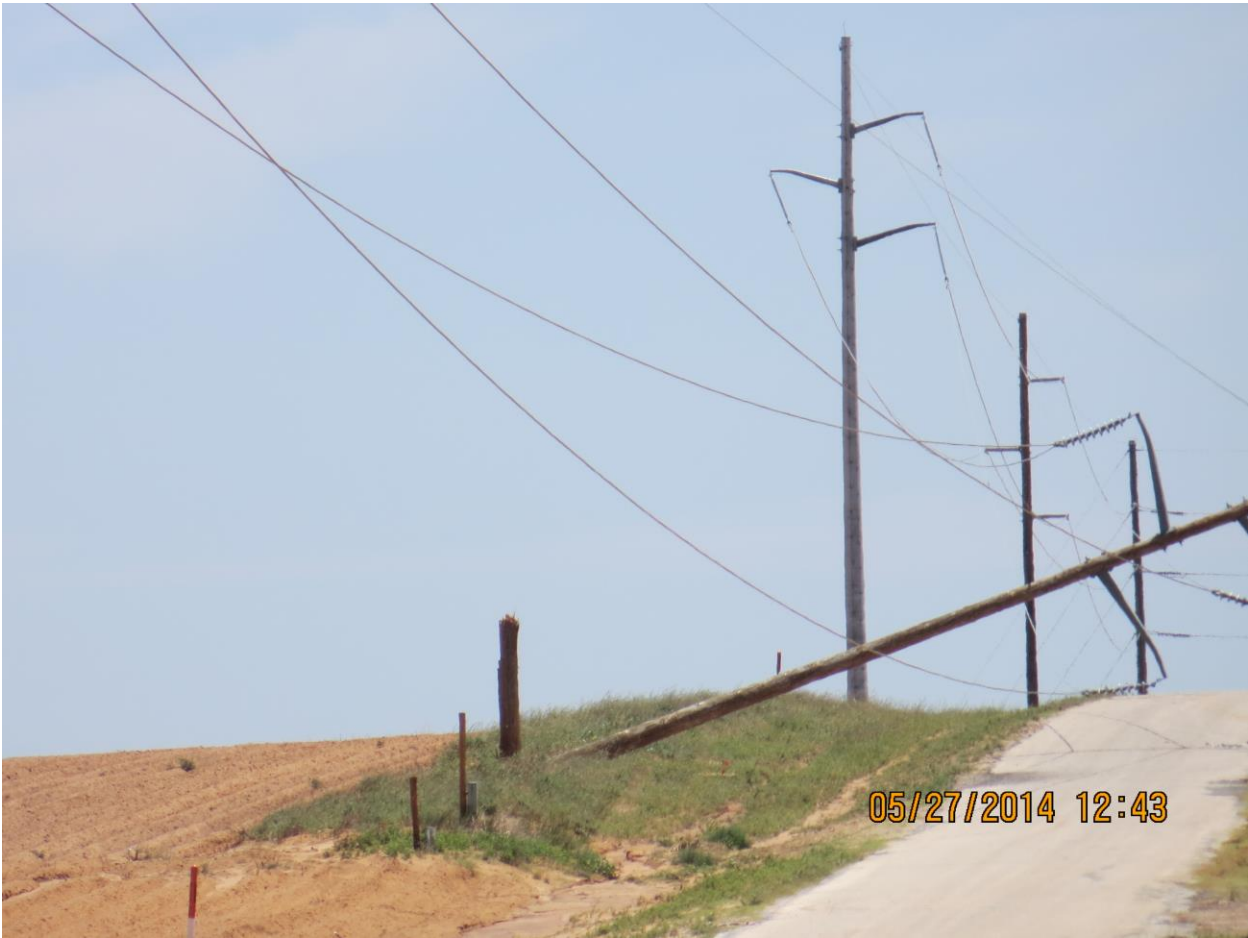
In Howard County near Big Spring and Coahoma there was a three mile long stretch of Centerpoint Road where there were 31 power poles snapped. This was most likely the result of a Rear Flank Downdraft from a severe thunderstorm. Based on damage indicators the estimated wind speed was likely between 85-100 mph (EF-1 equivalent). The map below shows the stretch of road.

The picture below shows one of the snapped poles.

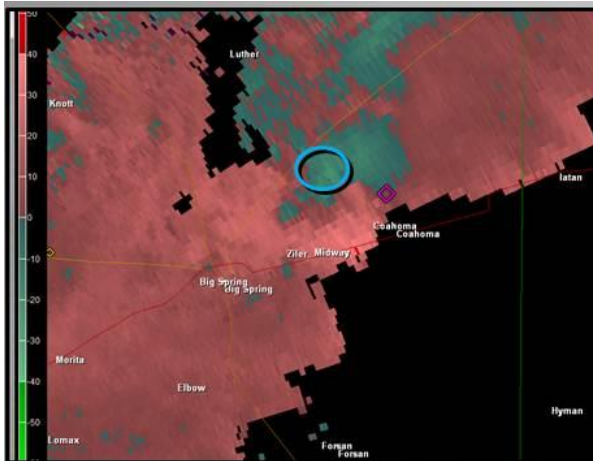
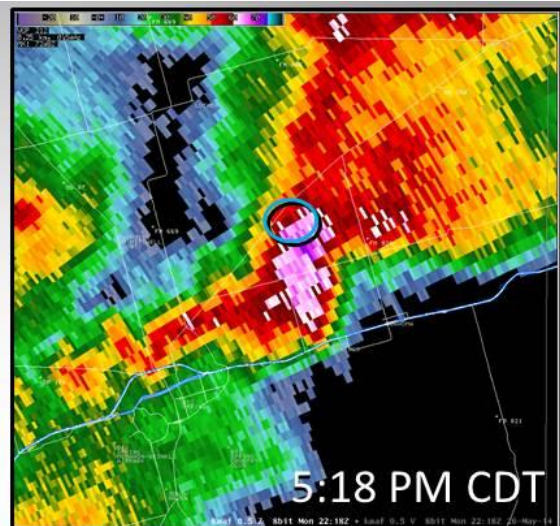
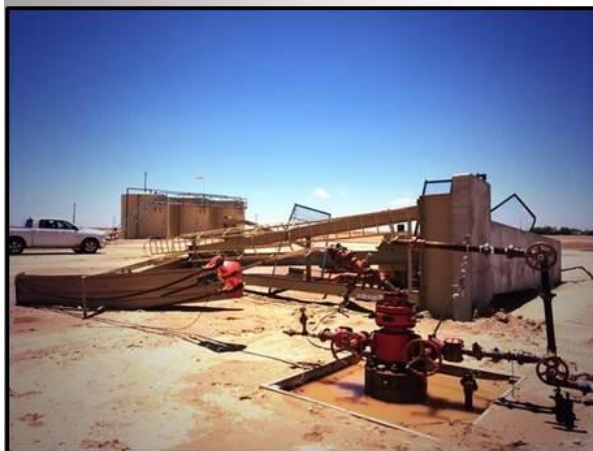
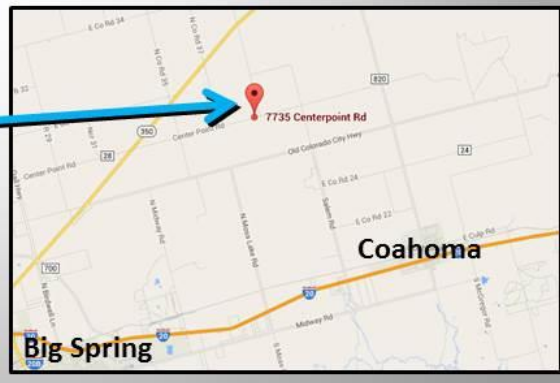
In Howard County near the site of the straight line wind damage there was confirmed tornado damage. An Ampscot 640 pump jack was overturned. The pump jack has a weight of 78,000 lbs (including concrete base and piping). A study was performed by Dr. Craig Miller and Dr Greg Kopp from the University of Western Ontario, Department of Civil and Environmental Engineering, as well as to Dr. Kishor Mehta, Professor of Civil Engineering at Texas Tech University and a leading authority within the wind engineering community for the Notrees, TX tornado of May 14, 2010 where two smaller pump jacks (Ampscot 320 pump jacks) were overturned. The Notrees tornado was rated an EF-3. The damage survey team rated this tornado a high end EF-2 (111-135 mph). The rationale behind this rating is that since the pump jack was bigger it had a larger area for the wind to affect and the cement base was not anchored to the ground. Additionally, there was no damage to the tanks near the pump jack. The picture below shows the overturned pump jack, SRM and reflectivity radar imagery, and the location of the pump jack.

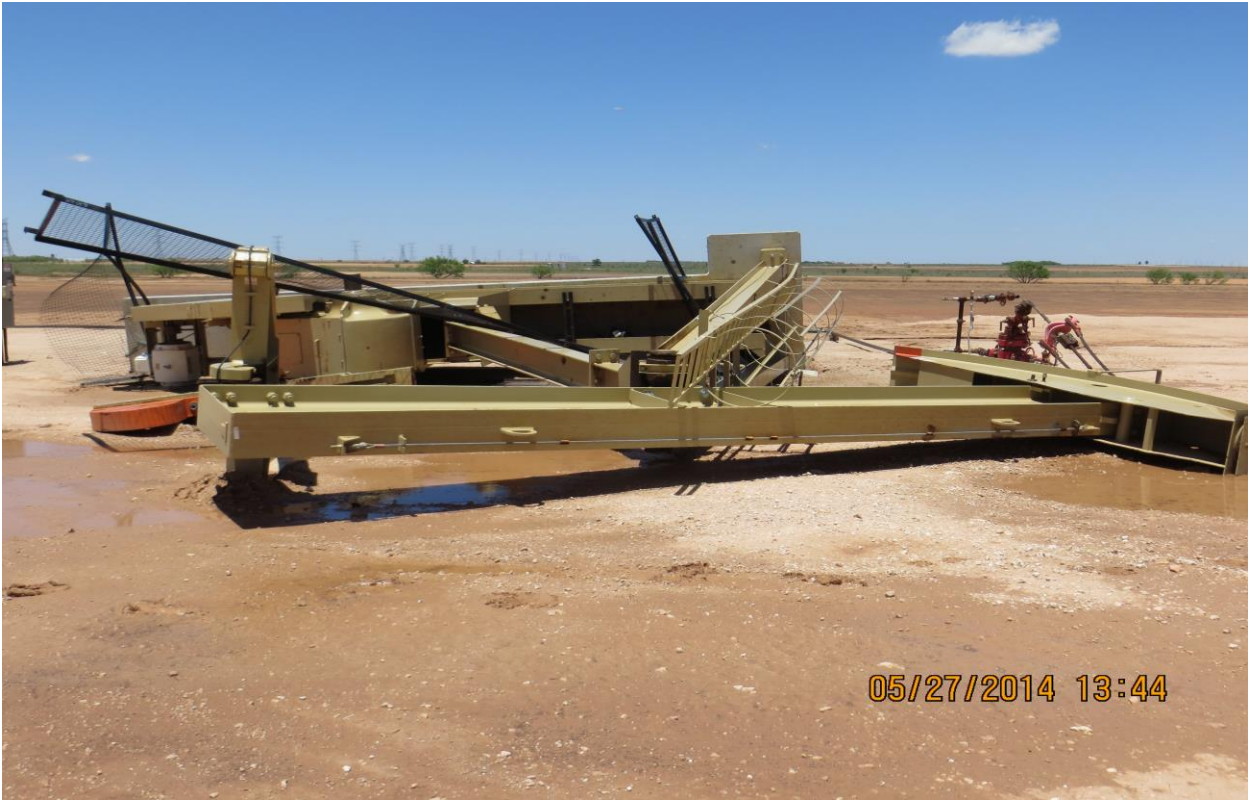
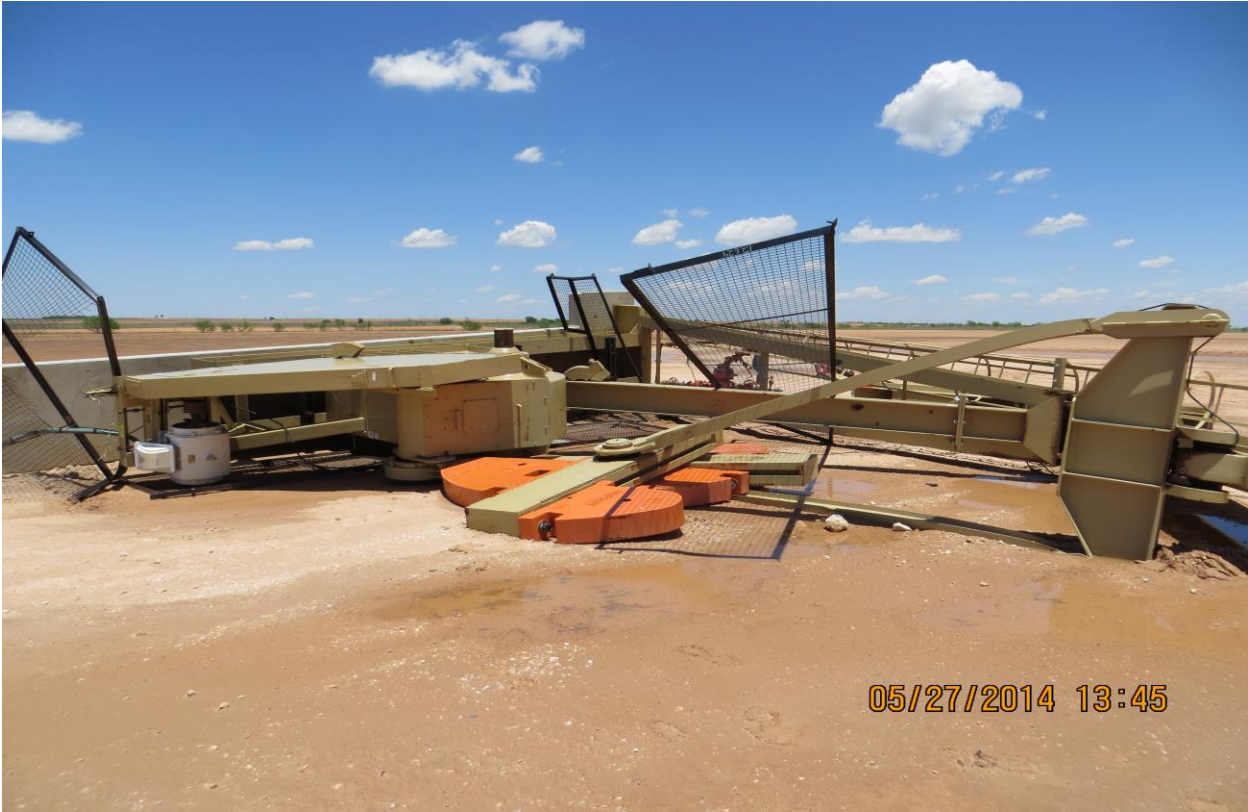
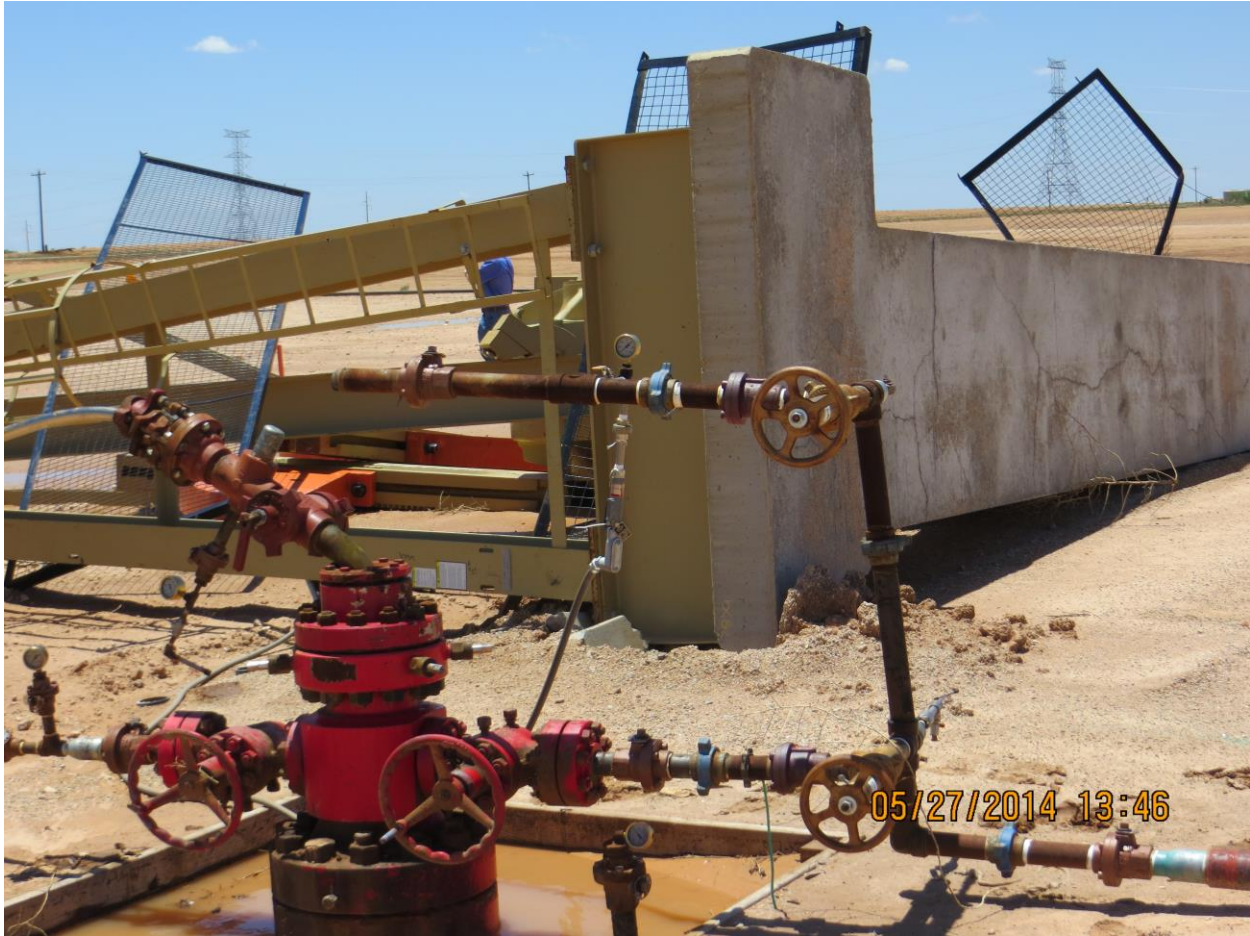
Here are other pictures of the overturned pump jack.

Due to the abundant rainfall, wet soil, and lack of vegetation it was not possible to determine the track of this tornado.

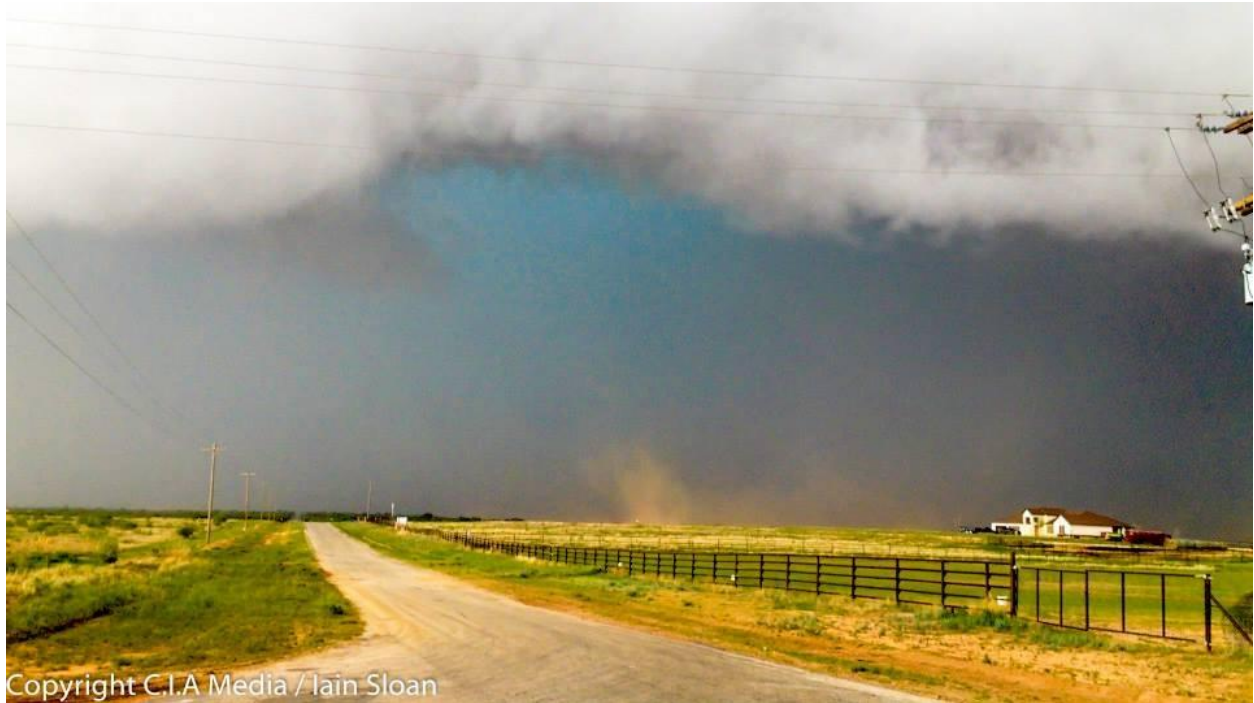
Three additional tornadoes were confirmed through pictures by spotters and the public. Since these tornadoes were of brief duration and did not produce any significant damage they were given a rating of EF-0 (65-85 mph). The following picture was courtesy of Jordan Matthews/Iain Sloan northwest of Coahoma, TX.
