May 22, 2016 Howard and Glasscock County Tornadoes

On May 23, 2016, meteorologists from the National Weather Service in Midland conducted a damage survey over portions of Howard and Glasscock counties for damage caused by severe thunderstorms during the evening hours on Sunday, May 22.

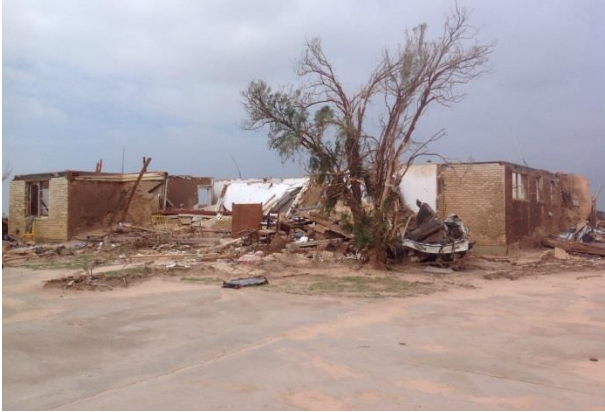
South of Interstate 20, the tornado exhibited erratic movement, being described by chasers and spotters as being “nearly stationary in a field.” Examination of radar imagery showed the primary storm circulation moved slowly southeastward to approximately ½ mile northwest of the intersection of Lintner Road and Rockhouse Road by 6:37 pm CDT, before turning eastward. The tornado continued to move east, with the southern periphery of the tornado affecting Home #1 (indicated on map). The tornado then began to move northeastward, crossing nearly directly over Home #2 around 6:40 pm CDT. A slight

tornado during the most intense portion of the tornado's life cycle, the entire roof was destroyed and exterior walls on this well-constructed residence were partially collapsed. This damage indicator suggests an EF3 intensity with wind speeds estimated at 140-160 mph. In the adjacent field east of Home #2, a 640 type pump jack was blown over. While not a formal damage indicator, similar type occurrences in past history would suggest that winds associated with EF3 tornadoes could cause pump jacks of this size to topple. The assessment team also looked at tree damage at Home #2. Both softwood and hardwood trees were viewed on the property. Damage to these large trees was indicative of high end EF2 to low end EF3 damage.

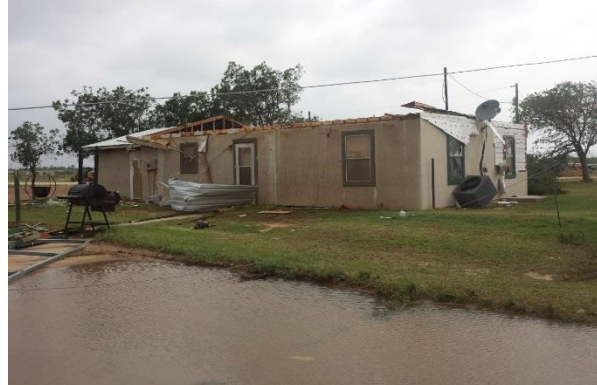
Home #1 and Home #3 experienced tornado damage indicative of EF2 damage. In the examples shown, large sections of the roof were removed, but with the walls still standing. At Home #3, there were power poles that were snapped approximately 5 feet off the ground. Wind speeds at this residence are estimated at 115 to 125 mph. At Home #1, trees were uprooted. Also, removal of the roof likely was aided by wind impacting an attached overhang on the

home. Wind speeds are estimated at this location of 105 to 115 mph.

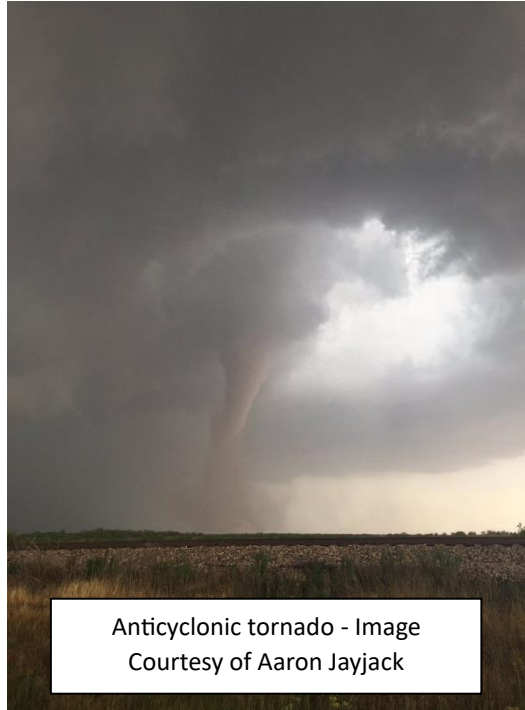
In total, eight tornadoes occurred on Sunday evening across Howard and Glasscock counties. One of the more viewed tornadoes during the event (referenced as "Tornado #2") was an anticyclonic tornado that was visible from Interstate-20. Tornado #2 developed at around 6:51 pm CDT, approximately 3 miles south of the interstate, close to Farm-to-Market Road 818. This tornado moved slowly east and then northeast. With the help of radar imagery, it is estimated that the tornado lasted 8 minutes, while travelling a path just short of 2 miles. With the tornado remaining over open fields, the assessment team rated the tornado as an EF0. The width was estimated at 100 yards.

Anticyclonic tornado - Image
Courtesy of Aaron Jayjack

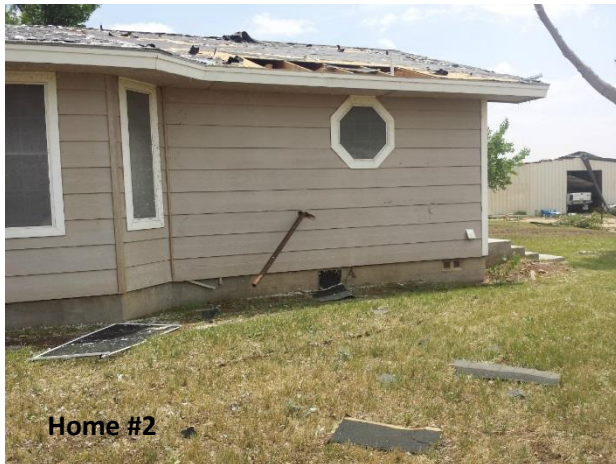
Tornado #7 developed around at 8:56 PM CDT, just over 1 ½ miles NNW of Garden City. This tornado produced a combination of EF1 and EF2 damage at two residences. A single-wide manufactured home at Home #1 was rolled and destroyed. This was indicative of damage produced by a tornado of EF2 intensity. As the tornado moved southwestward and impacted Home #2, a combination of EF1 and EF2 damage was noted. Tree damage was indicative of EF1, while the metal barn appears to

have sustained lower-end EF2 damage. It is noted however that the barn construction made it more susceptible to wind entering the structure, which could have resulted in damage at a lower wind threshold. Wind speeds are estimated at 100-115 mph with this damage.

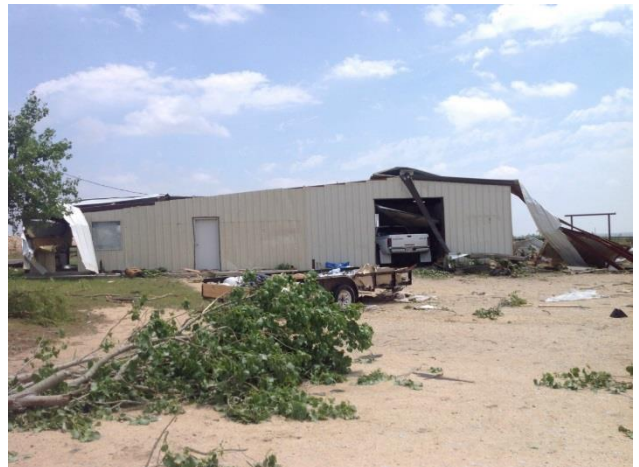
As the tornado moved southwestward, it was the opinion of the assessment team that the tornado intensified. At approximately 9:01 PM CDT, the tornado knocked over a 320 type pump jack west of

County Road 417. With this slightly smaller pump jack type, it was felt that winds in the 120-135 mph range could potentially produce this damage. Thus, we rated the tornado as being of high-end EF2 intensity. Oil field workers noted that there was damage over open fields farther to the southwest. Using radar estimates, the team concluded that this tornado dissipated at 9:02 pm CDT just short of reaching Highway 158, 1 ½ miles west of Garden City. The total path length for tornado #7 was 1.9 miles with its greatest width estimated at 150 yards.
