July 8, 2016 Midland, Texas Microburst:

National Weather Service Meteorologists conducted a storm survey for a microburst associated with a severe thunderstorm that affected portions of Midland, Texas around 7:50 pm CDT on July 8, 2016 (Figure 1).

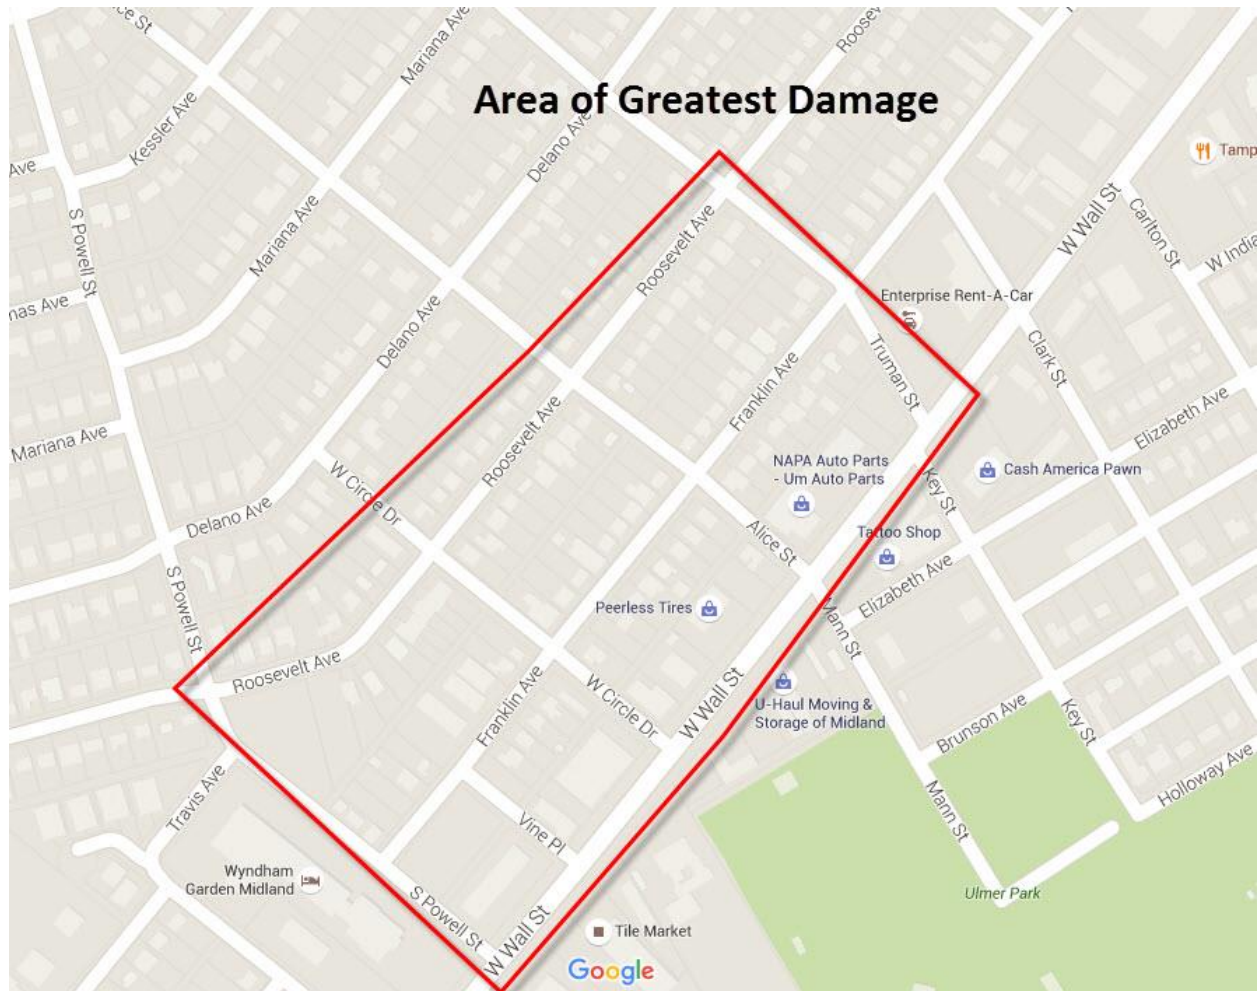
Figure 1 – Area of greatest damage in Midland, Texas.

The American Red Cross Permian Basin performed a preliminary Damage Assessment on the morning of July 9, 2016. In addition to damage to a number of businesses along Wall Street; the American Red Cross assessed 92 homes in the highlighted area in Figure 1. Of the 92 homes assessed by the American Red Cross, 28 were found to have had damage from the Microburst.

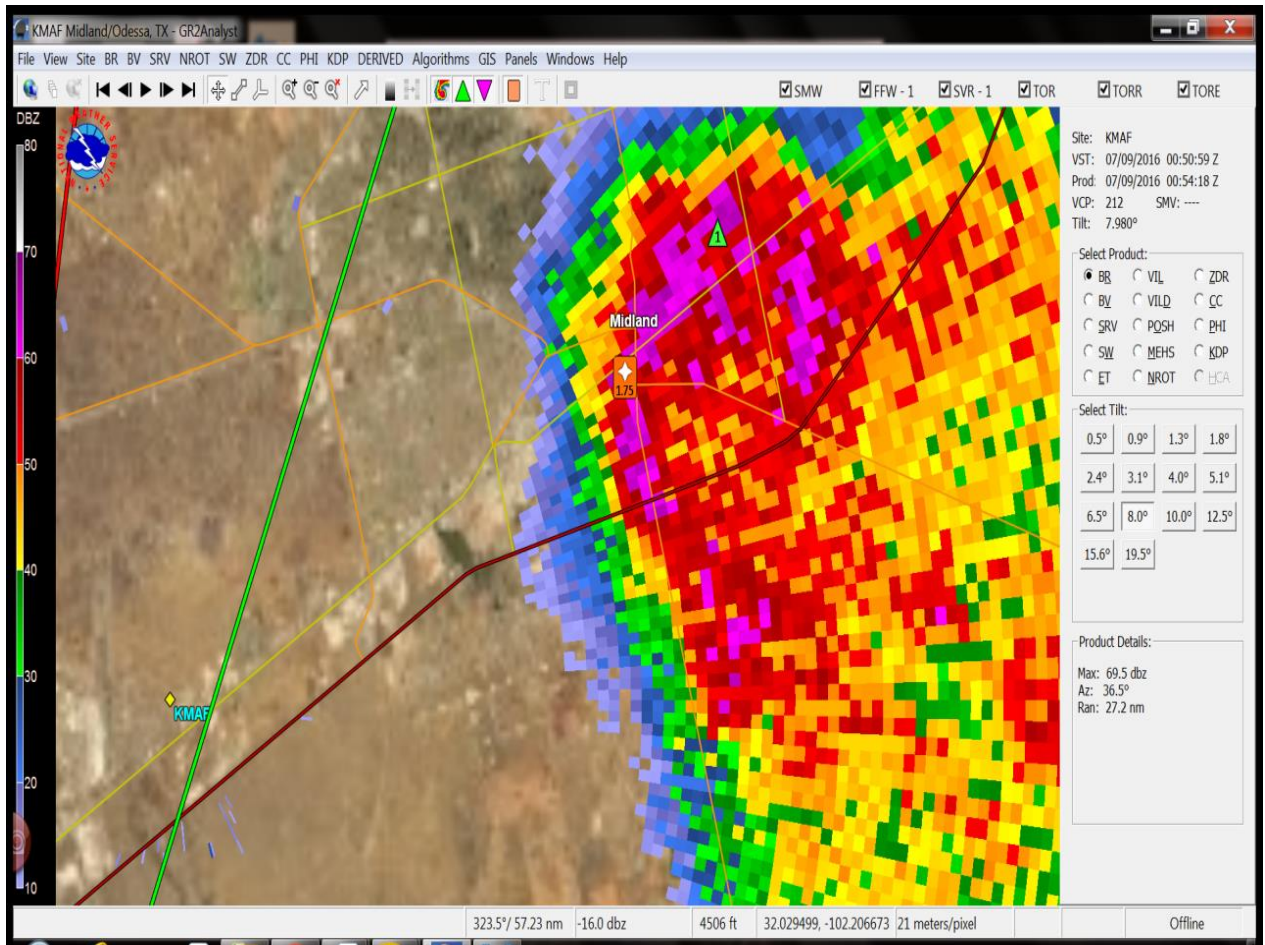
Figure 2 – Base Reflectivity Image at 7:50 PM CDT.

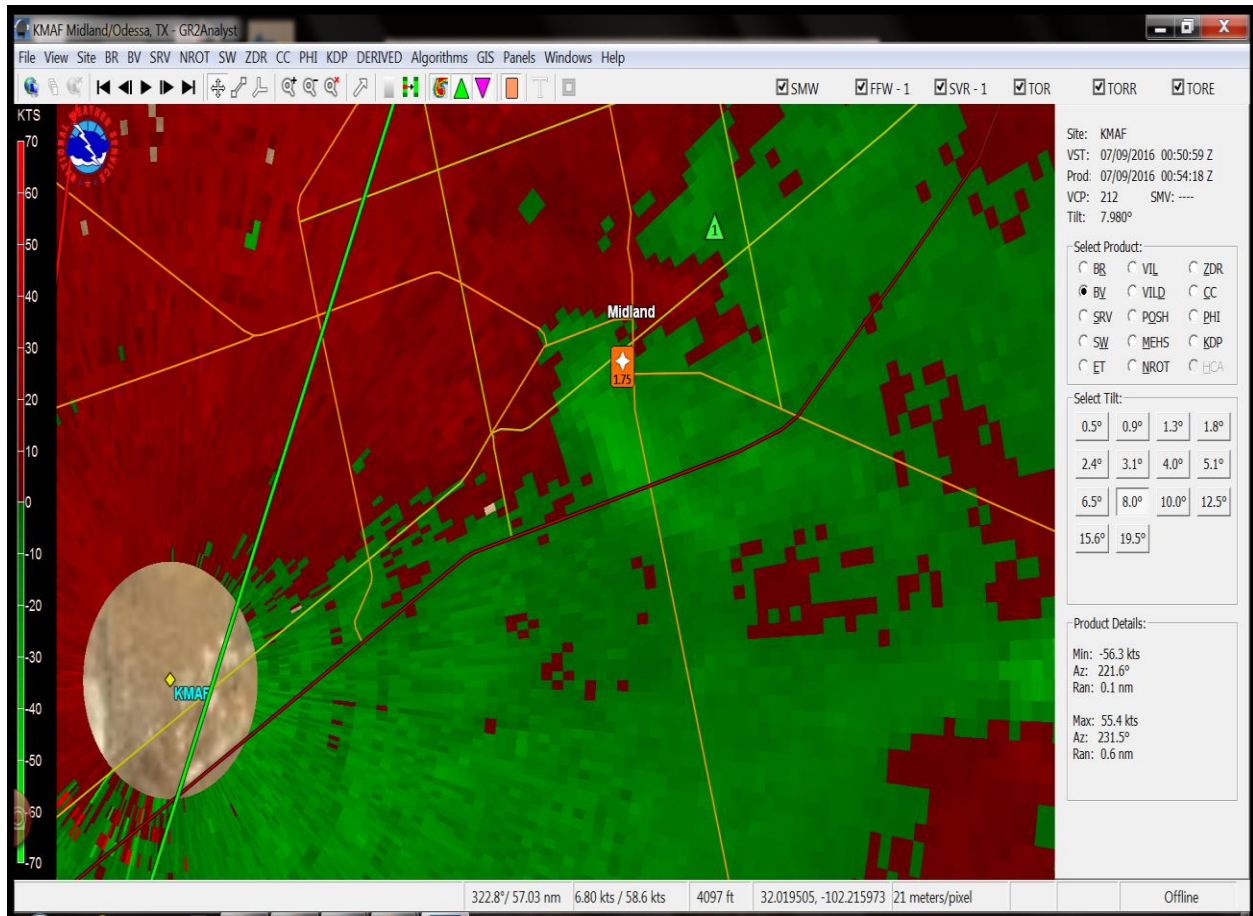
Figure 3 – Base Velocity Image at 7:50 PM CDT.

The KMAF Base Velocity image shows an area of convergence above the surface. The green color indicates inbound wind toward the radar(KMAF) whereas the red color indicates outbound wind away from the radar (KMAF). In Figure 3 the area of convergence is WSW of downtown Midland – the area with the greatest concentration of damage.

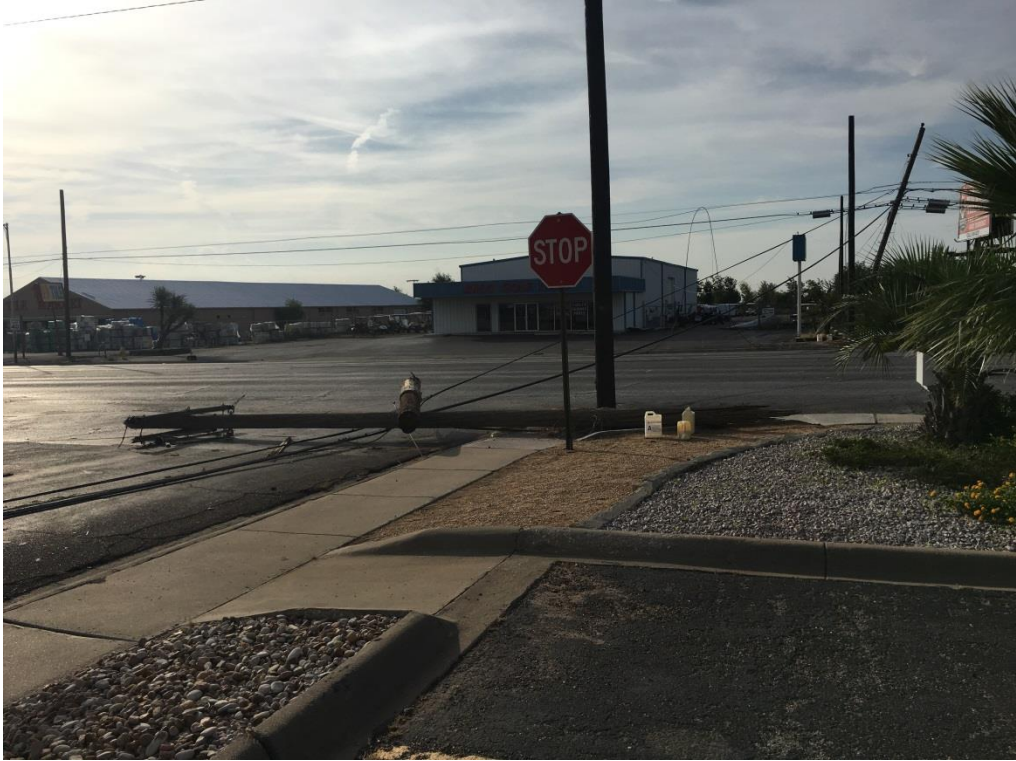
Figure 4 – Power poles snapped at the corner of Wall St and Powell St (Courtesy of Amber Hluchan) .

Based on the damage witnessed, the top wind speed was estimated to be between 80-100 mph.

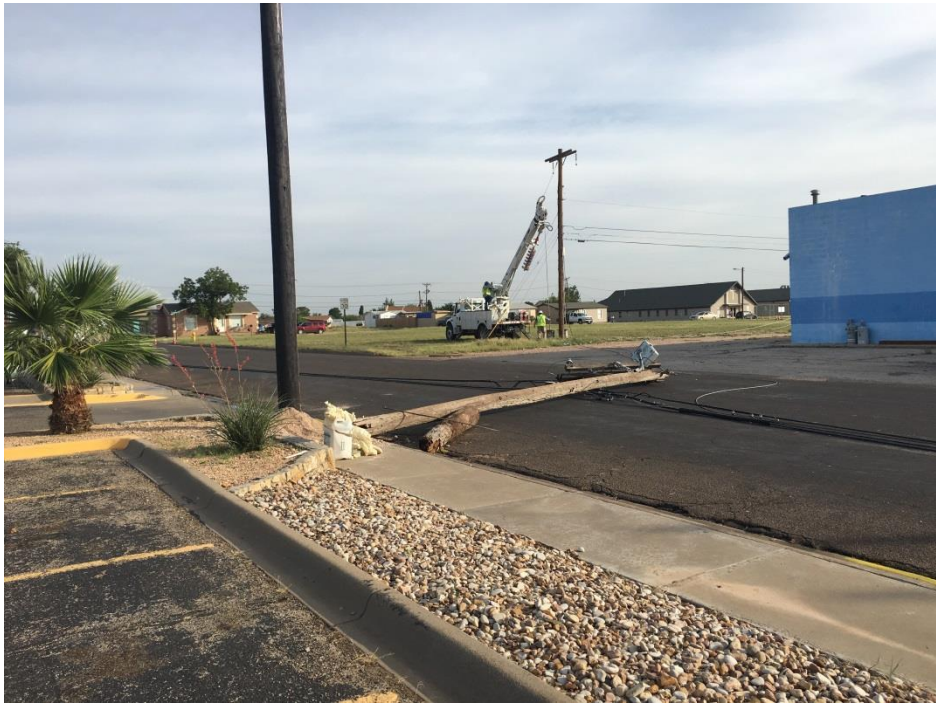
Figure 5 – Power poles snapped at the corner of Wall St and Powell St (Courtesy of Amber Hluchan).

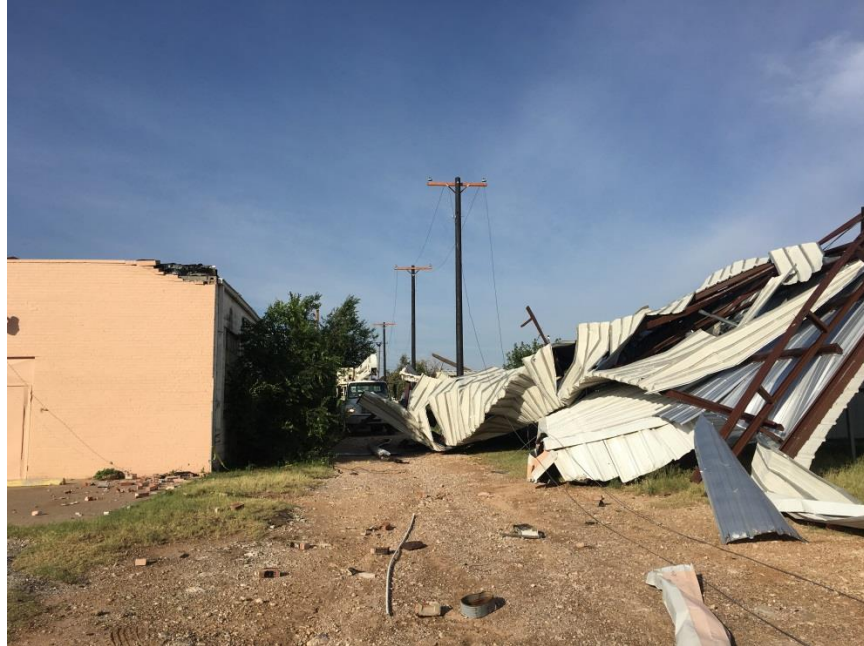
Figure 6 – Wind damage (Courtesy of Amber Hluchan).

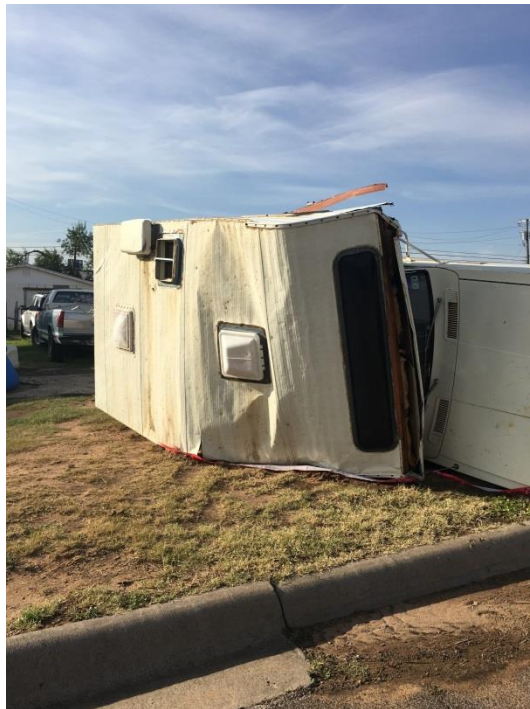
Figure 7 – Overturned camper (Courtesy of Amber Hluchan).
