March 28, 2017 Severe Weather Event

During the afternoon and evening hours of Tuesday, March 28, severe thunderstorms developed over a large portion of the Texas Permian Basin. On Wednesday, March 29, two teams from the National Weather Service in Midland surveyed the damage from these storms. The following are the results.

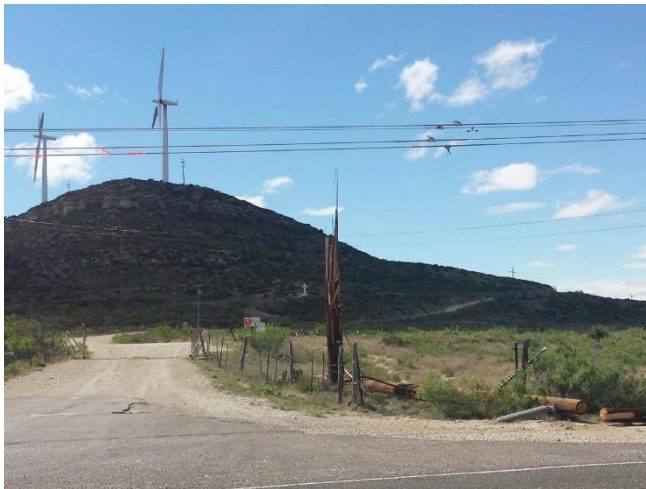
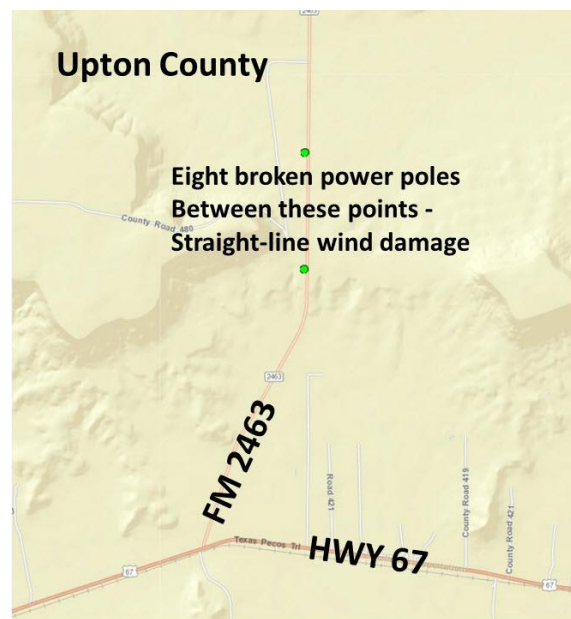
Upton County – King Mountain Road (7:04 pm CDT) – Straight-line winds

Along King Mountain Road (Farm to Market Road 2463), located just northeast of the community of McCamey, 8 power poles were snapped along an eight-tenths of a mile stretch of roadway. Radar data from around 704 pm CDT suggests that while there was a circulation associated with the severe thunderstorm in question, there was also an inflow of stronger winds on the back-side of the thunderstorm that resulted in the damage. Based on power pole damage, such as shown below, winds were estimated at around 80-100 mph at this location.

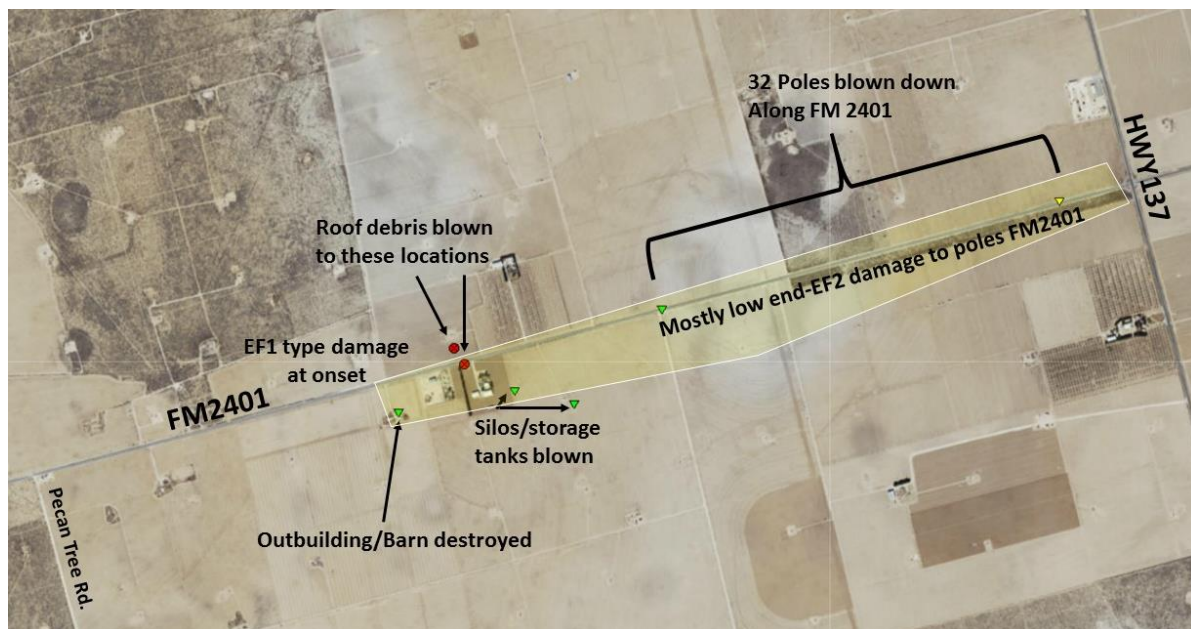
Tornado #2 – EF2 SW Glasscock County along FM 2401 (7:28-7:34 pm CDT)

The track of Tornado #2 can be seen in the image above, with a more detailed image seen below. Shortly after Tornado #1 dissipated, another Tornado #2 formed just slightly to the east of Tornado #1 along Farm to Market Road 2401. The team deliberated regarding several different scenarios that could have produced the damage seen along the 1.8 mile path. However, the mostly scenario is that a relatively narrow tornado (50-75 yards wide) moved almost parallel and just south of FM 2401 during a 1.8 mile stretch, before finally weakening somewhere near Highway 137.

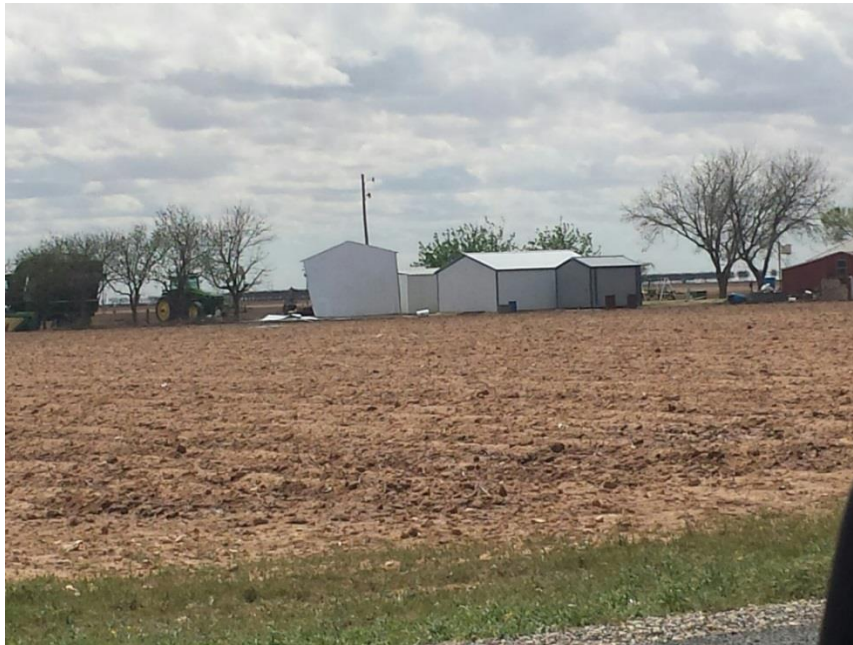
A small barn or outbuilding was destroyed by the tornado at approximately 7:28 pm. In the image below, one wall of the structure remains. This type of damage is indicative of EF1 damage with winds of approximately 100-110 mph. Pieces of the metal roof were blown northeastward across FM 2401 into an open field.

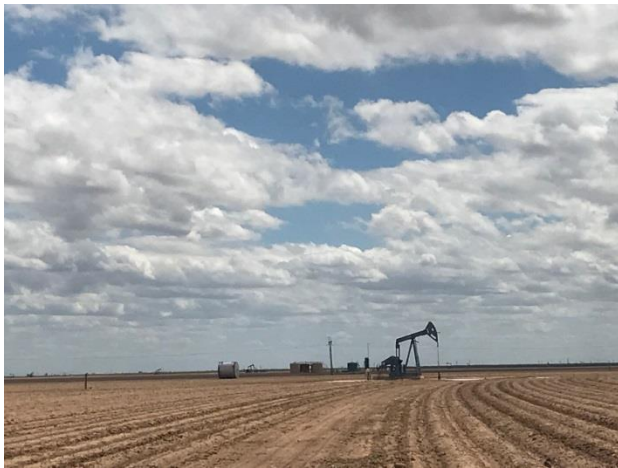
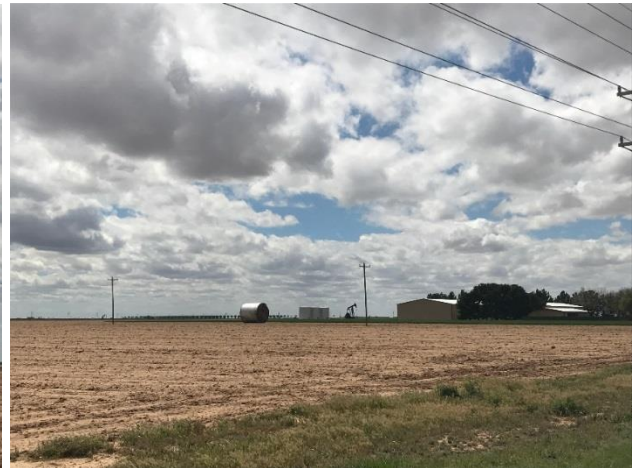
Similar winds speeds likely resulted in two silos/storage tanks being displaced from their original locations.

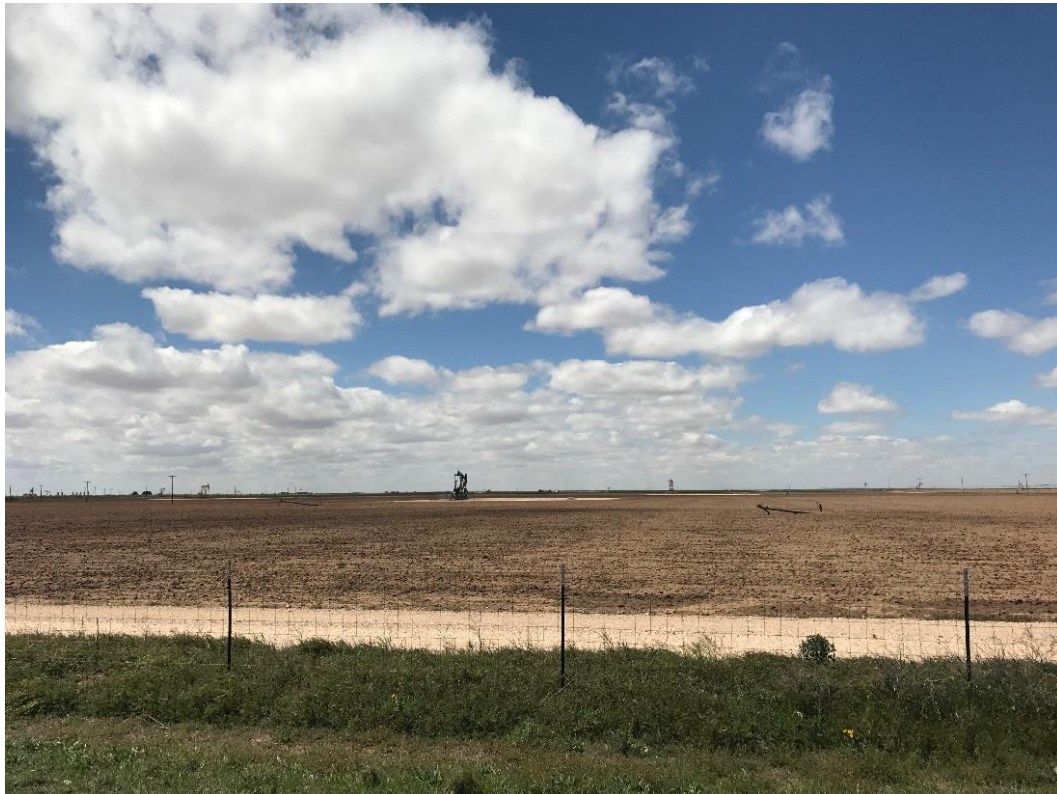
Northwest of Garden City – Farm to Market Road 415 – Straight line winds (7:58 pm CDT)

In dynamic wind situations like this, it is very common to see widespread power pole damage. Many locations across the Permian Basin experienced wind speeds between 60-80 mph, with higher gusts, on Tuesday evening. The image below shows damage that was likely seen in several locations across the area. This particular example is from just northwest of the community of Garden City along Farm to Market Road 415.

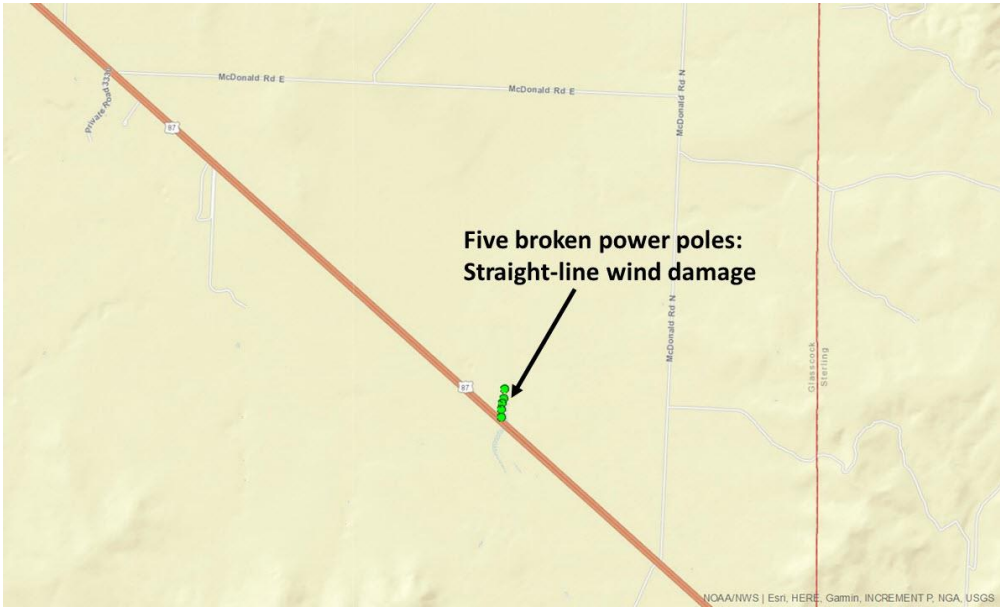
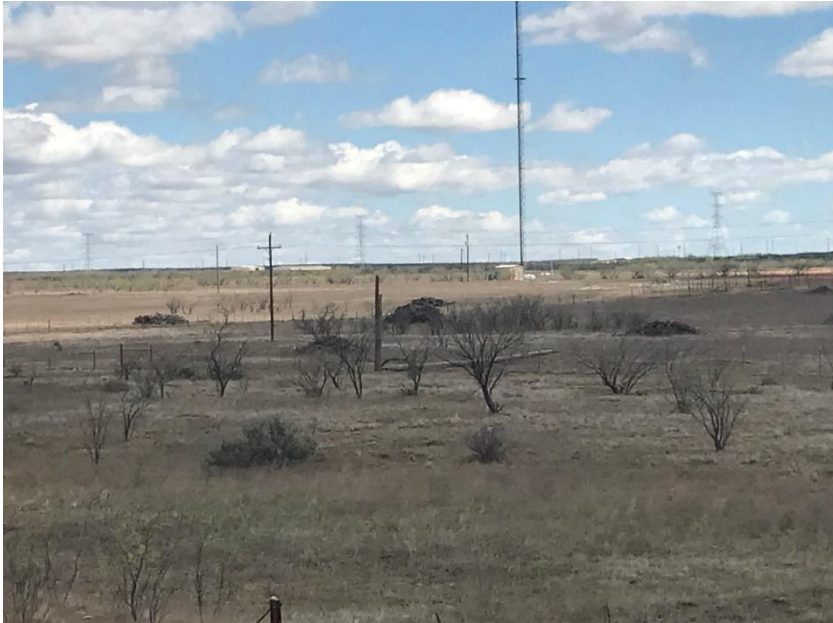
Northeast Glasscock County south of Forsan – Highway 87 - Straight line winds. (8:07 pm CDT)

Along Highway 87 in northeast portions of Glasscock County, straight-line wind damage was noted. Inspection of radar data also confirmed this. The team counted five power poles down at this location, although others may have been worked on at this location. The pole damage was of varying degrees with wind speeds estimated in the 80-100 mph range.
