June 14, 2017 Odessa, Texas Wind and Hail Event:

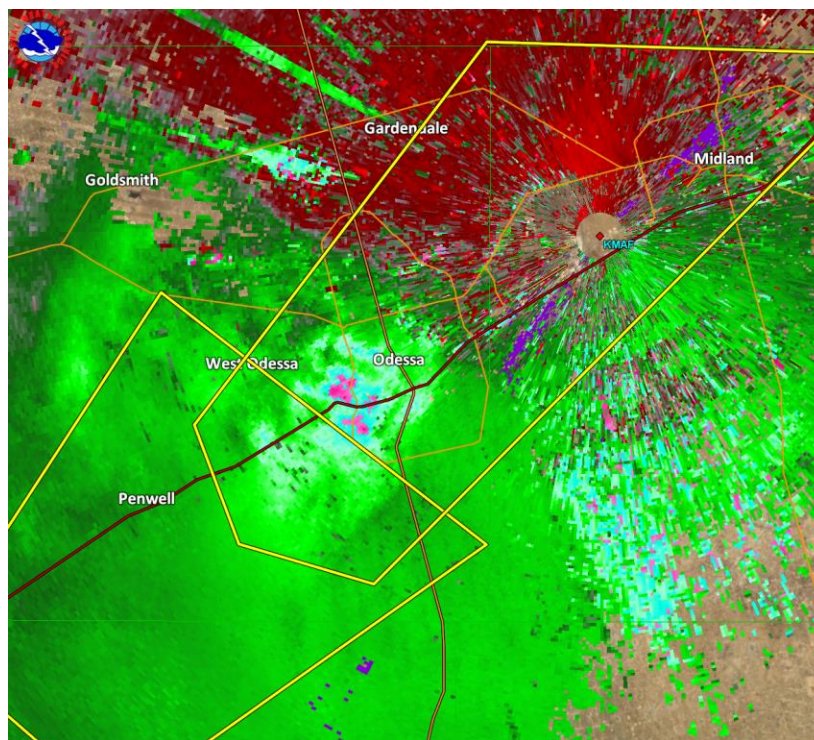
Figure 3 – Base velocity imagery at 6:41 pm CDT with winds greater than 70 mph over West Odessa, Texas.

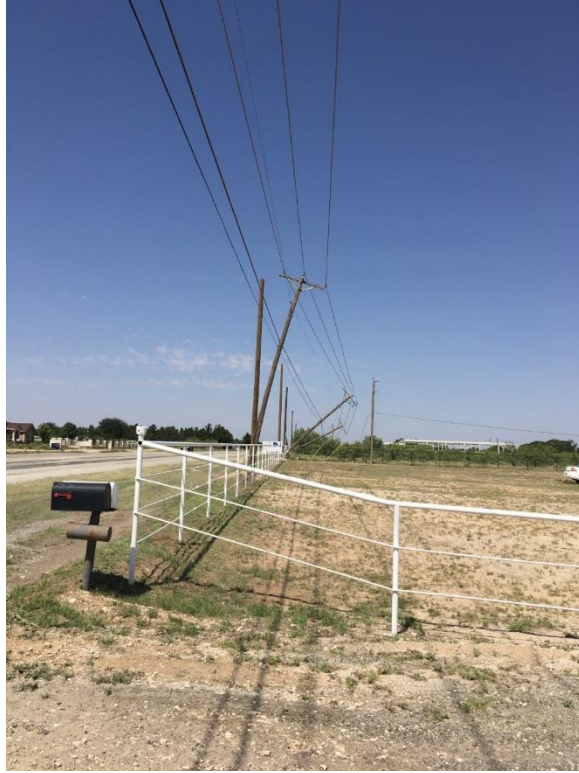
The storm survey noted damage across a wide area of Odessa and West Odessa. There were reports of damage to buildings at the University of Texas Permian Basin. Figure 6 shows power polls snapped (16 were snapped) along W 16th Street in West Odessa. This was likely caused by a microburst with estimated wind speeds of 100 mph. There were numerous reports of baseball size (2.75 inches) or larger hail (Figures 7 and 8); and the storm survey found evidence of hail possibly larger than softball size (4.50 inches). Figure 9 shows the La Quinta hotel near Faudree Road and Highway 191 with nearly every west facing window broken by hail. Figure 10 shows roof damage from hail at the Odessa Country Club. Figure 11 shows hail damage to a vehicle at the Dorado Ranch Apartments near Faudree Road. Figure 12 shows hail damage to a house in central Odessa near E 42nd Street. Figure 13 shows hail damage to the Sherwood Baptist Church in central Odessa near E 42nd Street. Figure 14 shows a tree uprooted in central Odessa near E 42nd Street.

Figure 6 – Power polls snapped along W 16th Street in West Odessa, Texas.

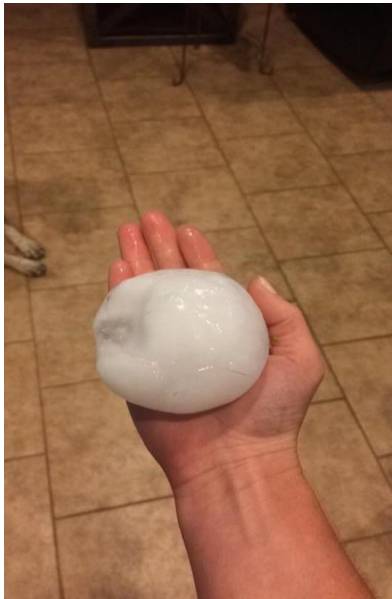
Figure 7 – Softball size hail at Mission Dorado in Odessa, Texas (Courtesy of Joie Belt).

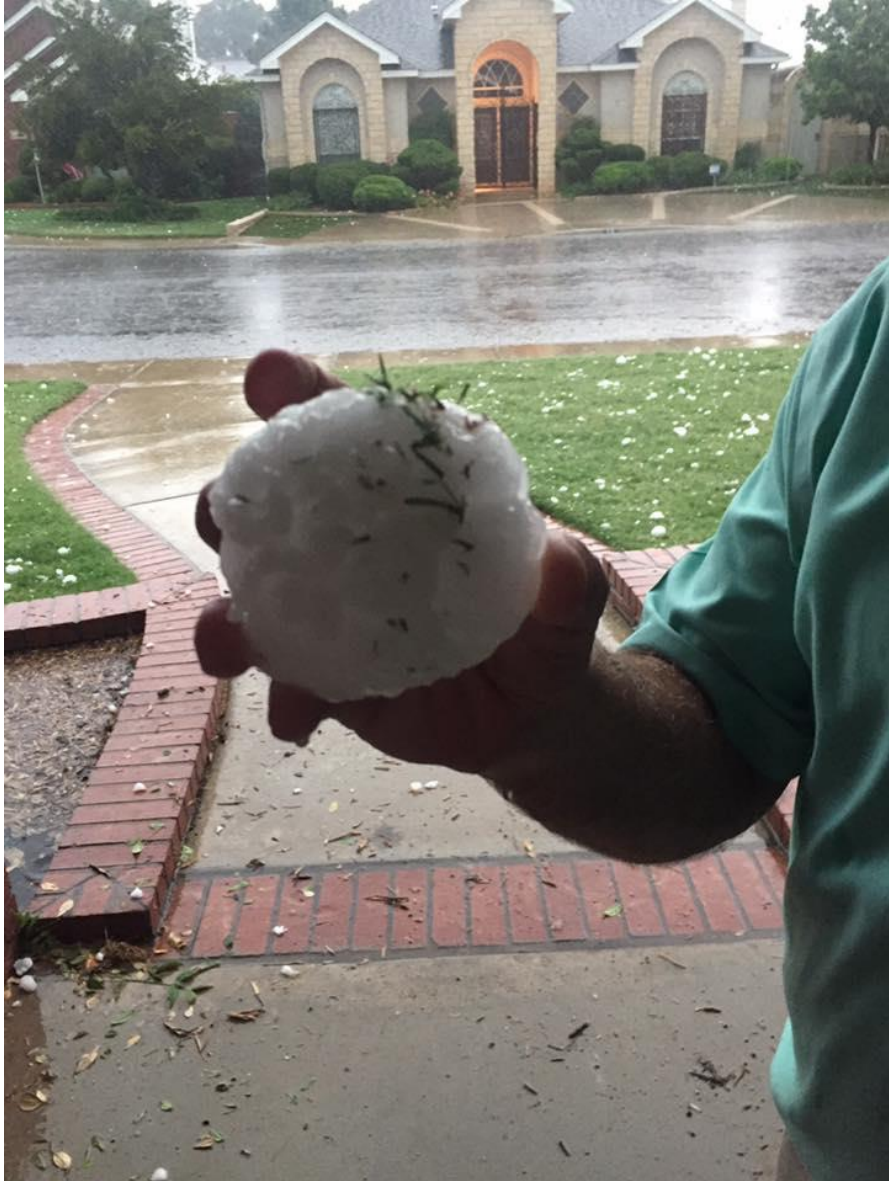
Figure 8 – Softball size hail in Odessa, Texas (Courtesy of Virginia Chisum).

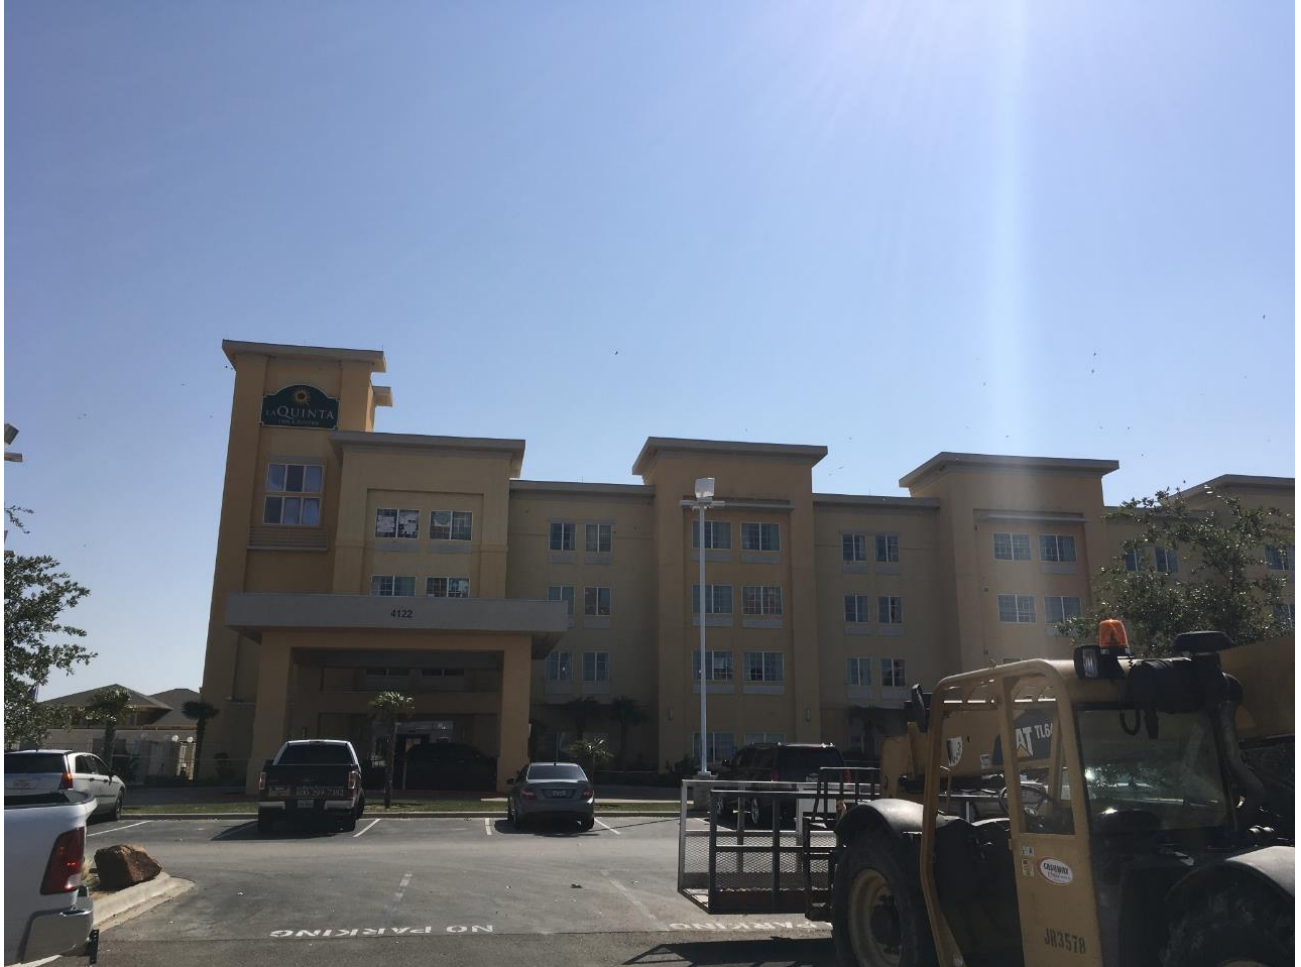
Figure 9 – Broken windows from hail at the La Quinta hotel near Faudree Road and Highway 191 in Odessa, Texas.

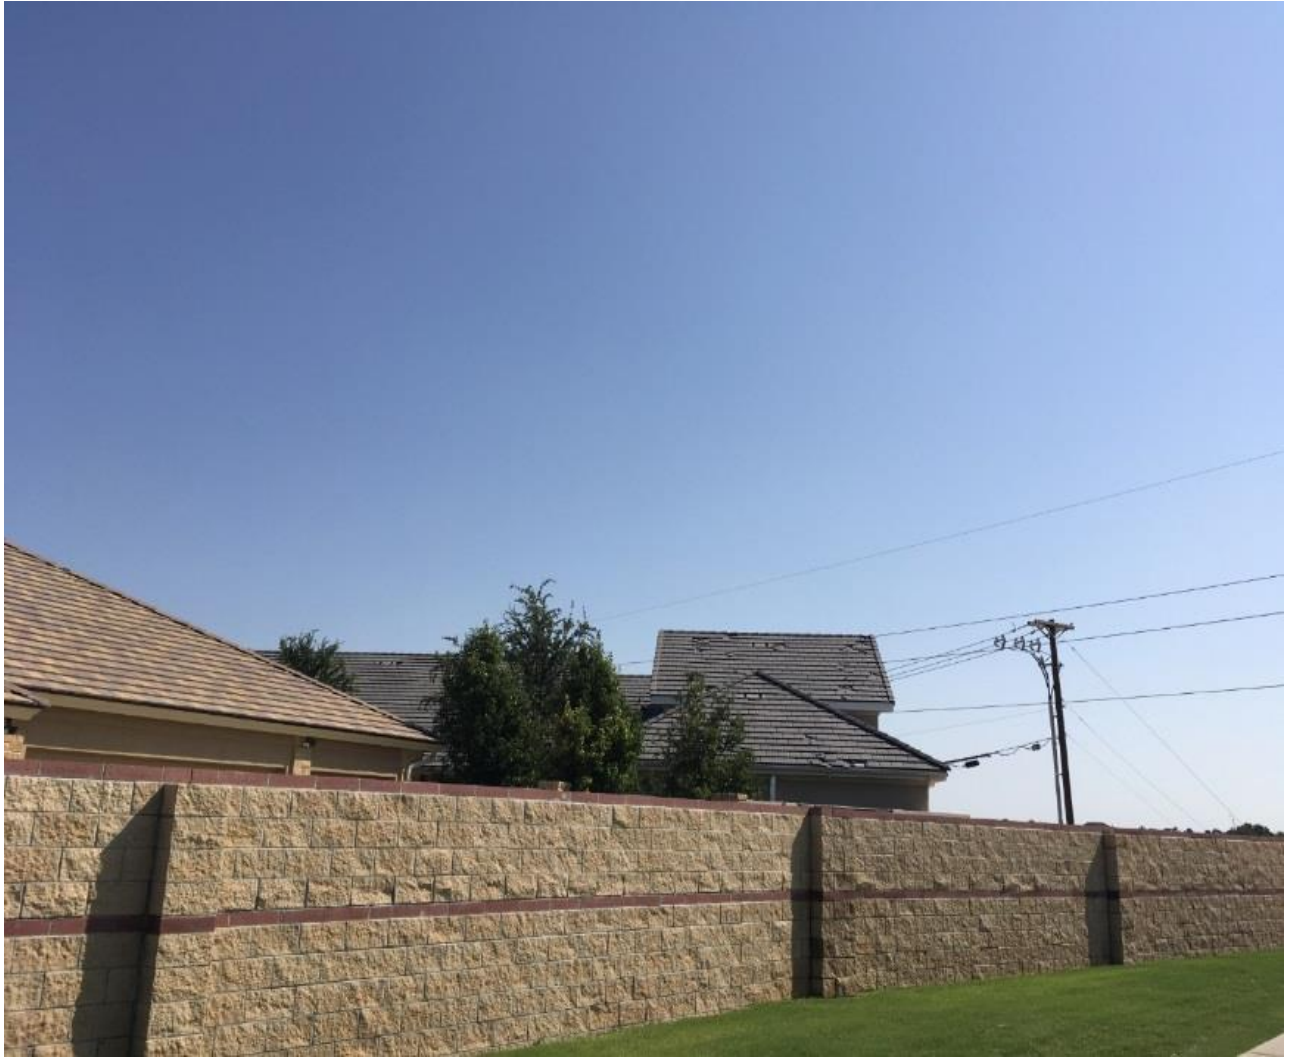
Figure 10 – Roof damage from hail at the Odessa Country Club in Odessa, Texas.

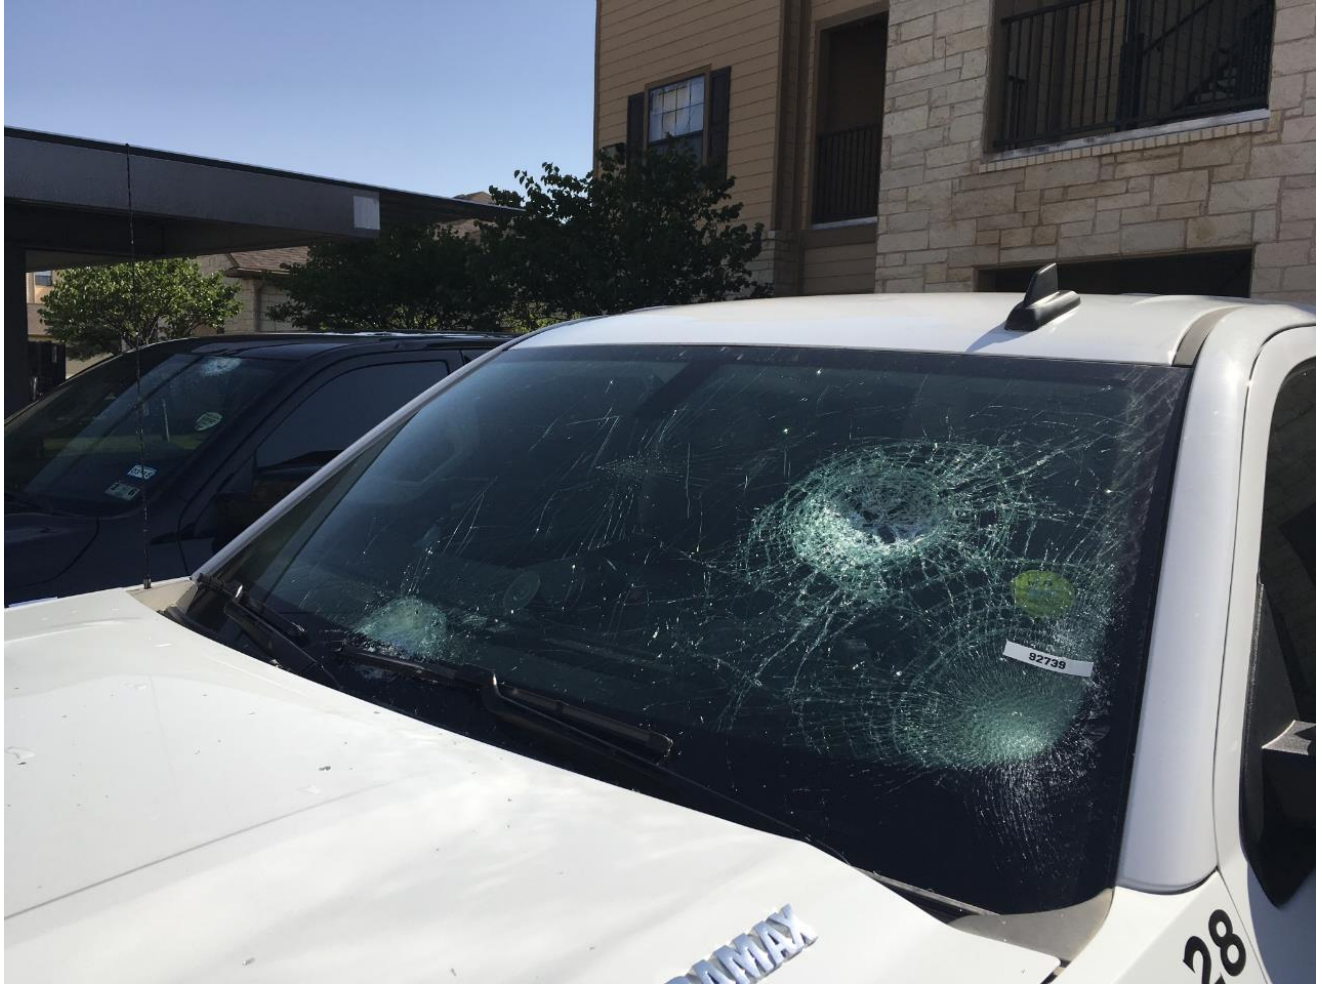
Figure 11 – Hail damage to vehicle at Dorado Ranch Apartments in Odessa, Texas.

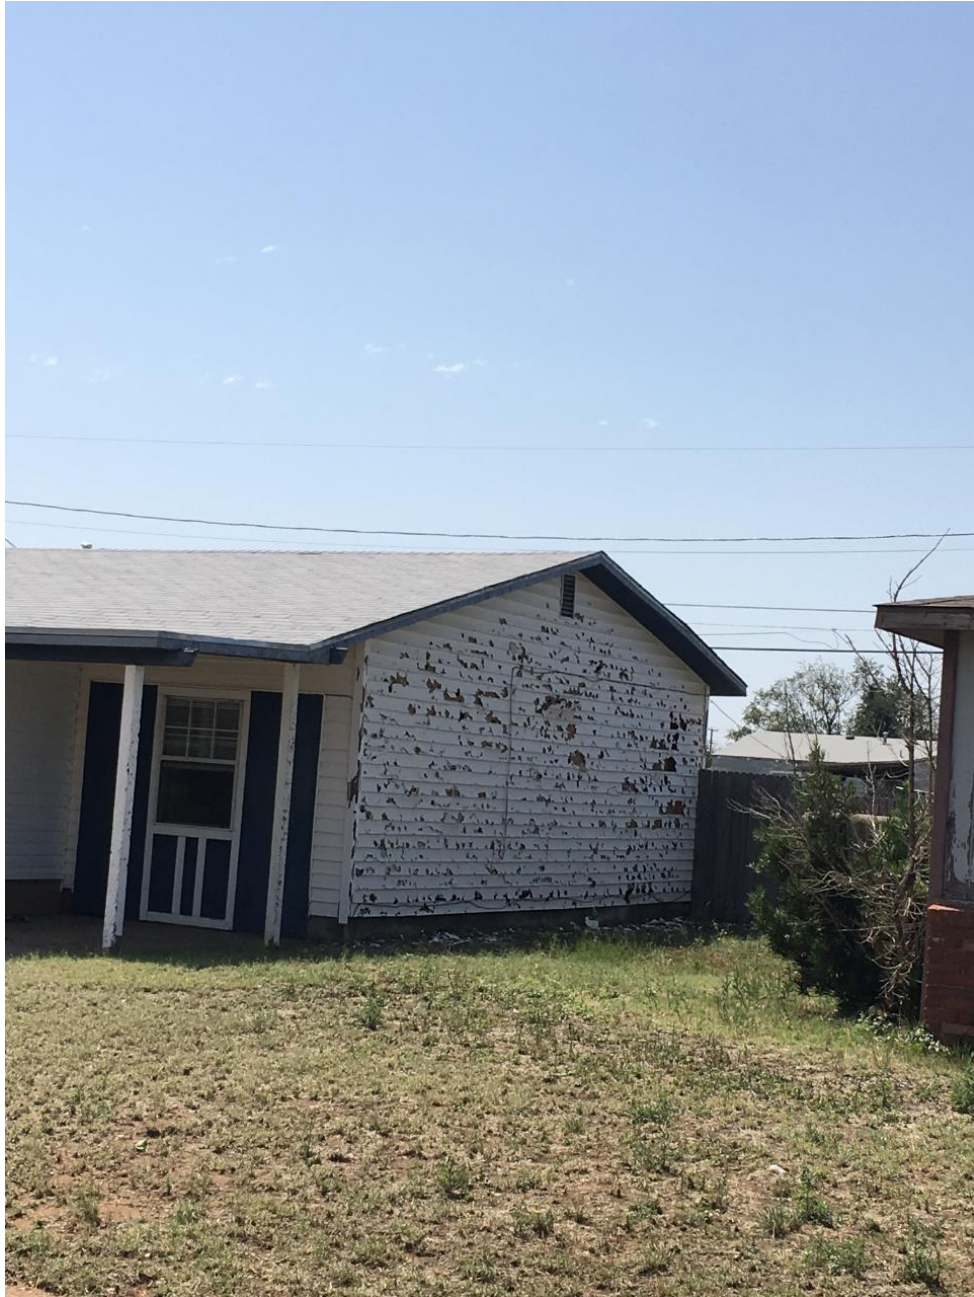
Figure 12 – Hail damage to a house near E 42nd Street in central Odessa, Texas.

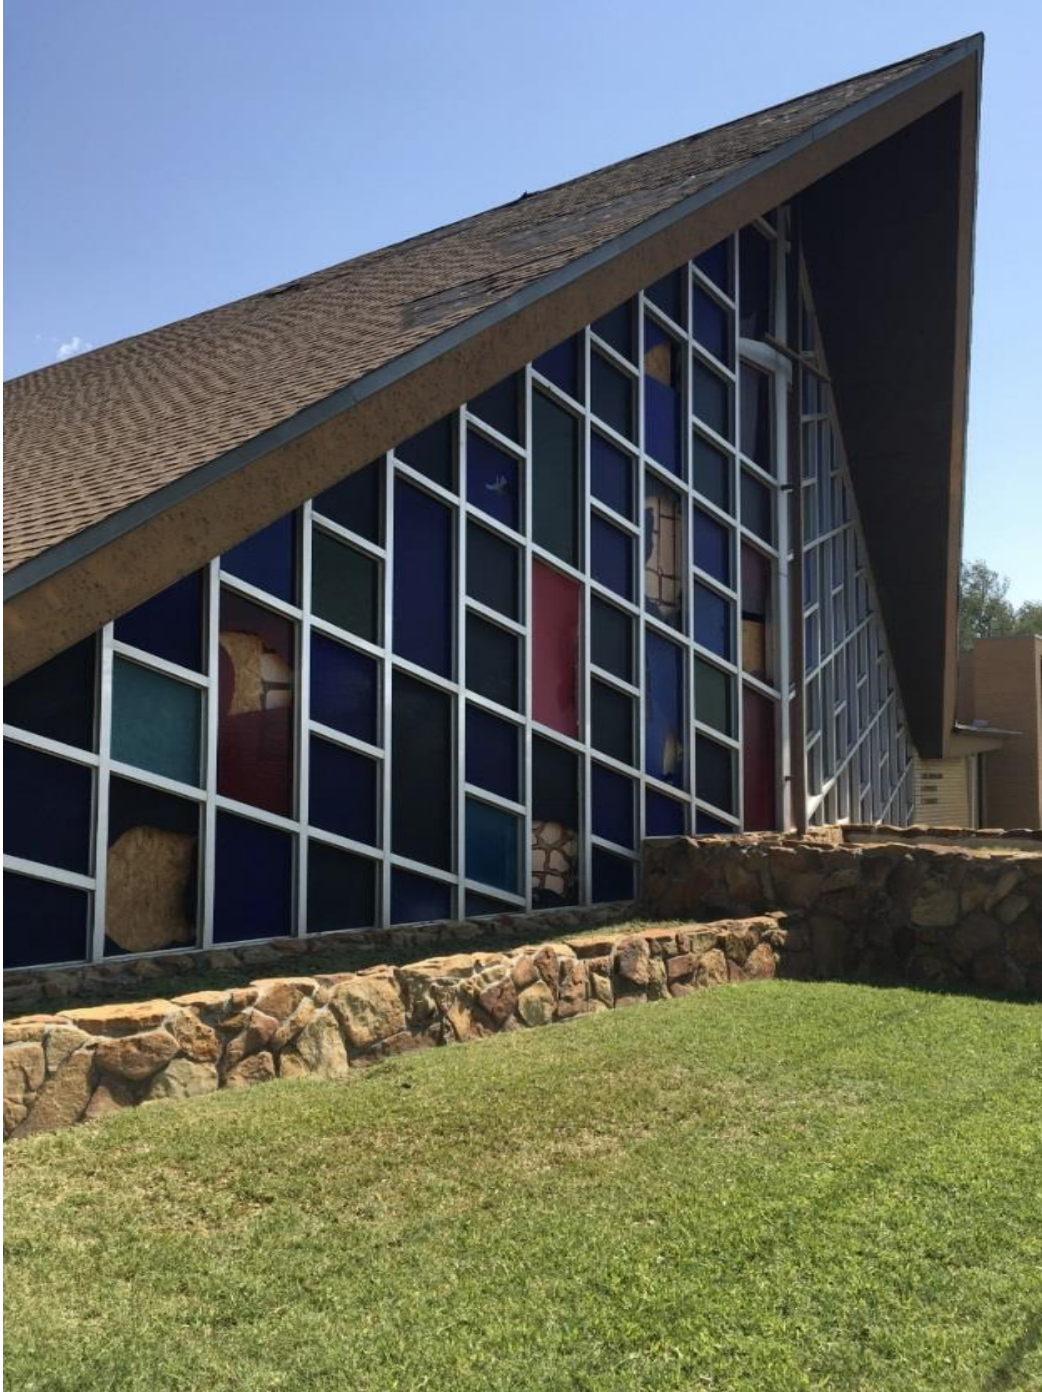
Figure 13 – Hail damage at Sherwood Baptist Church near E 42nd Street in central Odessa, Texas.

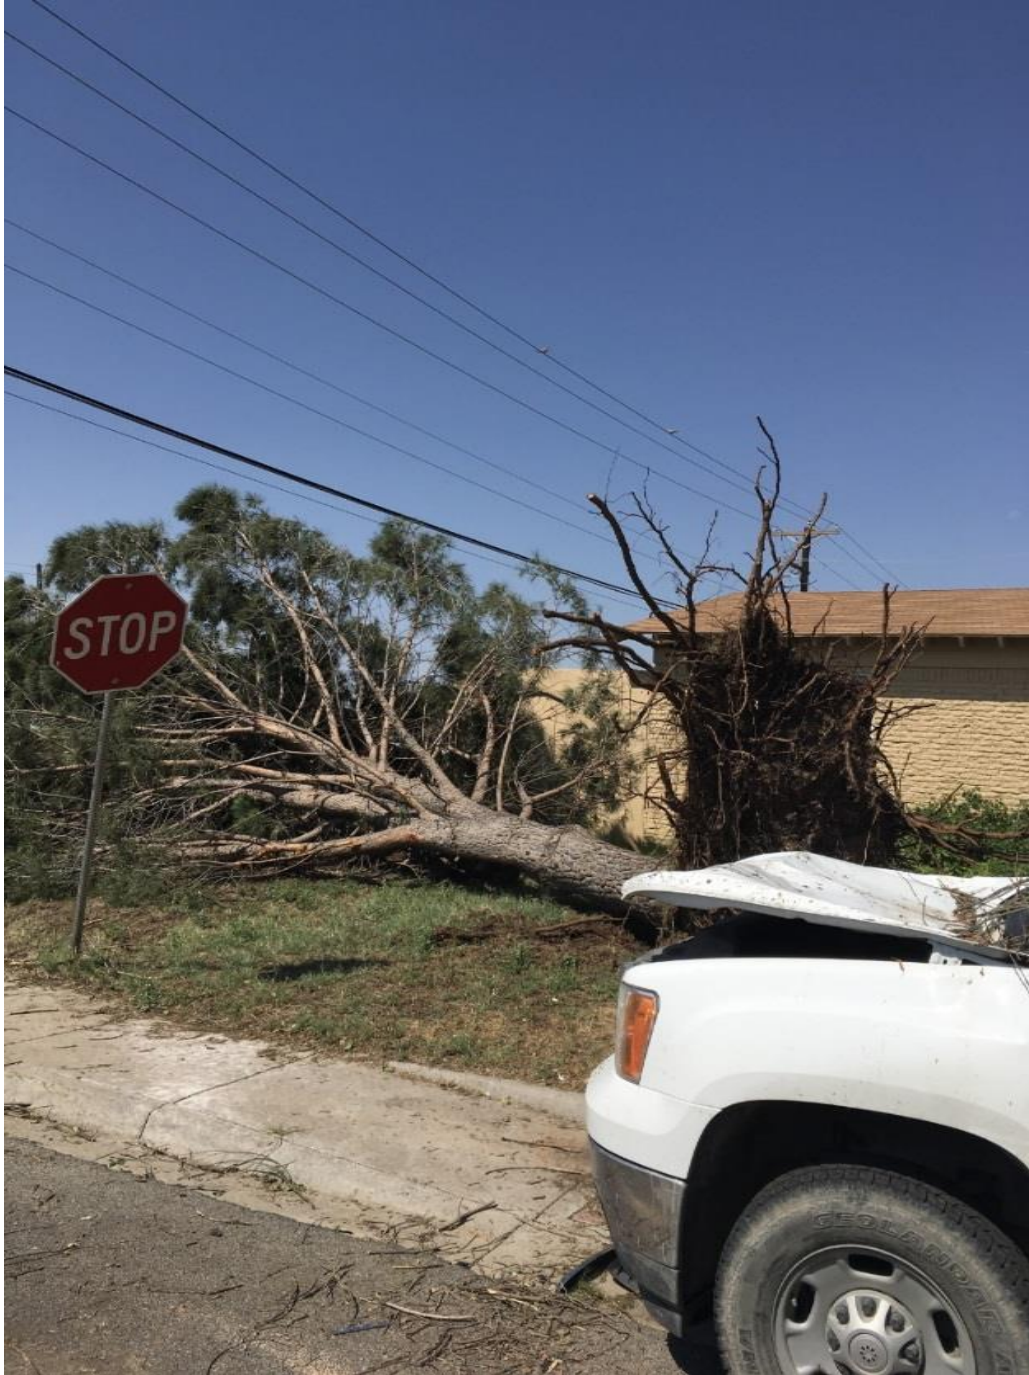
Figure 14 – Tree uprooted near E 42nd Street in central Odessa, Texas.
