Severe Weather Impacts from Tuesday March 12, 2019

On Thursday, March 14, the National Weather Service in Midland conducted damage surveys at 3 locations that were impacted by severe weather on Tuesday evening and very early Wednesday morning. The following are the determinations of those teams:

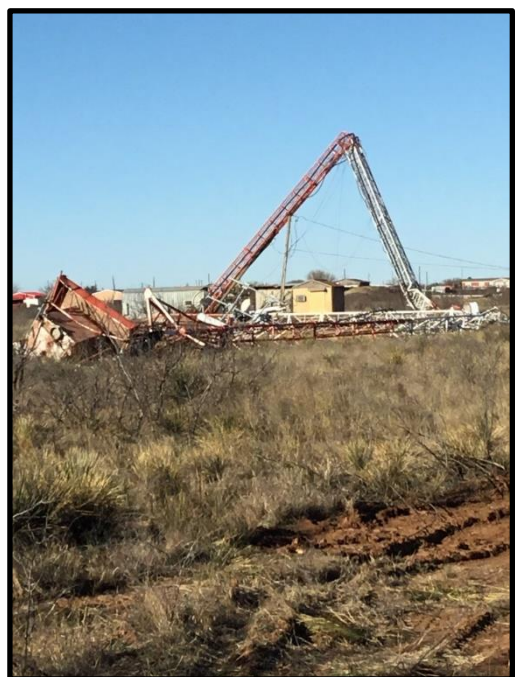
With the close correlation of the meso-circulation with observed damage, the survey team determined that damage was the result of a tornado. Damage to outbuildings, residential structures, power poles, and to a 300-foot transmission tower (image to the right) suggest that the most significant damage is indicative of a moderate to high end EF-1 tornado, with wind speeds estimated at 80-100 mph. The tornado was estimated to be 1/5 mile wide and traveled northeast along a path approximately 3.5 miles long. Based on radar and damage information, it is believed that the tornado had a life span of 6 minutes, from approximately 9:55 pm to 10:01 pm. The radar image below, from 10:02 pm CDT, shows the pronounced rear inflow notch, a weakened and occluding circulation, and a newly developing circulation further south.

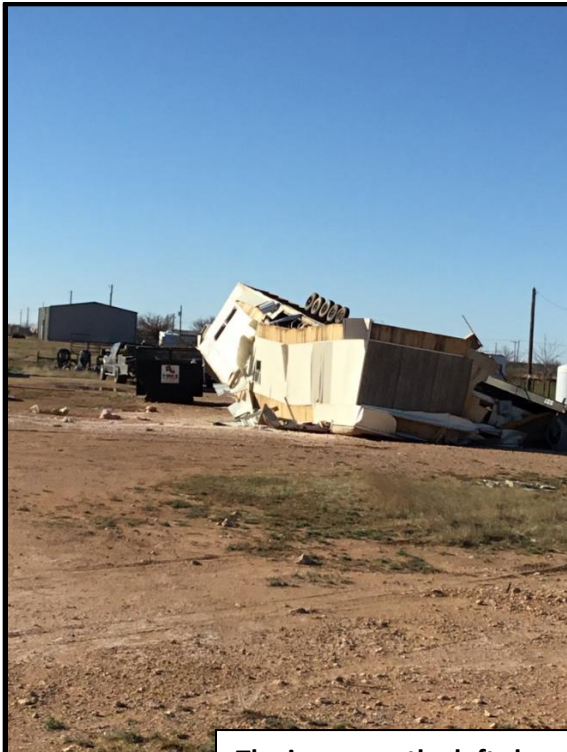
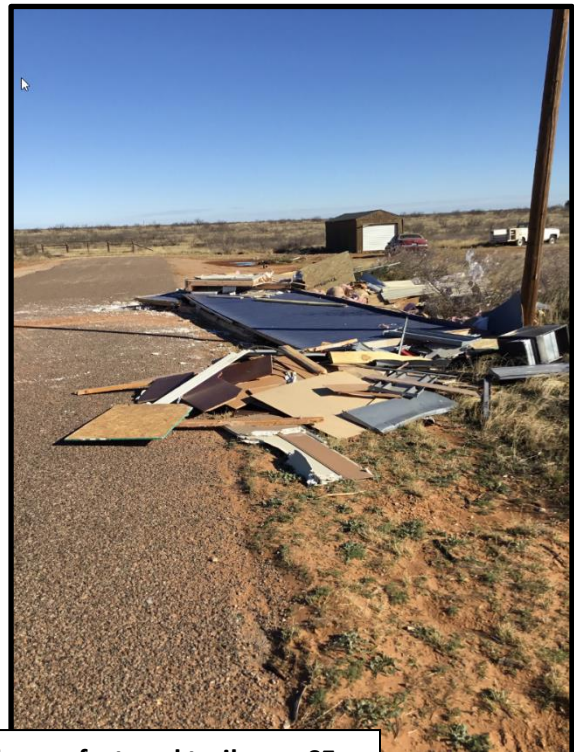
The image on the left shows a rolled manufactured trailer on SE 650 Rd. On the right is a destroyed outbuilding on SE 2601 Rd.

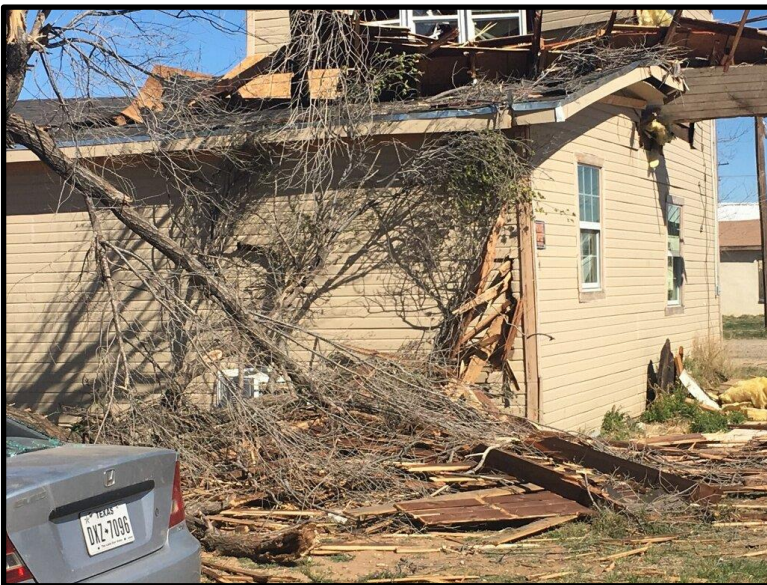
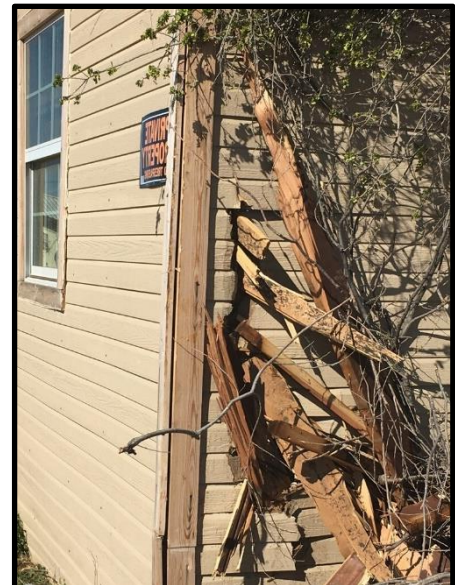
The images above show debris blown from a local business at least a block away. Photos provided by Nathan Hines.

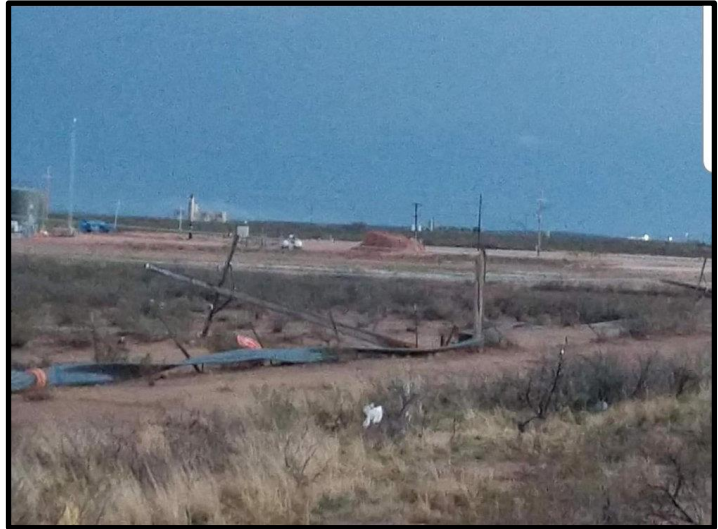
Damaged power poles (image to the right, provided by Malaga Volunteer Fire Dept.) along Highway 285 were located slightly further south than was indicated on radar, 3.75 miles to 4.05 miles south of Malaga. This was used as a starting point. With the tornado crossing the power poles at approximately a 45-degree angle, the width of the tornado was estimated at 1/5 mile.

Approximately 10 power poles that were damaged to some degree as the tornado crossed Highway 285. Poles on the north and south limits were snapped at 1/2 to 2/3 height from the ground, while near the center-line of the tornado's path, poles were snapped close to ground level. The observed damage is consistent with damage of an EF2 tornado, with winds estimated at approximately 112 mph.

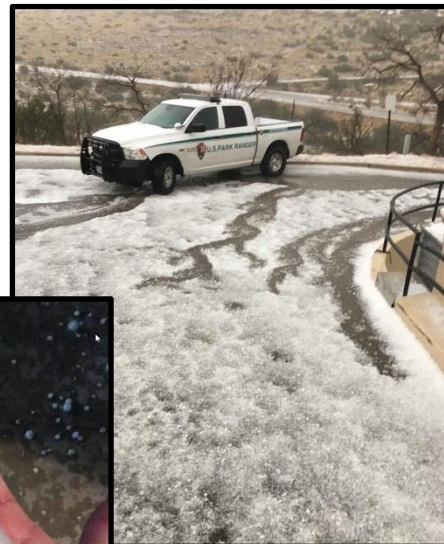
Photo above provided by Carlsbad Caverns Park Ranger, David Hall.

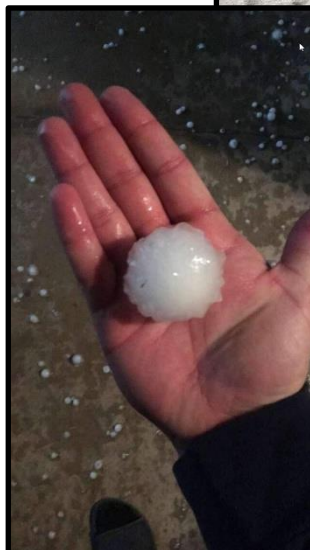
Photo to the left of Loving, NM hail provided by Wendell Malone.
