## December 16, 2007 Land O' Lakes Tornado Damage Survey

**Anthony Reynes, Daniel Noah - NWS Tampa Bay**

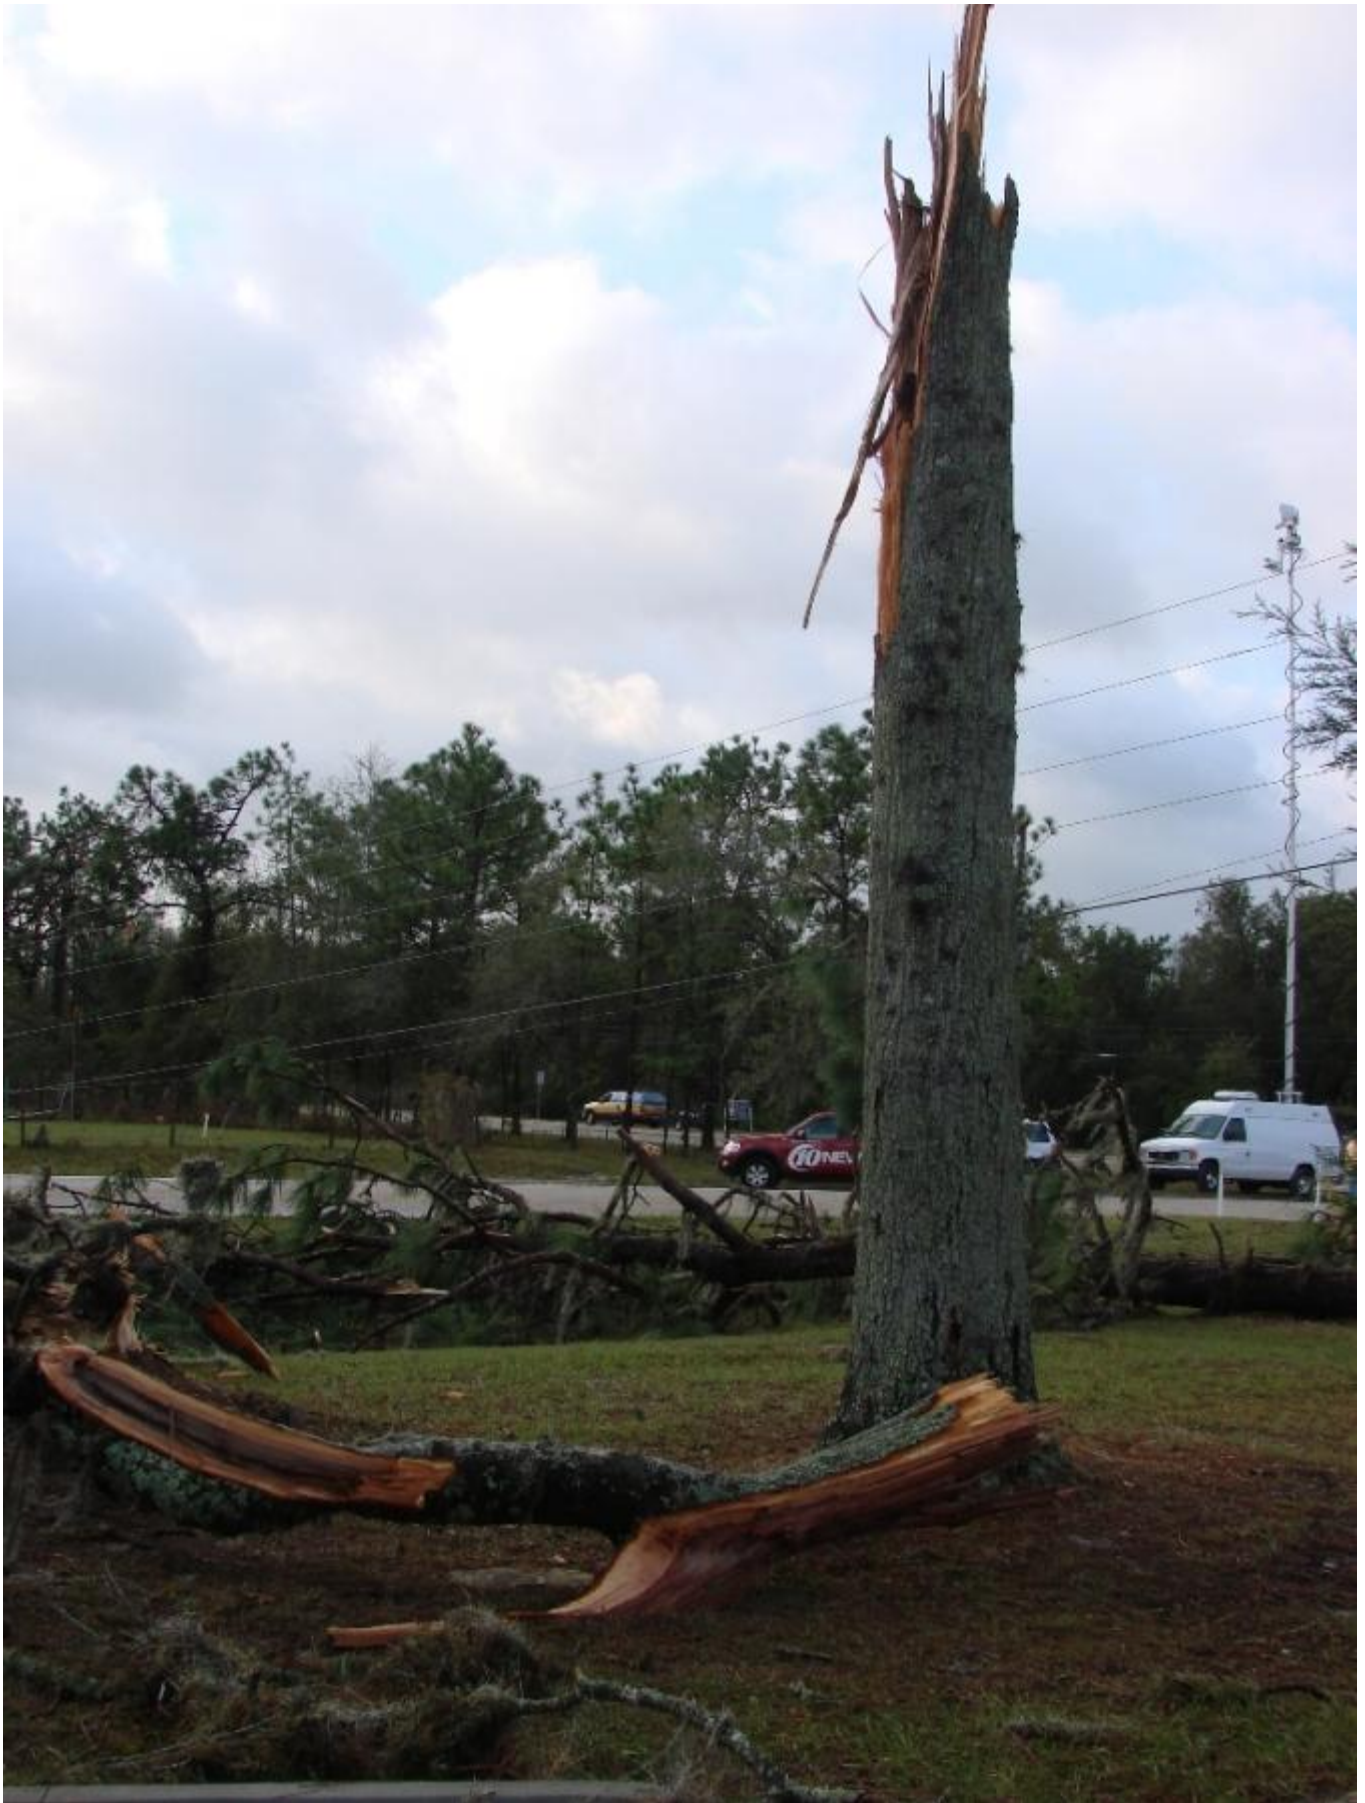
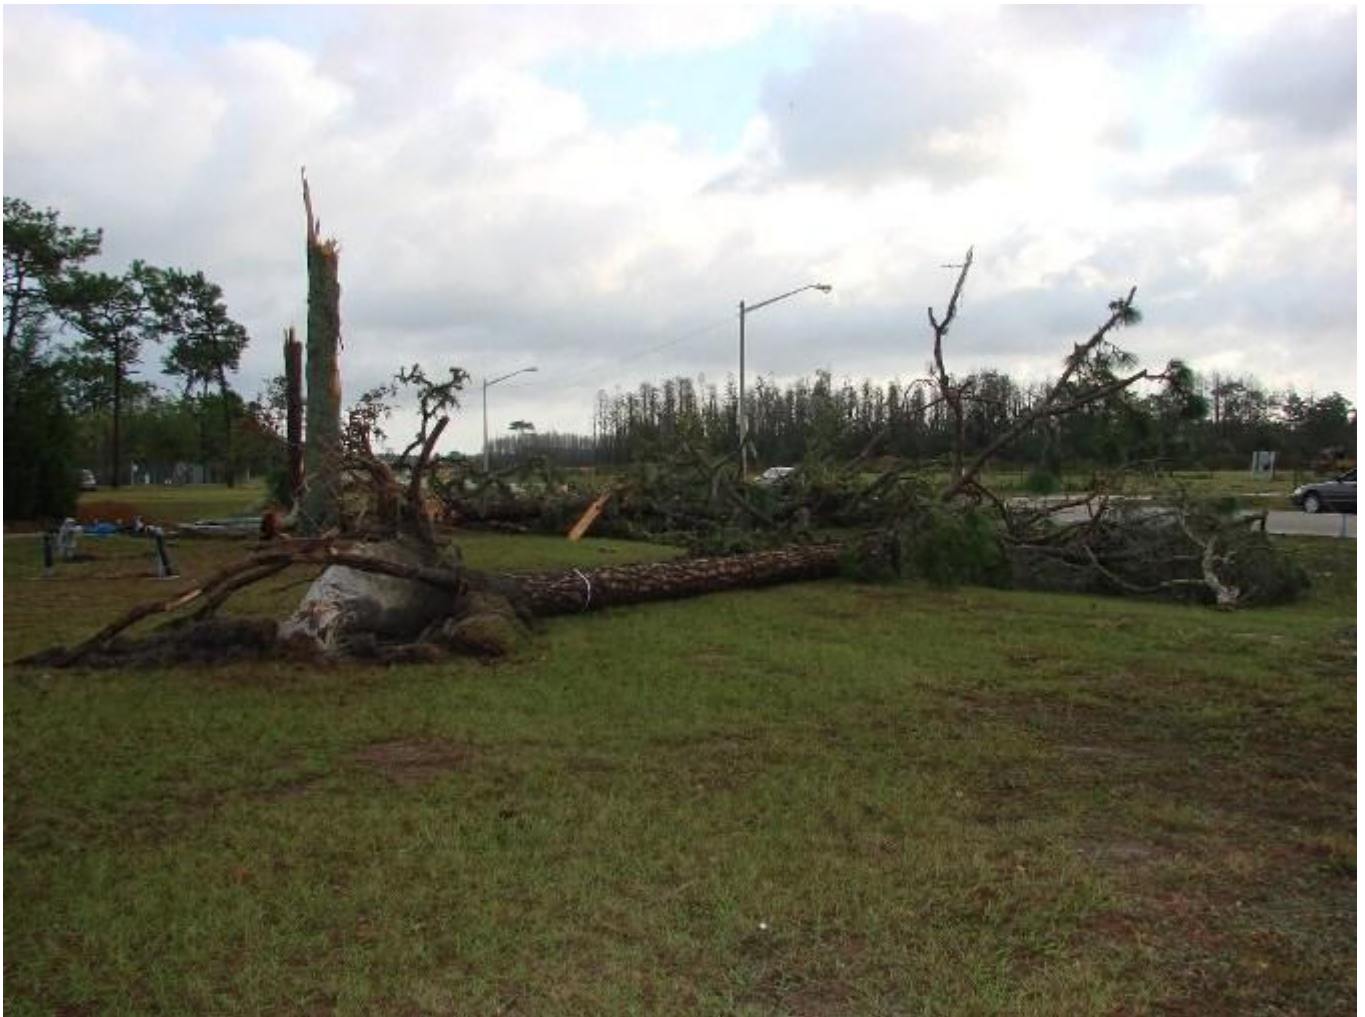
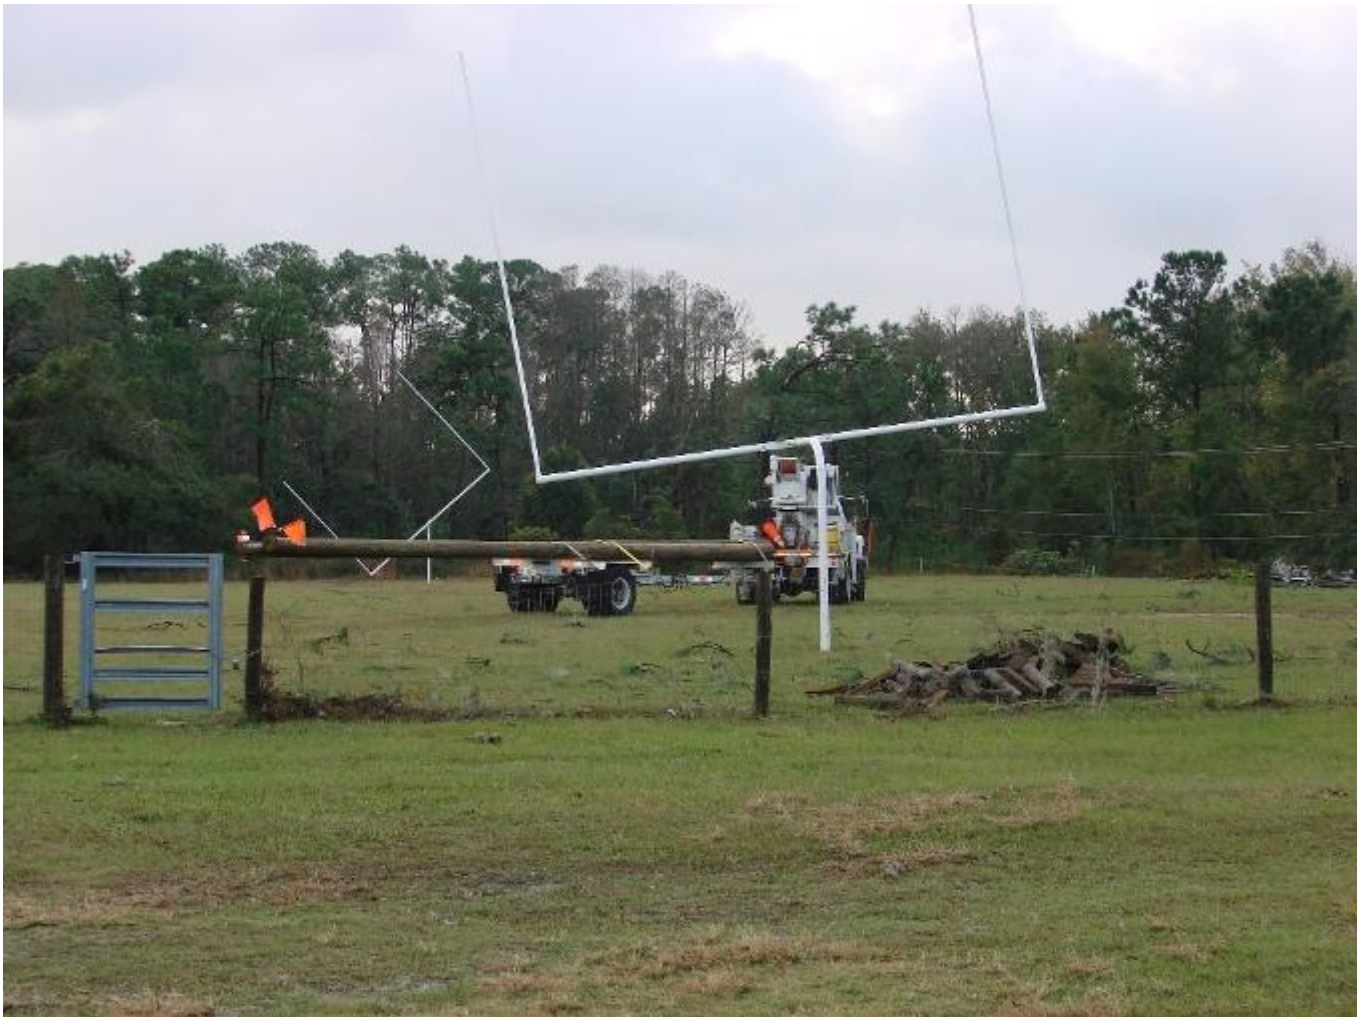
The path of damage (Figures 3 through 7) began with two large trees in front of the Fire House. An adjacent football field was also damaged by the winds. Half a mile down the road, the tornado struck gardening facilities and a pig farm. A hydroponic garden structure was destroyed, along with a large storage shed. A large field of scattered debris was found.

**Figure 3.** Site A damage (beginning of Central Blvd Rd and Fire House Station).

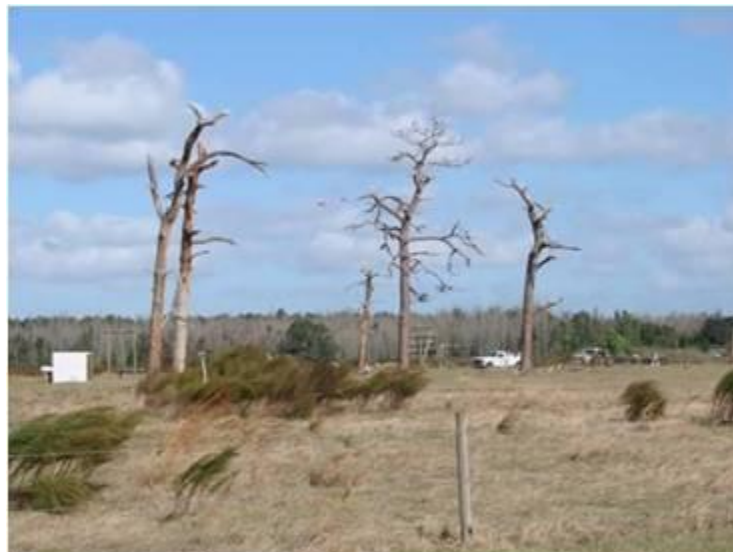
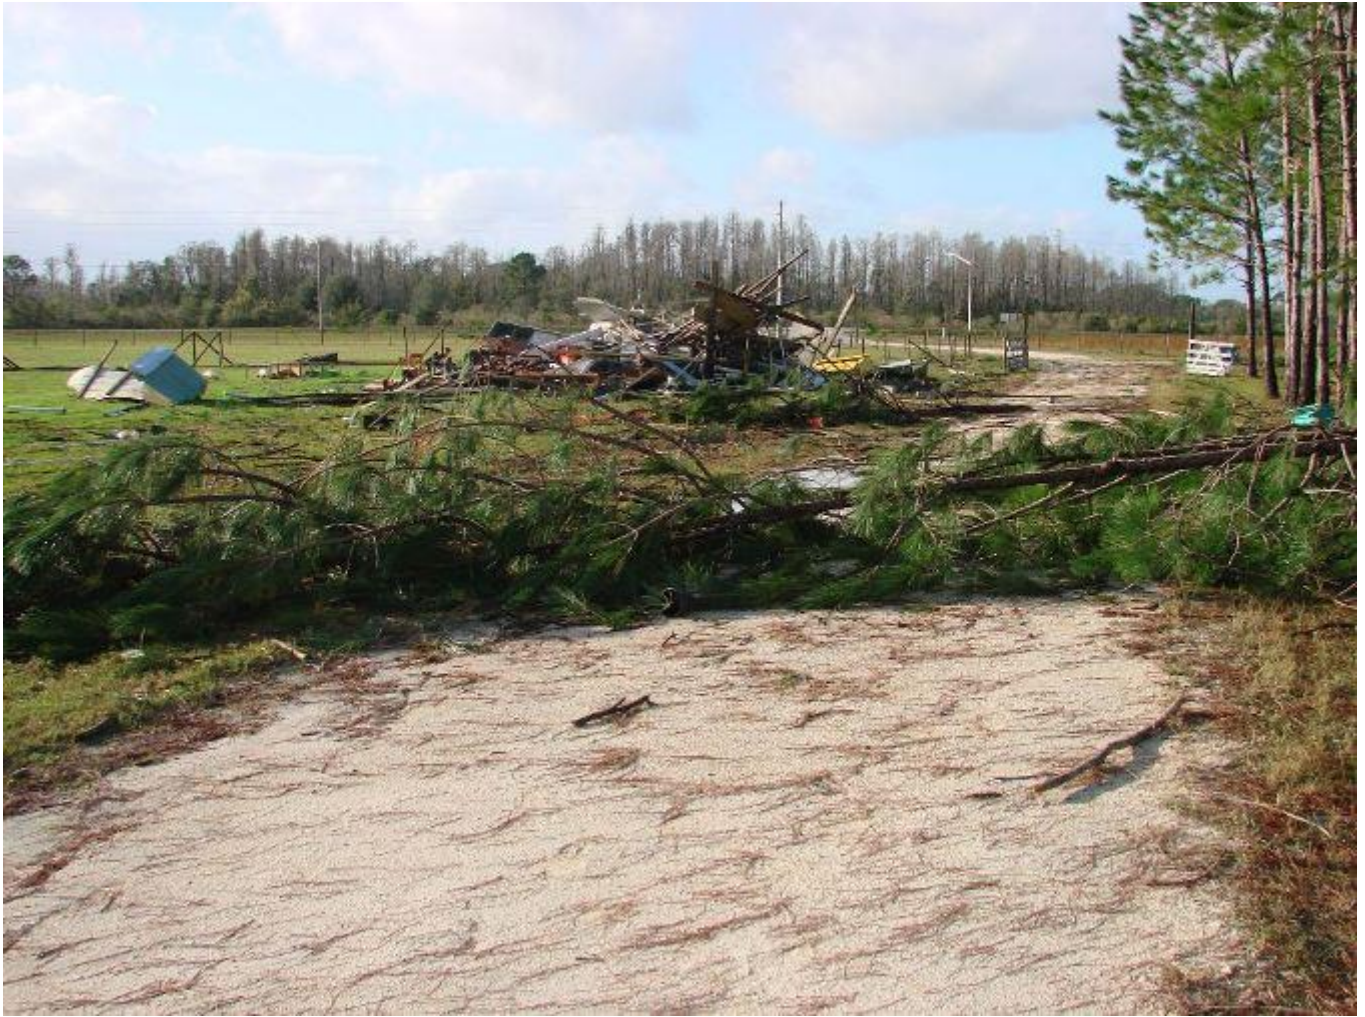
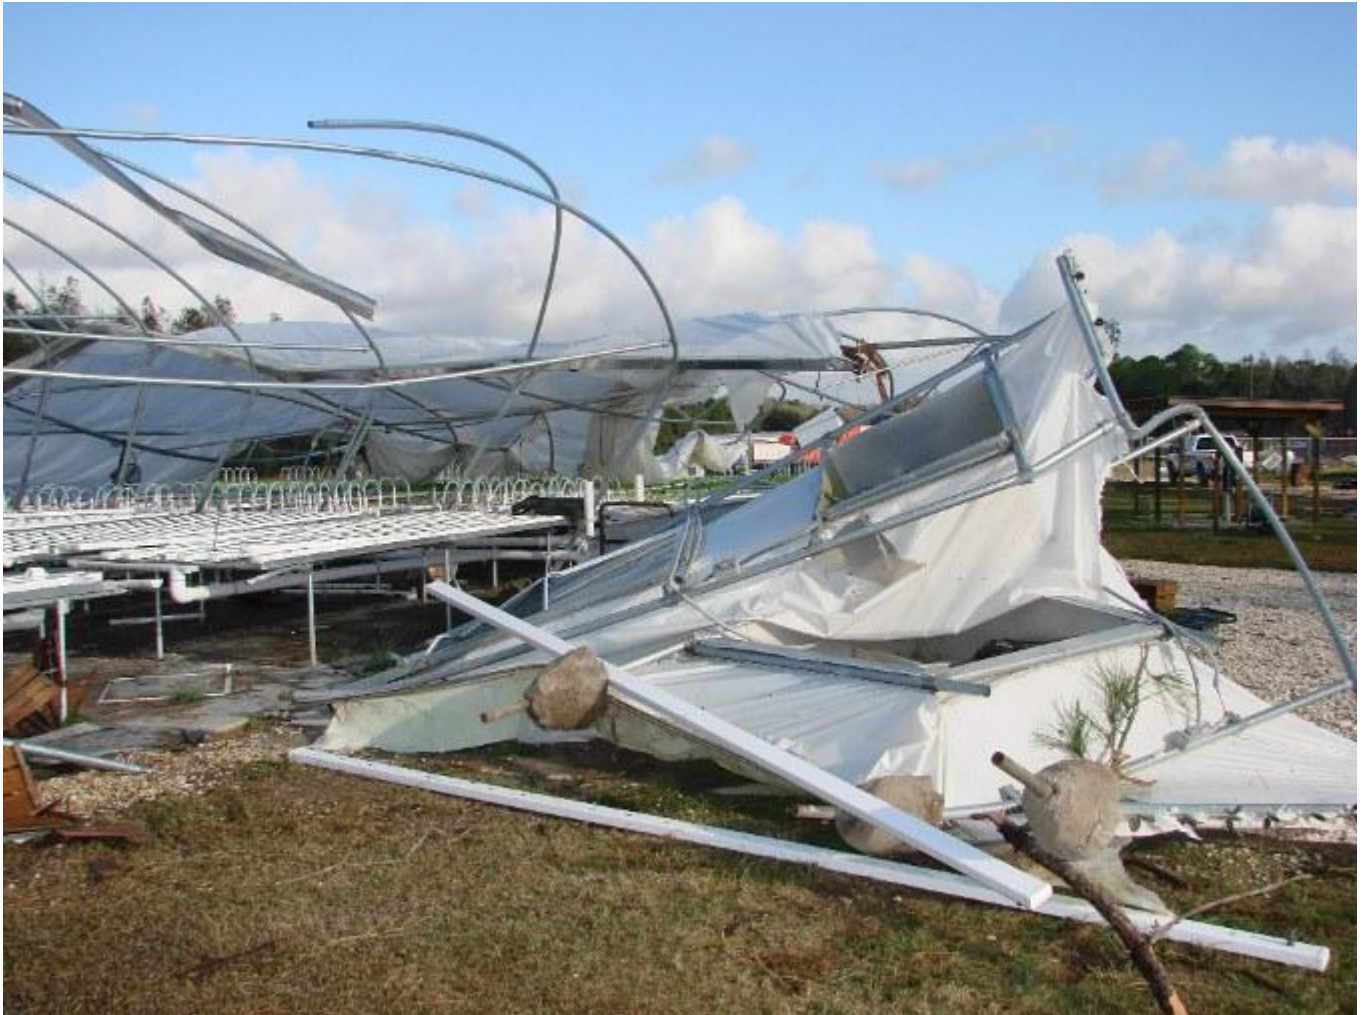
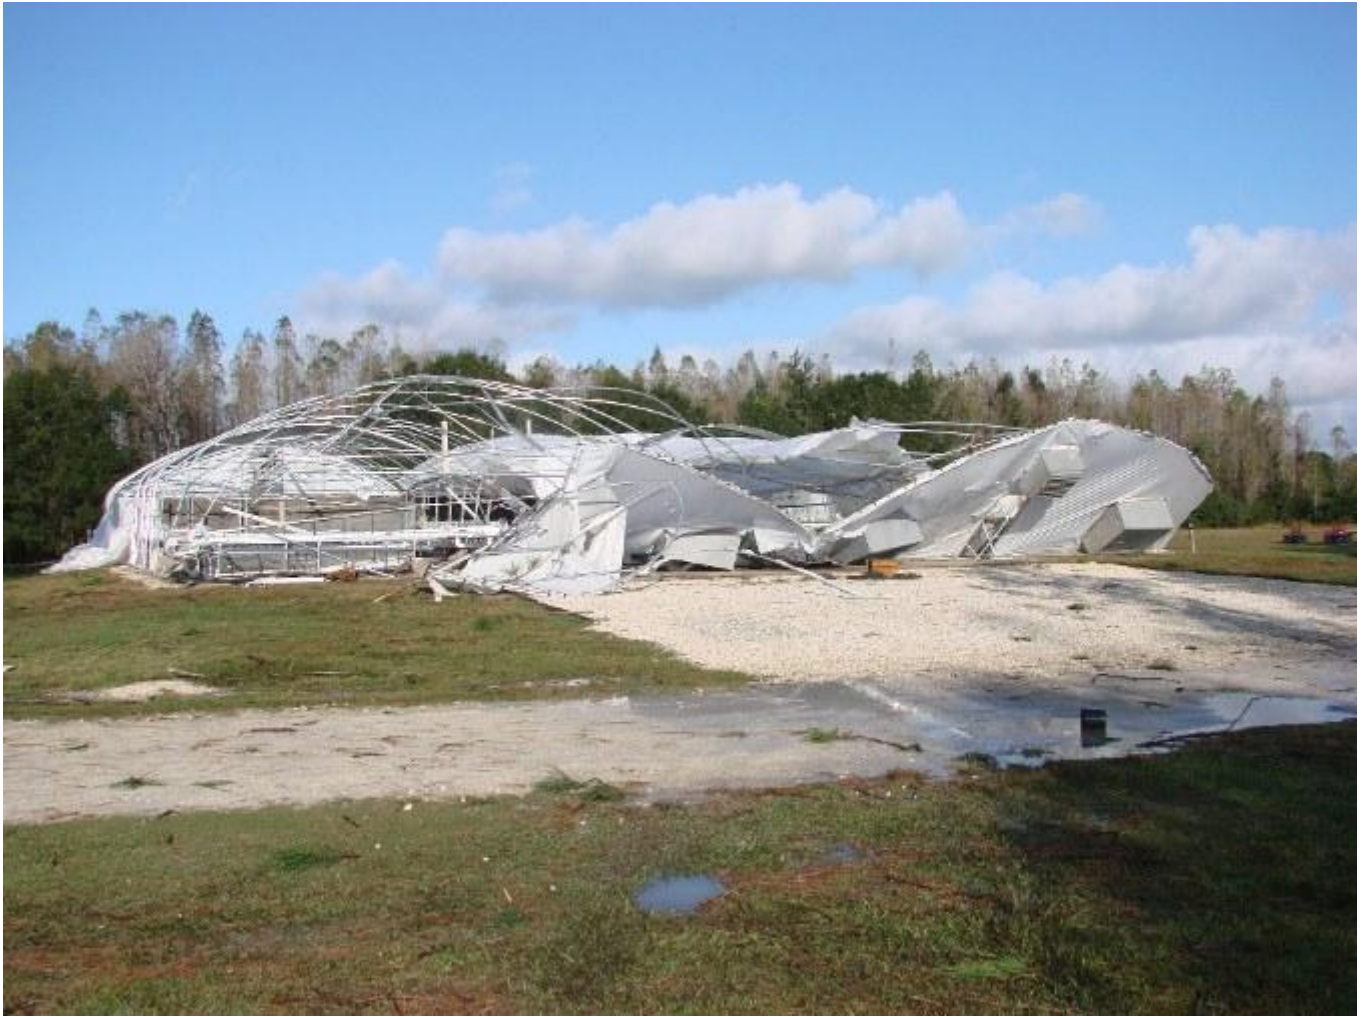
**Figure 4.** Site B damage (Gardening & farm facilities).

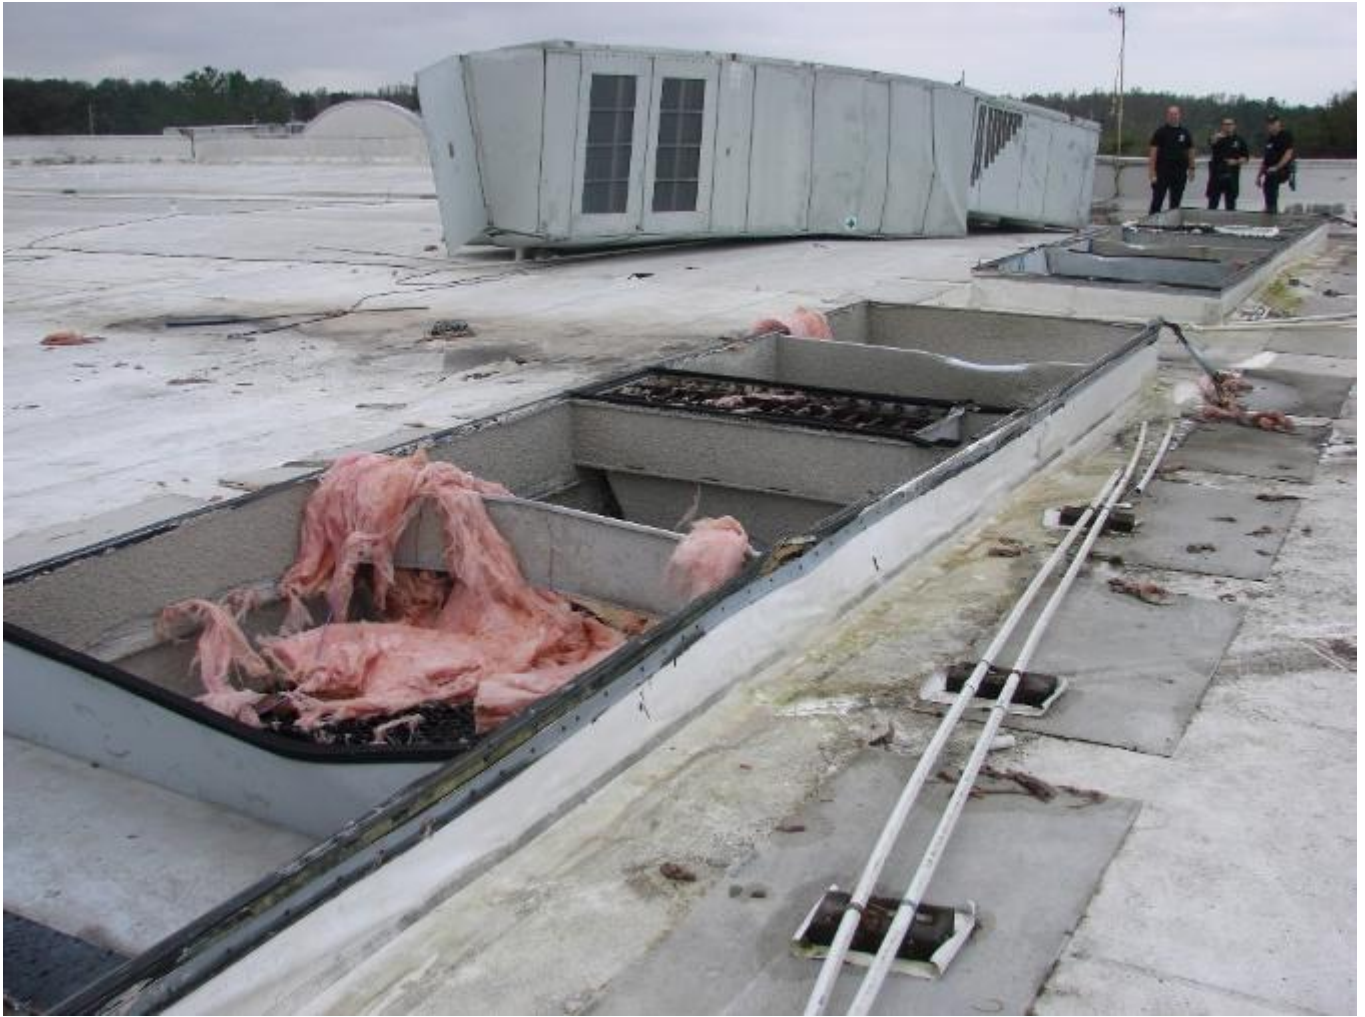
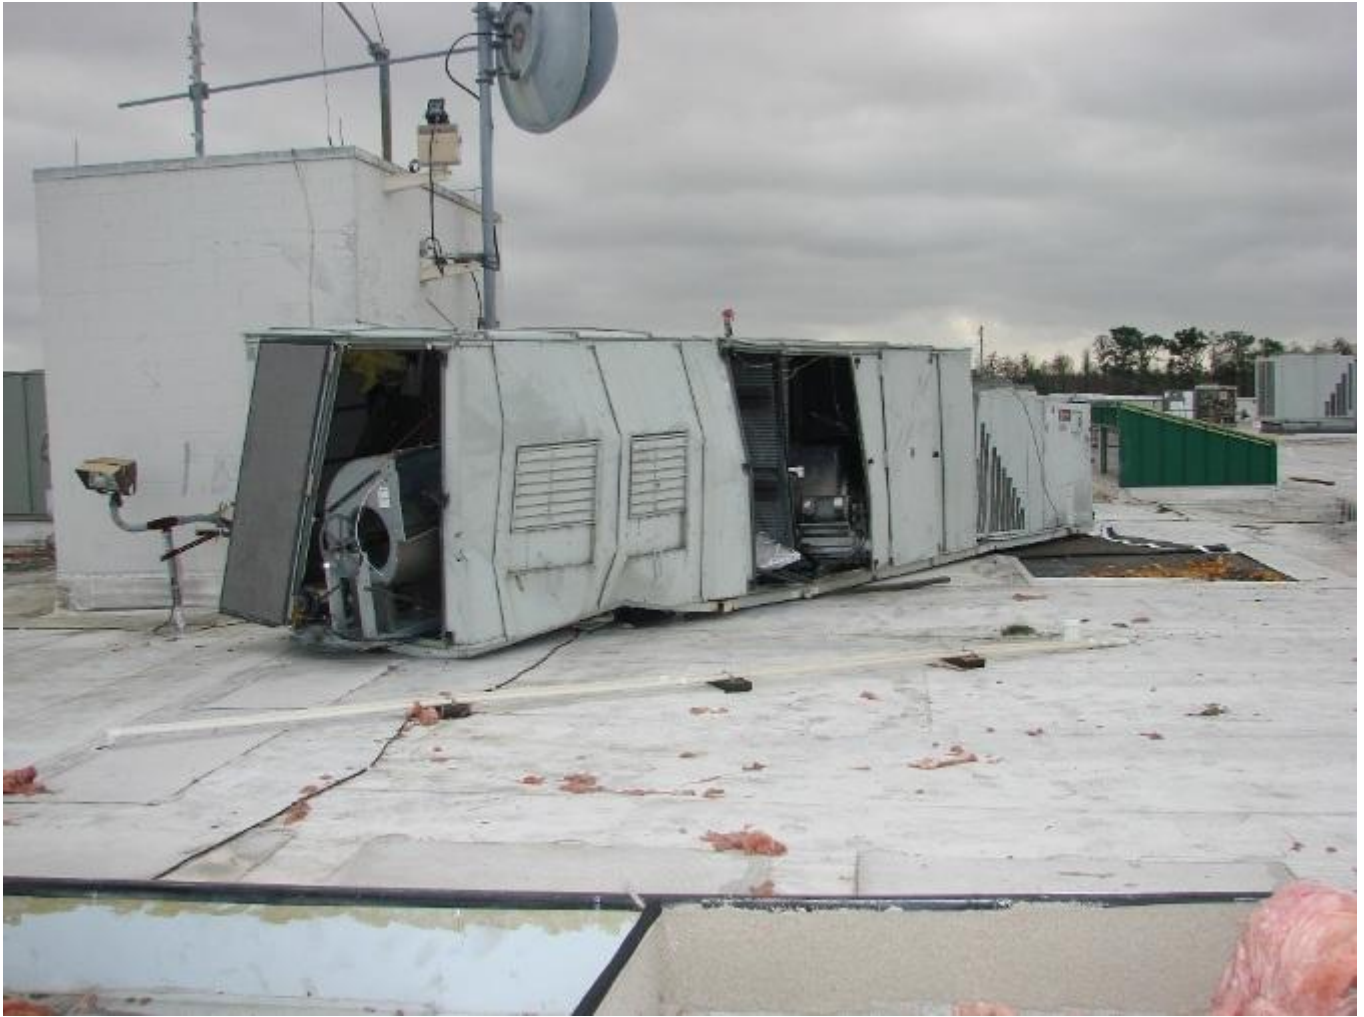
At the Jailhouse main building, there was damage to the front parking lot facility. This damage included downed traffic signs and uprooted trees. There was also a service pickup truck observed to be overturned and leaning against a power pole (Figure 6). Also at the main building, the most significant damage was found on the roof where several industrial air conditioning units were moved from their foundations. Each unit weighs approximately 7000 lbs and rested on an iron base. Three units were partially or completely destroyed (Figure 5). The most heavily impacted area was a temporary facility in back of the main building. It was completely destroyed (Figure 6). Another large vehicle was turned sideways (not shown). At the end of the estimated path of the tornado, on State Road 52, a line of power poles was damaged. Many broke in half or were twisted until reaching the ground (Figure 7). The preliminary conclusion is that this was a solid EF-1 with winds of 100 mph.

Figure 5. Site C damage (Jailhouse air conditioning roof units).

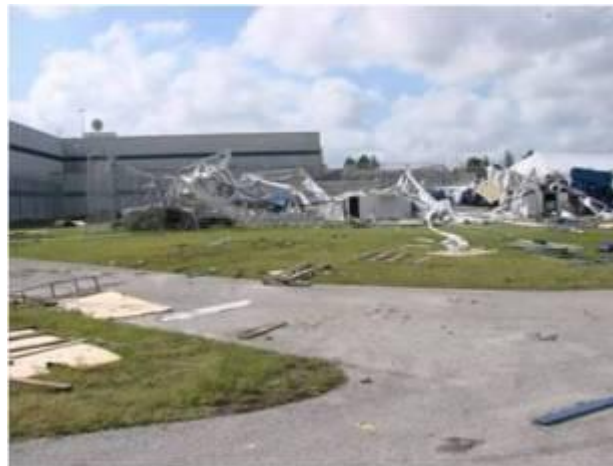
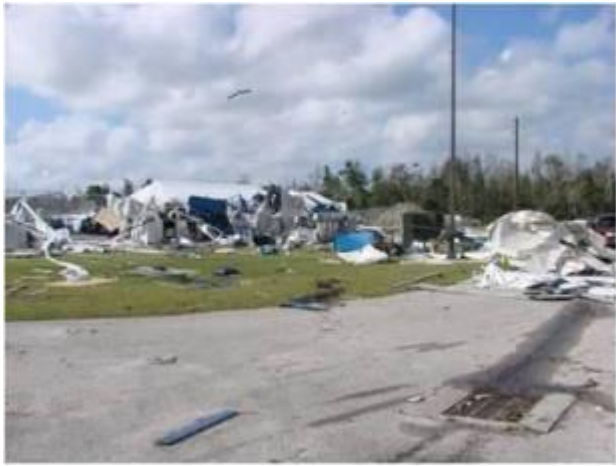
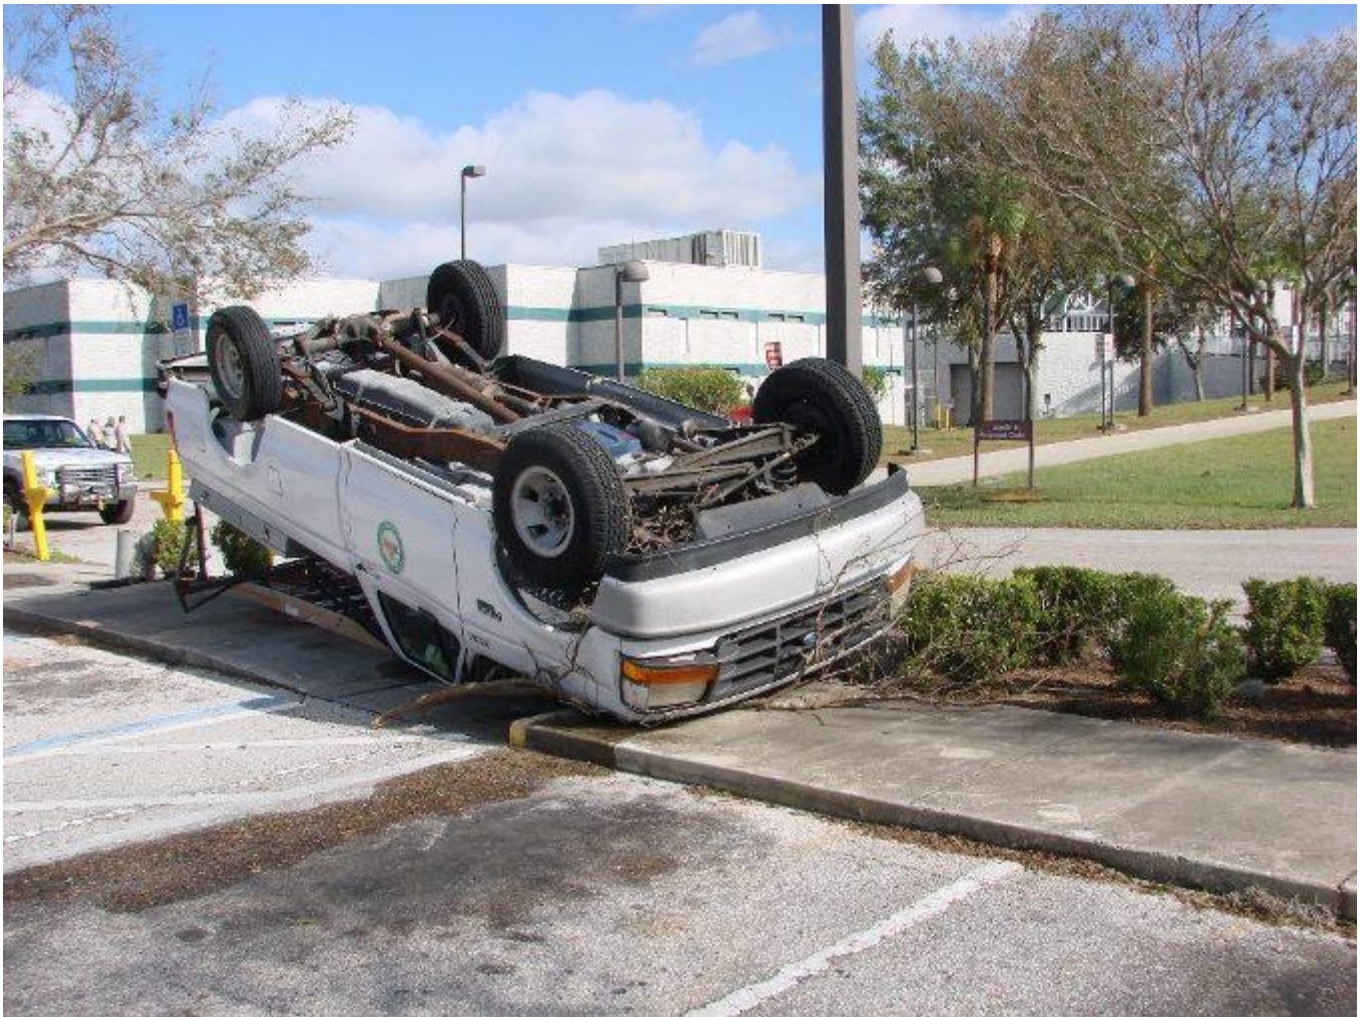
Figure 6. Site C damage (Jailhouse parking lot and rear field).

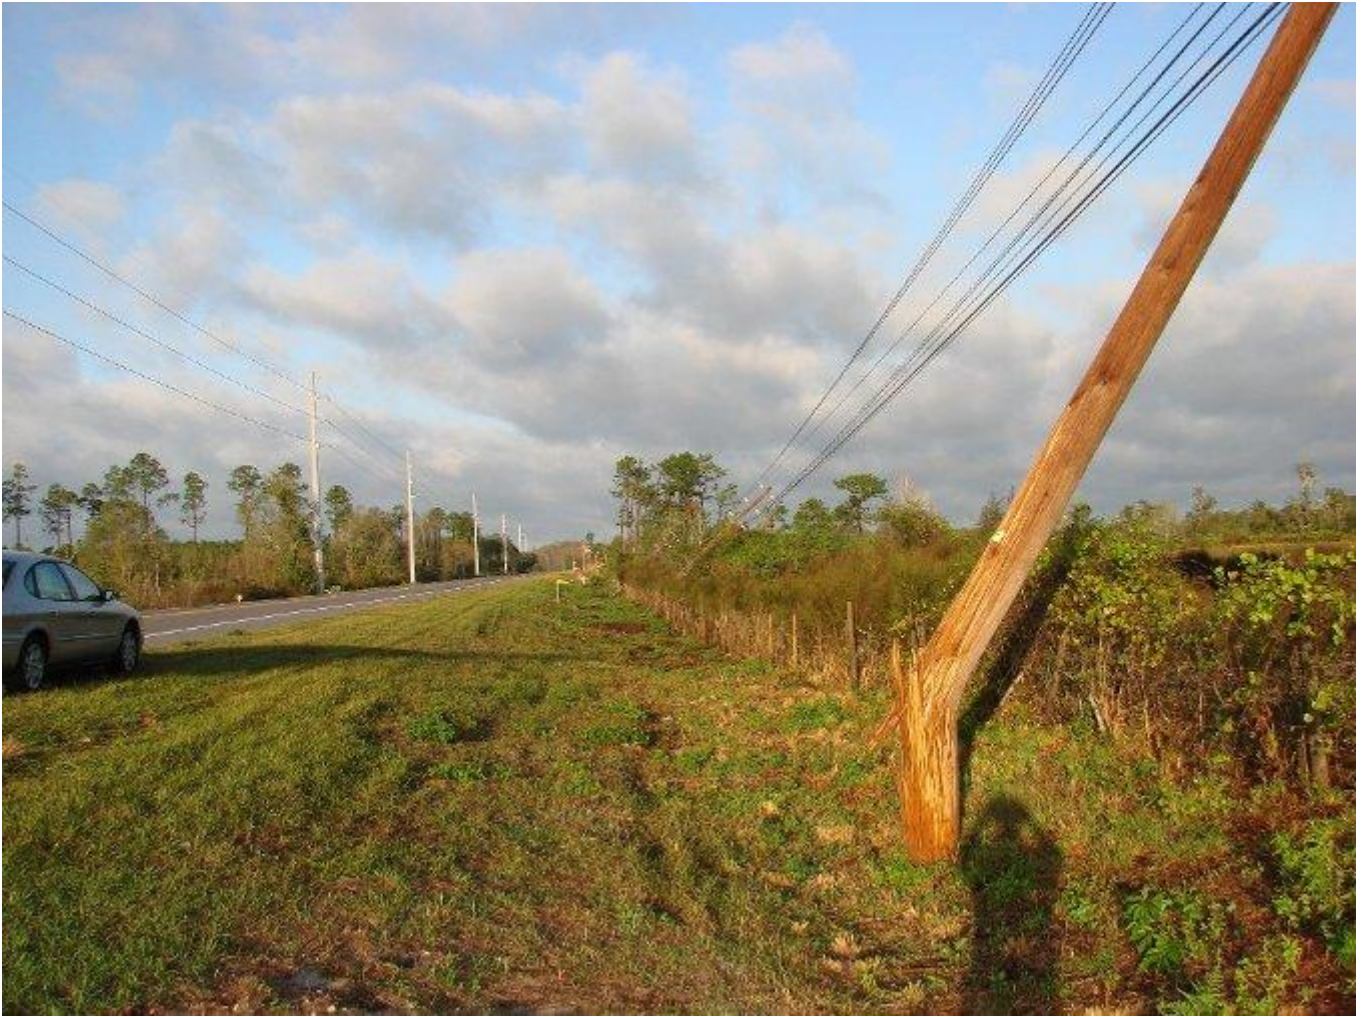
A detailed visual inspection of the row of power poles damaged near State Road 52 suggested a tornado width of around 80 to 100 yards. This information was later compared with the damage to the roof of the Jailhouse's Main Building. The overall length of the roof is slightly over 100 yards. Picture comparisons revealed that air conditioning units on opposite sides of the roof were pushed inwards, and towards the center of the roof. This important finding, coupled with the fact that the original spacing between the opposing units was nearly 100 yards substantiates the findings near State Road 52. The preliminary conclusion is that the tornado was 100 yards wide.

**Figure 7.** Site D damage (State Road 52).
