Hurricane Wilma in the Florida Keys

KENNARD "CHIP" KASPER

National Oceanic and Atmospheric Administration (NOAA)/National Weather Service (NWS) Weather Forecast Office (WFO) Key West, Florida

1 March 2007

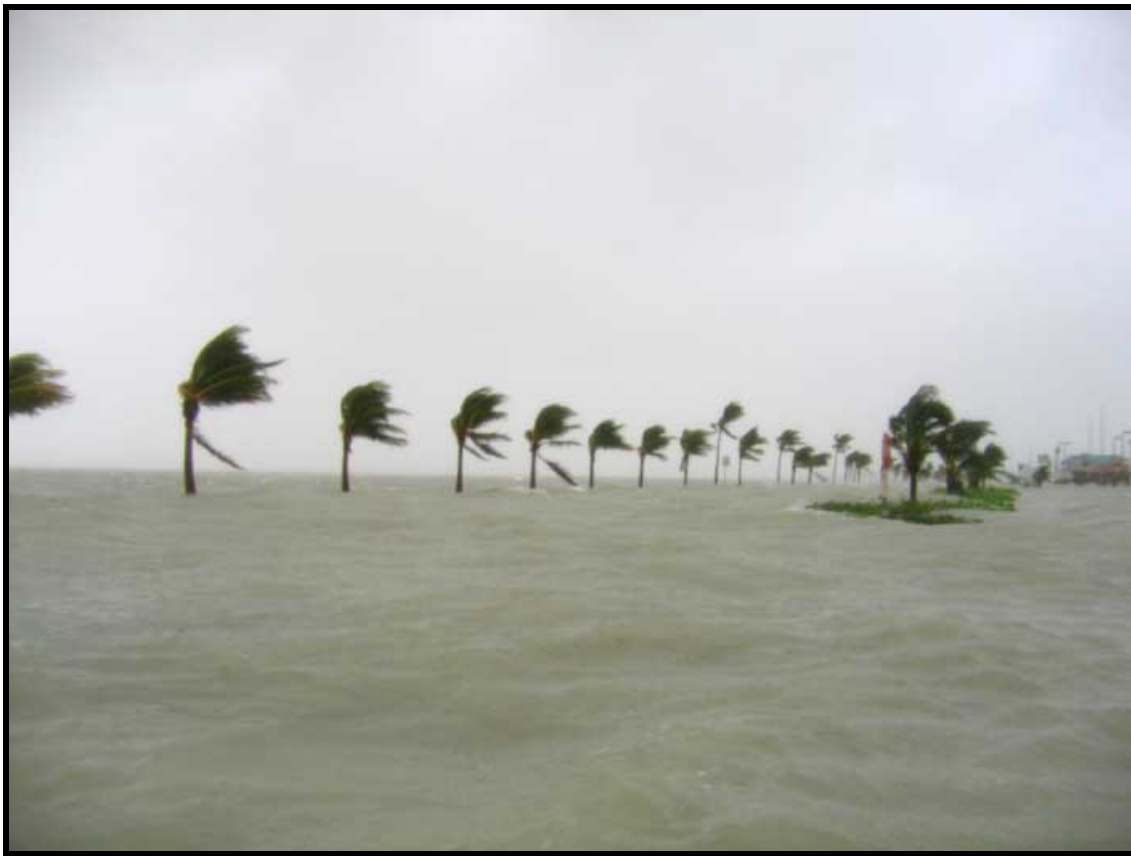
Fig. 1. North Roosevelt Boulevard, Key West, FL, inundated by a storm tide of near 6 feet (ft) above mean sea level, at approximately 0900 Eastern Daylight Time (EDT), 24 October 2005. The boulevard runs east to west, parallel to the line of coconut palm trees, on the north side of Key West (photograph by Mike Hentz of *The Key West Citizen*).

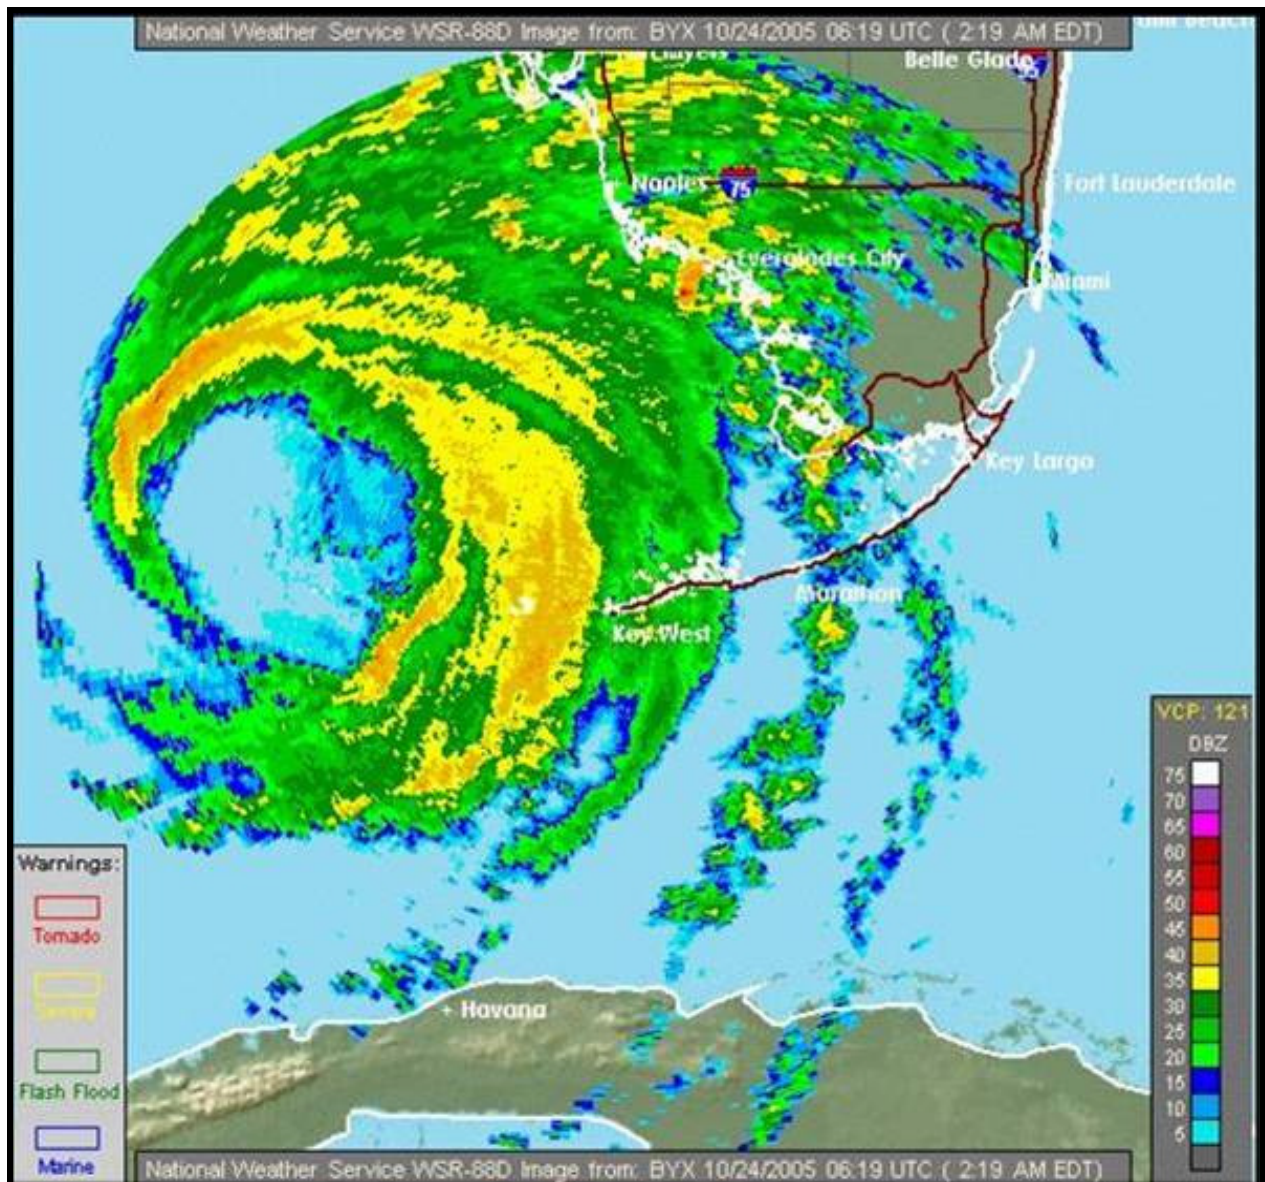
Fig. 3. KBYX WSR-88D composite reflectivity image of Hurricane Wilma at 0219 EDT, 24 October 2007.

(category one) Hurricane Wilma emerged off the north coast of the Yucatan peninsula around 2000 EDT, 22 October. Wilma then turned northeast, accelerated, and intensified as it moved across the southeastern Gulf of Mexico toward the southern Florida peninsula. Figure 3 is a radar image of Hurricane Wilma at 0219 EDT, 24 October from the Key West (KBYX) Weather Surveillance Radar 1988-Doppler (WSR-88D). Note the large eye (approximately 50-60 nautical miles in diameter). Hurricane Wilma made landfall as a category three hurricane near Cape Romano in Collier County on the southwestern coast of the Florida peninsula at 0630 EDT, 24 October. Figure 4 shows the complete track of Hurricane Wilma.

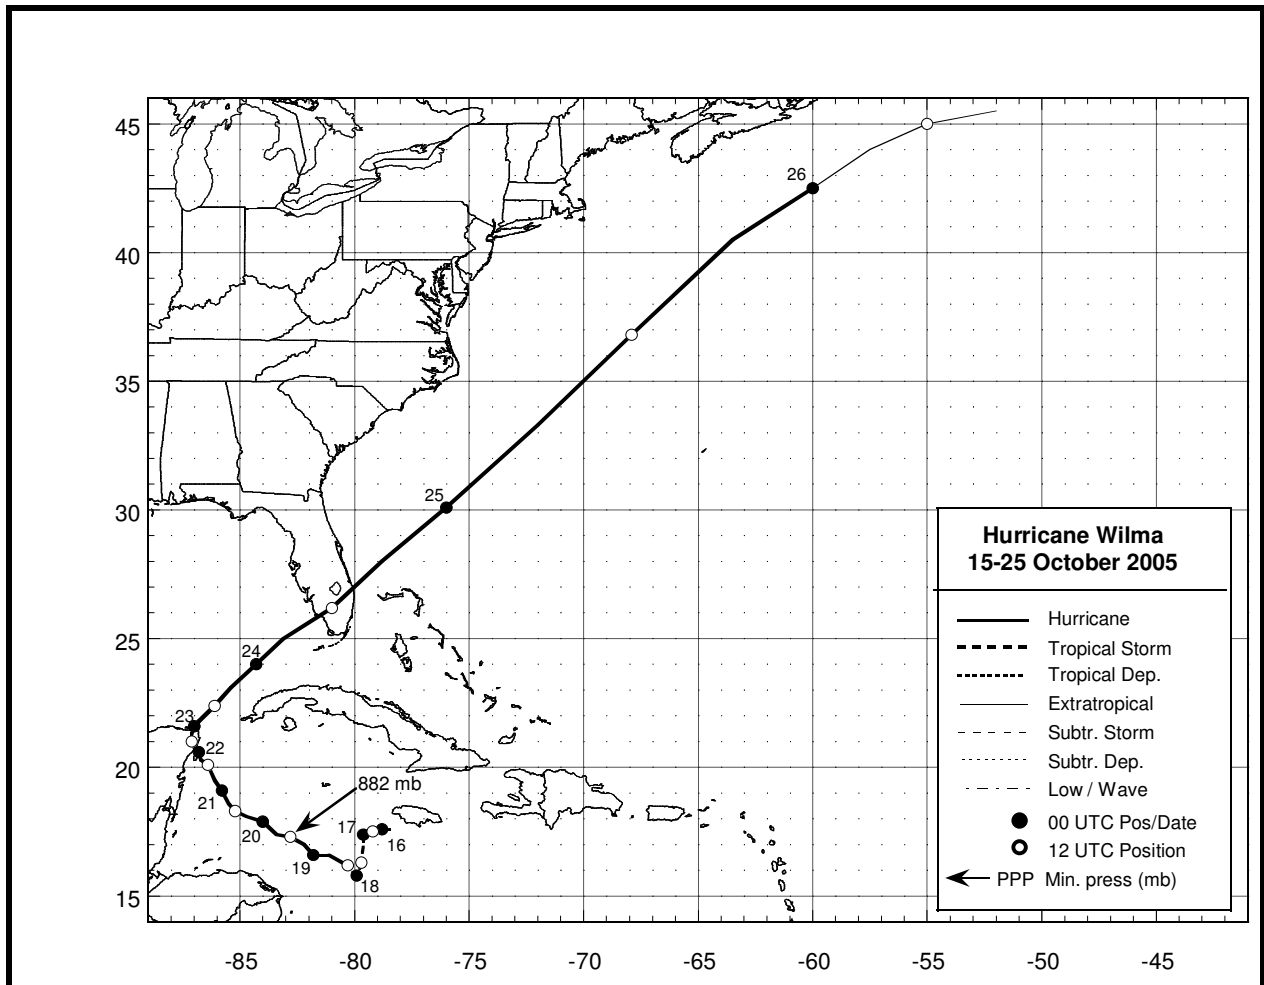
Fig. 4. Best track positions for Hurricane Wilma, 15-26 October 2005 (Pasch et al. 2006)

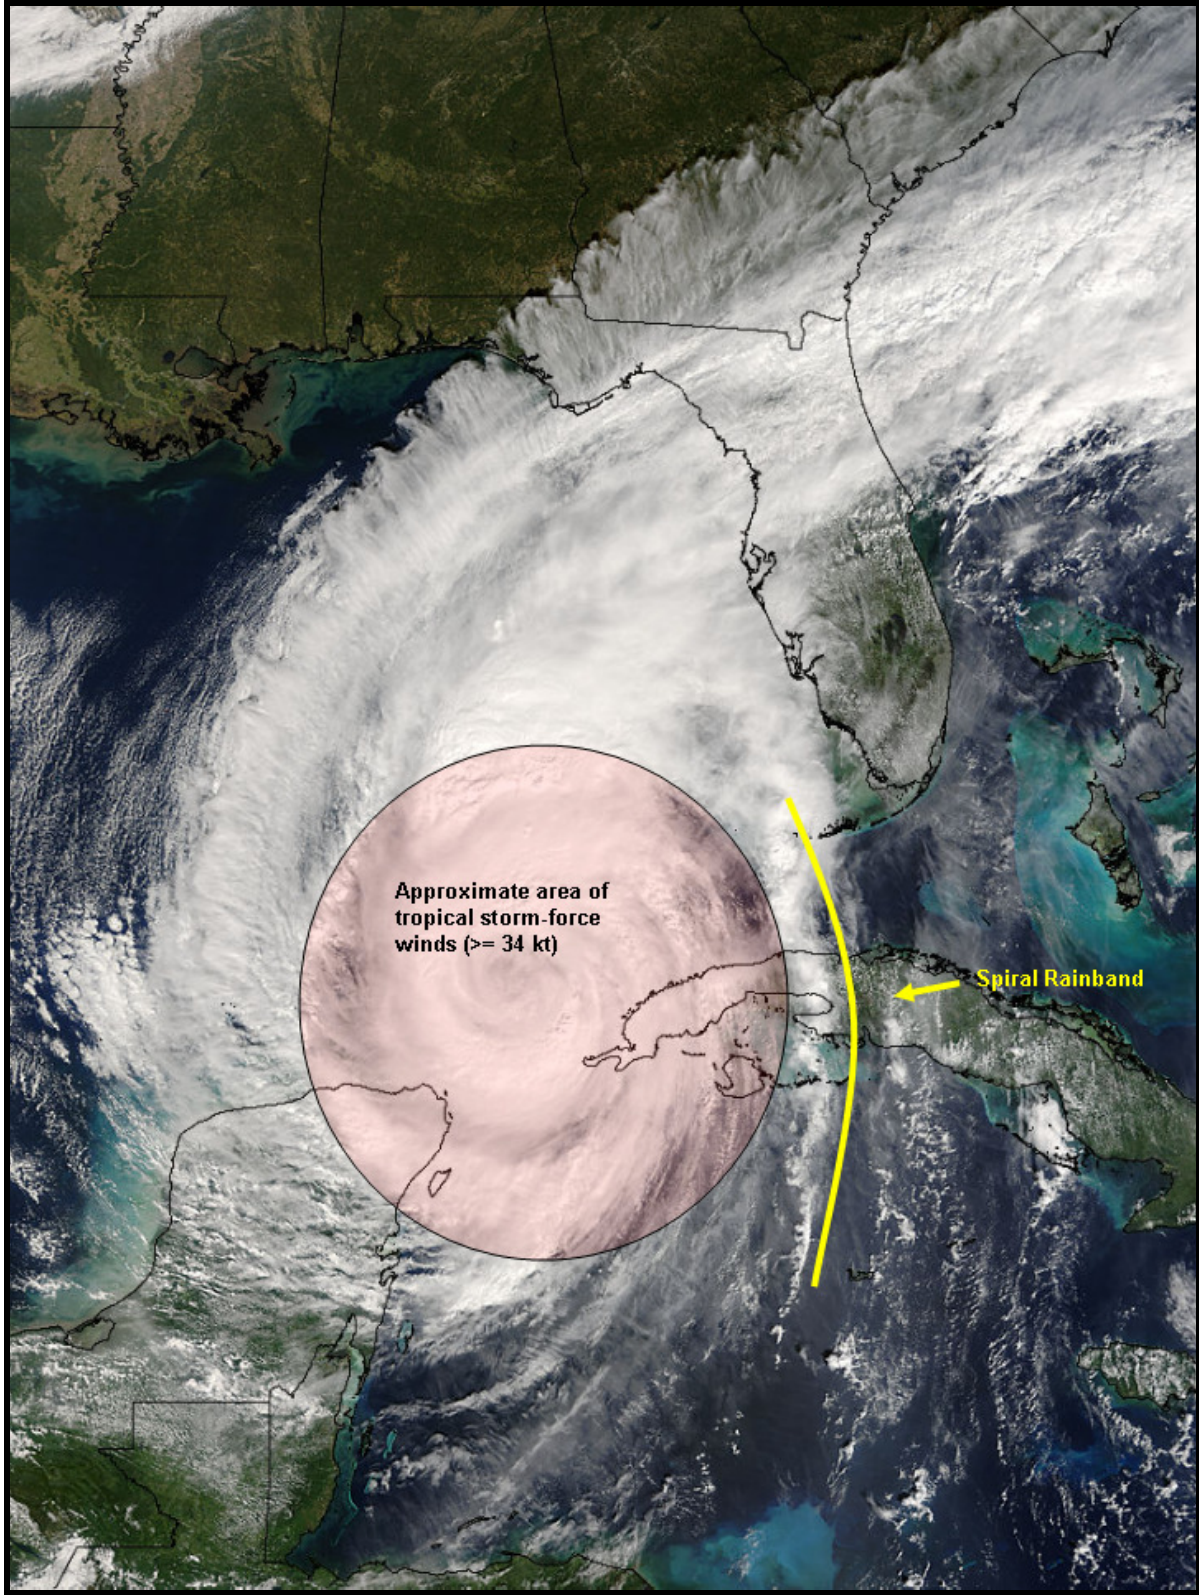
Fig. 5. Satellite image of Hurricane Wilma at 1215 EDT, 23 October 2005. Approximate area of tropical storm-force winds (one-minute average, 10-meter wind speeds greater than or equal to 34 kt) shaded in red; an outer spiral rainband denoted by bold yellow line east of storm center. Image courtesy of MODIS Rapid Response Project at NASA/GSFC.

The weather across the Florida Keys and adjoining waters during the daylight hours on Sunday, 23 October was characterized by increasing high cloudiness and scattered showers. Fresh to strong southeast breezes of 20-30 knots (kt) prevailed over the lower Florida Keys and adjacent waters, whereas moderate to fresh breezes of 10-20 kt prevailed over the middle and upper Florida Keys and adjacent waters. By 1100 EDT, Hurricane Wilma was centered north of the Yucatan Channel, and was moving northeastward at 7 kt. Maximum sustained winds were 85 kt with gusts to 105 kt. Figure 5 is a satellite image of Hurricane Wilma taken at 1215 EDT by the

Moderate Resolution Imaging Spectroradiometer (MODIS) instrument aboard the Terra satellite. An outer spiral rainband can be seen approaching the lower Florida Keys from the southwest. A long-lived mesocyclonic waterspout developed a few hours later from a convective cell associated with this rainband, and moved within a few miles west of Key West around 1600 EDT.

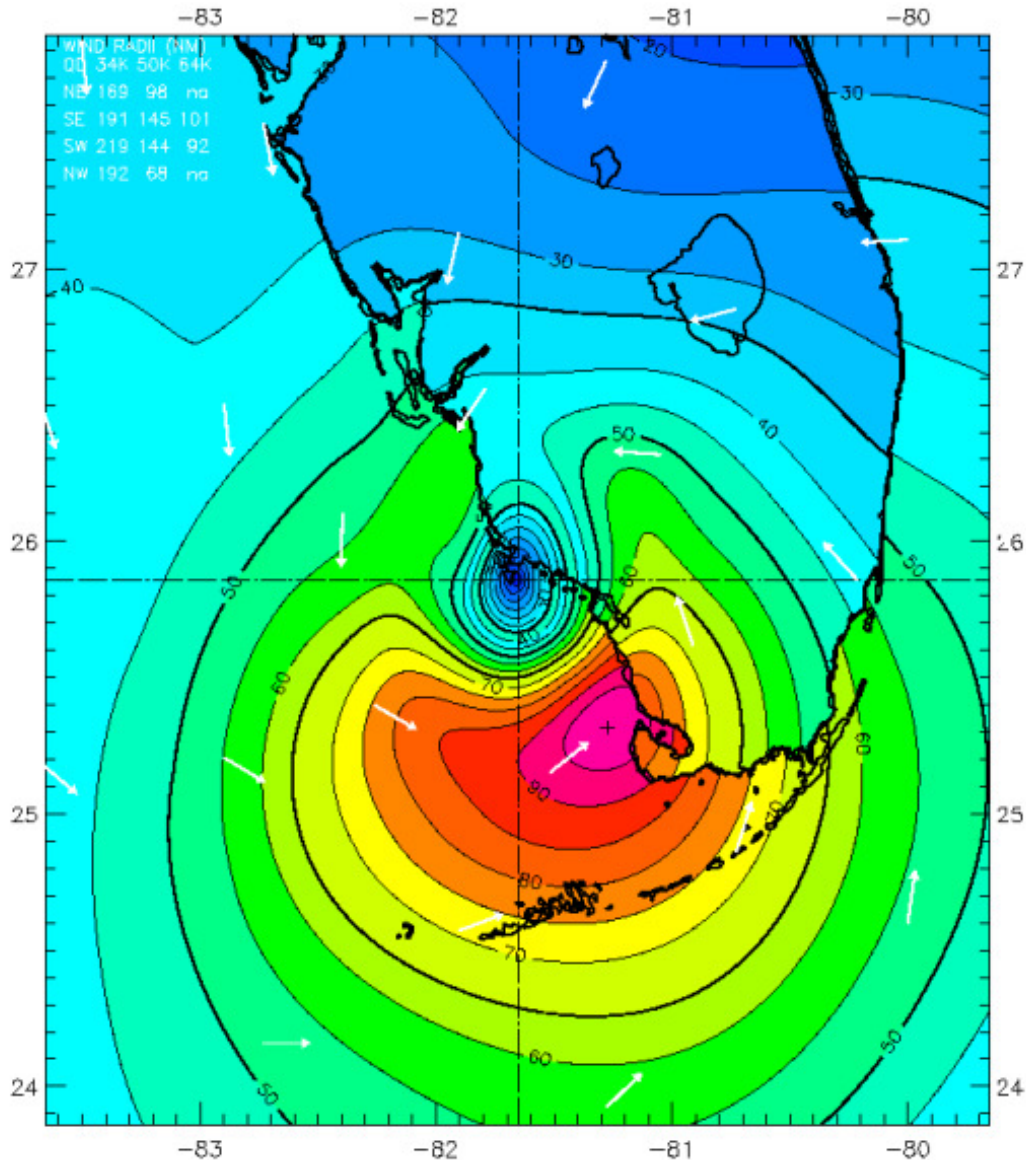
Hurricane Wilma 1030 UTC 24 OCT 2005

Max 1-min sustained surface winds (kt) for marine exposure
Valid for marine exposure over water, open terrain exposure over land

Analysis based on CMAN from 0729 - 1029 z; MOORED_BUOY from 0729 - 1029 z;
GOES_SWIR from 1002 - 1002 z; FCMP_TOWER_LD_TO from 0731 - 1024 z;
ASOS_LD_TO from 0727 - 1029 z; GPSSONDE_SFC from 0750 - 1018 z;
AFRES adj. to surface from mean height 2820 m from 0725 - 1029 z; QSCAT from 1010 - 1012 z;
GPSSONDE_WL150 from 0750 - 1018 z; CMAN_LD_TO from 0729 - 1029 z;
GPSSONDE_MBL from 0750 - 1018 z;

1030 z position interpolated from 1014 Vortex; mslp = 951.0 mb

Fig. 6. Experimental surface wind analysis from NOAA/Hurricane Research Division, 0630 EDT, 24 October 2005.

Peak recorded wind speeds across the Florida Keys during Hurricane Wilma varied according to instrument location, exposure, height, and averaging period (see Table 1). In addition, several instrument systems failed before or during the period of highest winds. Figure 6 is a wind analysis graphic from the NOAA/Atlantic Oceanographic and Meteorological Laboratory (AOML) Hurricane Research Division (HRD), valid at 1030 UTC (0630 EDT), 24 October. This analysis shows sustained (one-minute average), 10-meter wind speeds of 60-80 kt across the Florida Keys near the time of landfall (on the southwest Florida coast) and closest approach of the hurricane core to most of the Keys. The HRD analysis was produced by compositing all available observations relative to the storm center, including Air Force and NOAA aircraft, ships, buoys, Coastal-Marine Automated Network (C-MAN) platforms, and surface airways. (Powell et al., 1998). All data were quality controlled and then processed to conform to a common framework for height, exposure, and averaging period. Therefore, the HRD hurricane wind analysis is an excellent product for attaining a realistic, comprehensive view of the surface wind field across the Florida Keys during Hurricane Wilma.

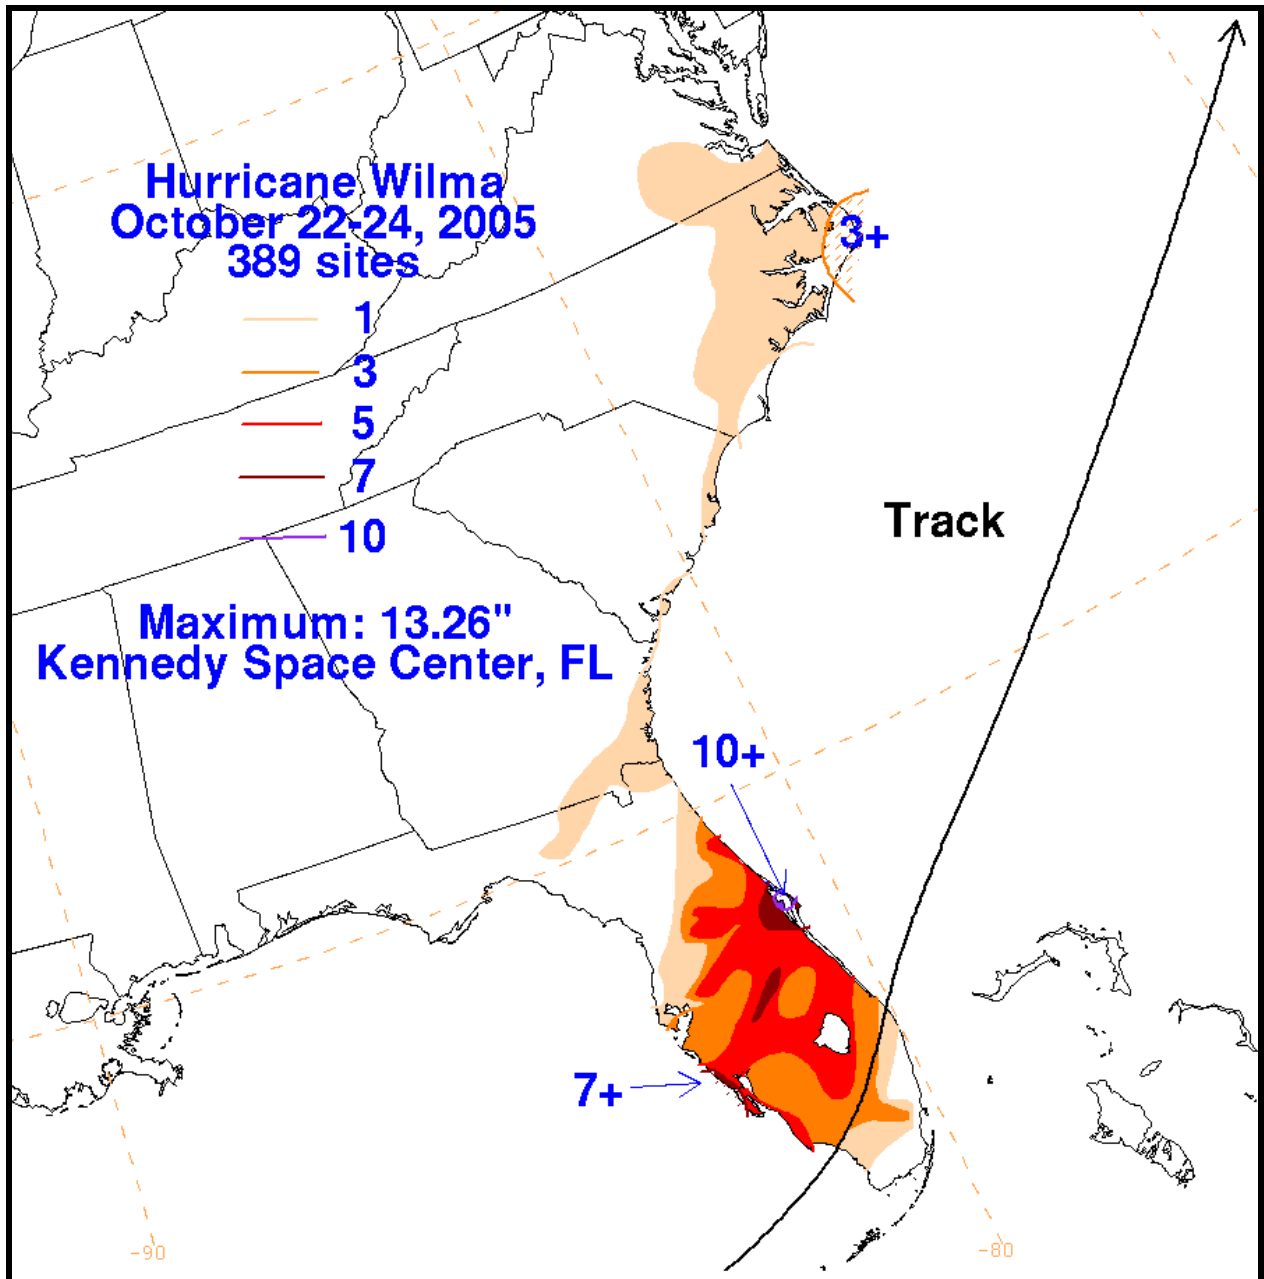
Fig. 7. Hurricane Wilma storm total rainfall map (22-24 October 2005), constructed using data provided by NWS River Forecast Centers and WFOs. (Image courtesy of NOAA/NWS/Hydrometeorological Prediction Center).

observed over central Florida (see Fig. 7) where rich tropical moisture from Wilma interacted with a frontal system.

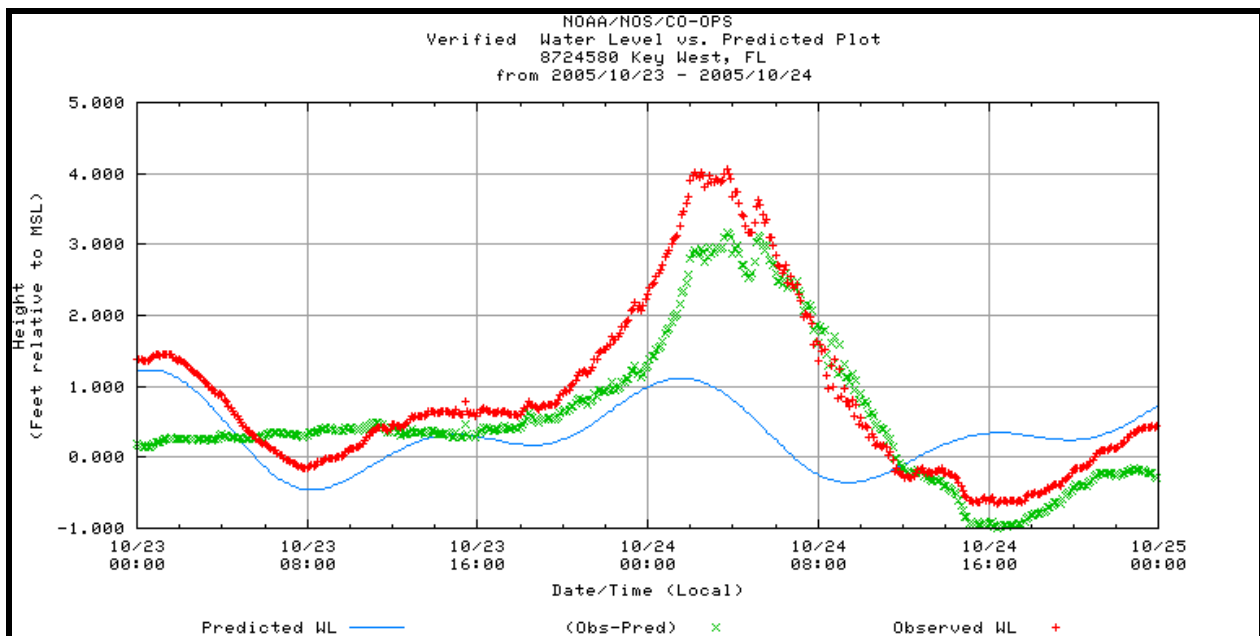
Fig. 8. Plot of predicted (blue), observed (red), and difference between observed and predicted (green) water level in feet relative to MSL from 0000 EDT, 23 October 2005 to 2400 EDT, 24 October 2005 at the NOAA/NOS tide gage, Key West Harbor.

Water levels along the southern and western shores of the lower Florida Keys first rose significantly above astronomically predicted values around 2000 EDT (Sunday evening), 23 October. Figure 8 is a water level plot from a tide gage located on the west side of Key West. Coastal flooding in Key West typically commences when water levels reach 3 ft above MSL. This threshold was met just after 0100 EDT according to Figure 8. Indeed, WFO Key West received its first report of coastal flooding at 0131 EDT (City of Key West officials reported flooding of South Roosevelt and Atlantic Boulevards on the south side of Key West). By 0230 EDT, Key West International Airport was flooded, with the runway complex inundated and the airport terminal flooded with six inches of salt water. At 0252 EDT, communications to the KEYW ASOS platform (located on the east end of the airport runway complex) were rendered inoperable due to storm surge flooding. At 0301 EDT, Flagler Avenue east of First Street was flooded with 1-2 ft of salt water. Parking lots on the southeast side of Key West were flooded with 2-3 ft of salt water. Some homes on the south side of Stock Island, as well as the intersection at U.S. Highway 1 and Cross Street, were flooded with up to 4 ft of water. At 0330 EDT, a report was received indicating that the NOAA Weather Radio transmitter on Sugarloaf Key had ceased operation (it was later discovered that the generator fuel tank floated away). At 0526 EDT, Sea Oats Beach at mile marker 74 was inundated. Canals throughout the lower Florida Keys began overflowing between 0500 and 0600 EDT.

Observations from NWS forecasters and spotters, City of Key West and Monroe County officials, and the public indicated that the second storm surge event began in northern sections of Key West around 0700 EDT, 24 October. However, an analysis of data from the Key West Harbor tide gage (Fig. 8) reveals that peak storm tides occurred around 0400 EDT, with a gradual drop in water levels thereafter. In addition, residents on Waddell Street near South Beach reported peak storm tides early in the morning (prior to sunrise), with falling tides thereafter. These observations suggest that the higher elevation areas on the western side of Key West (elevations above 8 ft MSL throughout much of Old Town; see Fig. 9) blocked southward-moving sea water from reaching areas to their immediate west and south. Peak storm tides, up to 6.5 ft above MSL in parts of Key West, occurred around 0900 EDT. Inundation originated along the Old Town Key West waterfront, Garrison Bight, and North Roosevelt Boulevard (see Fig. 1). Flooding crossed the island from north to south, meeting Hawk Channel (Atlantic side) at the west end of South Roosevelt Boulevard. Figure 10 shows storm surge flooding in southern portions of Key West just after its peak. City of Key West officials estimated that about 60 percent of Key West was inundated, and up to 35 percent of municipal vehicles were flooded.

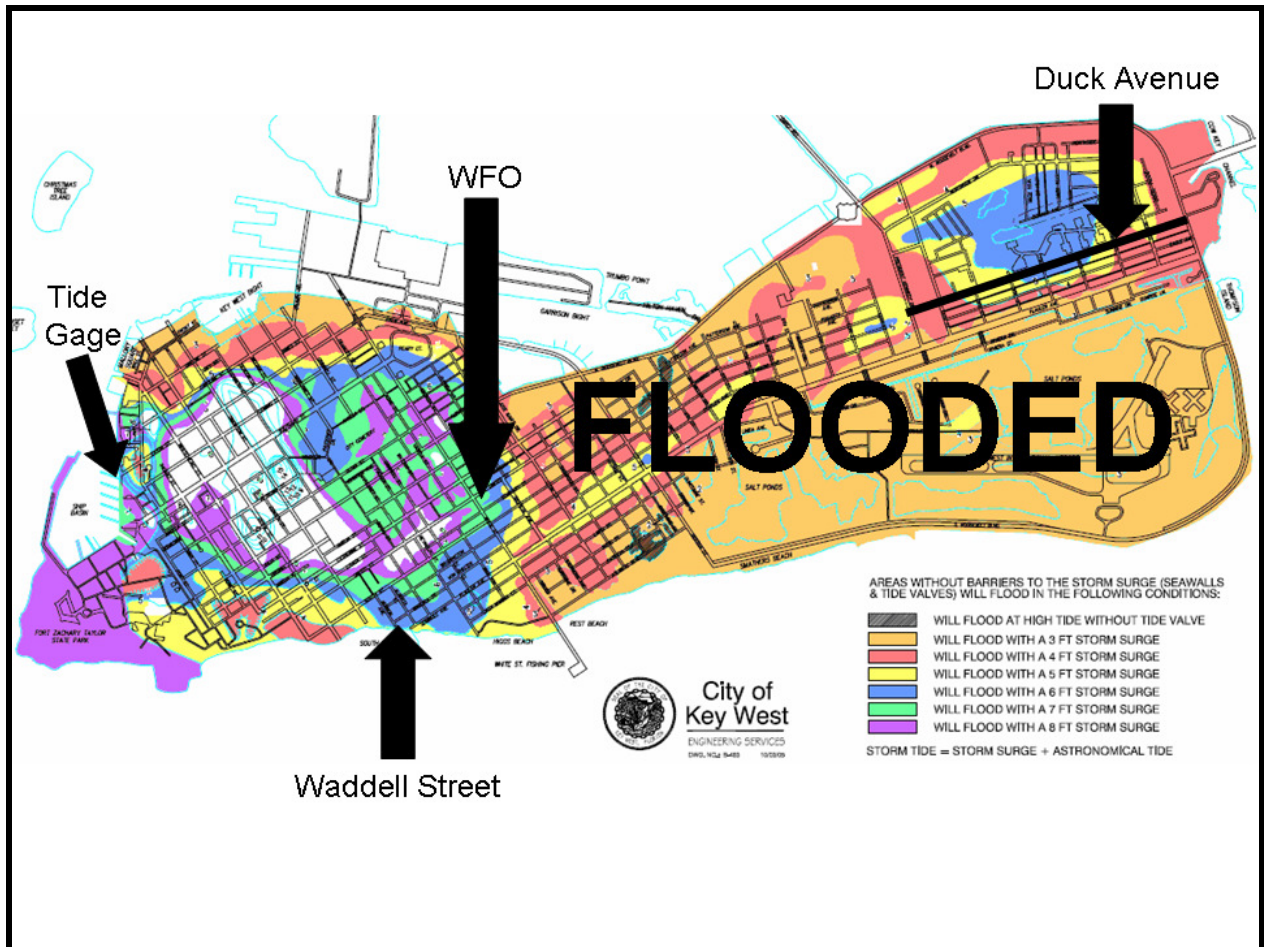
Fig. 9. Storm surge flood potential map of Key West, FL. Areas shaded in orange, red, yellow, blue, green, and purple are likely to flood with storm surges of 3, 4, 5, 6, 7, and 8 ft, respectively. During Hurricane Wilma, storm *tides* peaked at 4.5-6.5 ft above MSL throughout Key West. Predicted astronomical tides at Key West Harbor during Hurricane Wilma ranged from 1.1 ft above MSL (0234 EDT, 24 October) to 0.4 ft below MSL (1027 EDT, 24 October), and peak storm surge values across Key West ranged from 4.0-6.0 ft above MSL, resulting in the inundation of more than 50 percent of the island. The NOS tide gage, Waddell Street, NWS WFO, and Duck Avenue are indicated by black arrows and referenced in the text (map courtesy of City of Key West Department of Engineering Services).

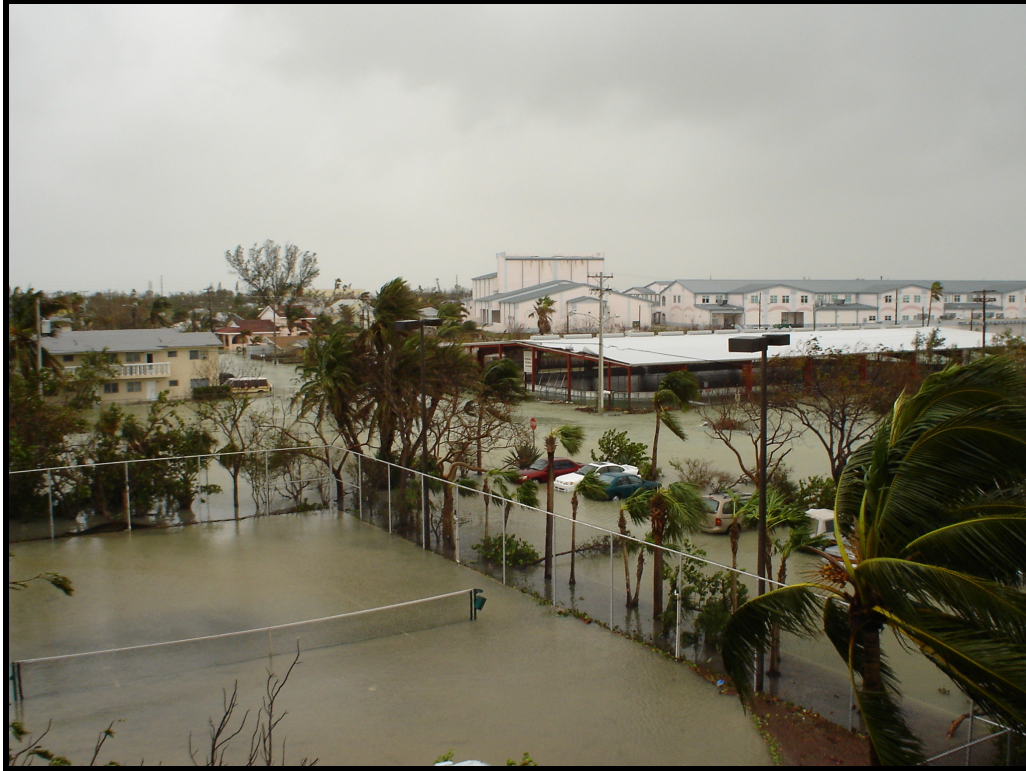
Fig. 10. Storm surge flooding around 1030 EDT, 24 October, Bertha Street and Atlantic Boulevard intersection, Key West, FL (photograph by Chip Kasper)

The author finished his operational shift at WFO Key West around 0800 EDT, 24 October, and subsequently observed the second storm surge event at its peak in portions of Mid Town Key West, between United Street and Atlantic Boulevard, and between White Street and First/Bertha Streets. The WFO Key West is located on a compound bordered by United Street on the north, White Street on the west, and Seminary Street on the south. The main building is within 50 ft of White Street, at an elevation of 7 ft above MSL (the operational floor of the building is raised to an elevation of approximately 15 ft above MSL). By 0900 EDT, sea water had moved inland to a point on United Street at 6 ft above MSL, less than 15 ft from the northeastern boundary of the WFO Key West compound. At this time, most of Key West east of White Street was inundated (greater than 50 percent of the island surface area). Waters rose very quickly, 2-3 ft in less than 15 minutes. Island terrain significantly modulated water levels and currents over the island. Floating debris, tree branches, and household goods were ubiquitous, and accumulations of debris and other flotsam caused constrictions in the current resulting in very turbulent flow locally, some of which was reminiscent of river rapids (see Fig. 11). In shallower depths, fish and other marine wildlife were visible swimming beneath the water surface, and numerous island residents reported dead fish and eels for days after the flood waters receded.

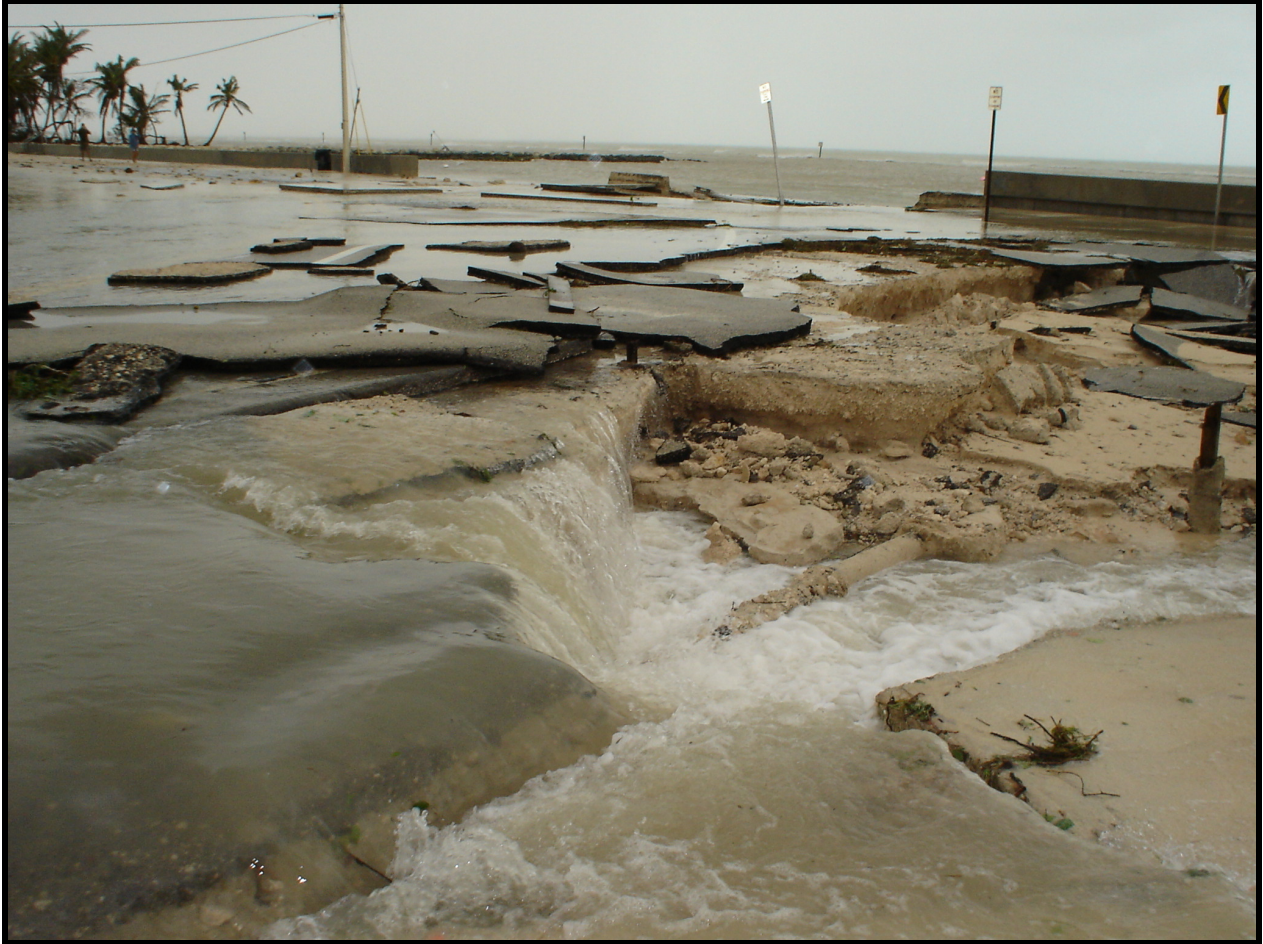
Fig. 11. Photograph of South Roosevelt Boulevard-Bertha Street intersection in Key West, FL around 1100 EDT, 24 October 2005. Note water flowing toward Hawk Channel (Atlantic Ocean) through large slabs of asphalt (photograph by Chip Kasper).

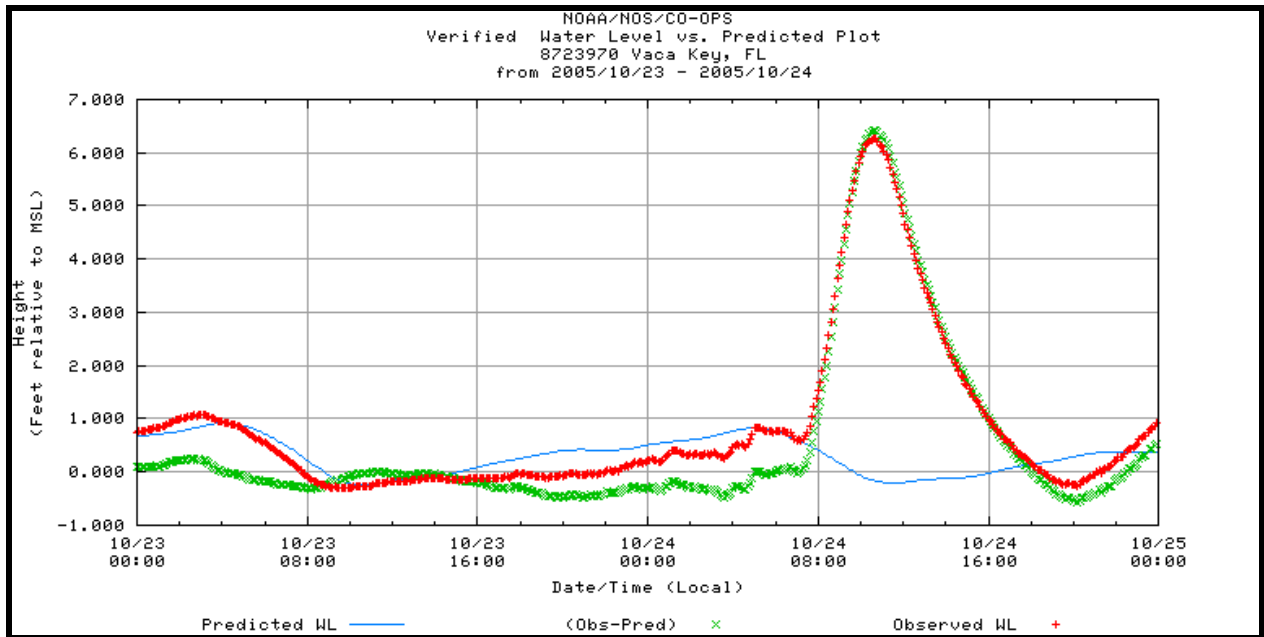
Fig. 12. Plot of predicted (blue), observed (red), and difference between observed and predicted (green) water level in feet relative to MSL from 0000 EDT, 23 October 2005 to 2400 EDT, 24 October 2005 at the NOAA/NOS tide gage, Vaca Key, FL.

Maximum storm tides of 5-8 ft above MSL were estimated between 1100-1300 EDT in Marathon and throughout the middle Florida Keys. Figure 12 shows a water level plot recorded by the NOS tide gage at Vaca Key (in the city of Marathon) during 23-24 October. U.S. Highway 1 was flooded at several locations. In addition, numerous homes, businesses, and Florida Keys Marathon Airport were flooded (see Figure 13 for a picture of storm surge inundation in Marathon).

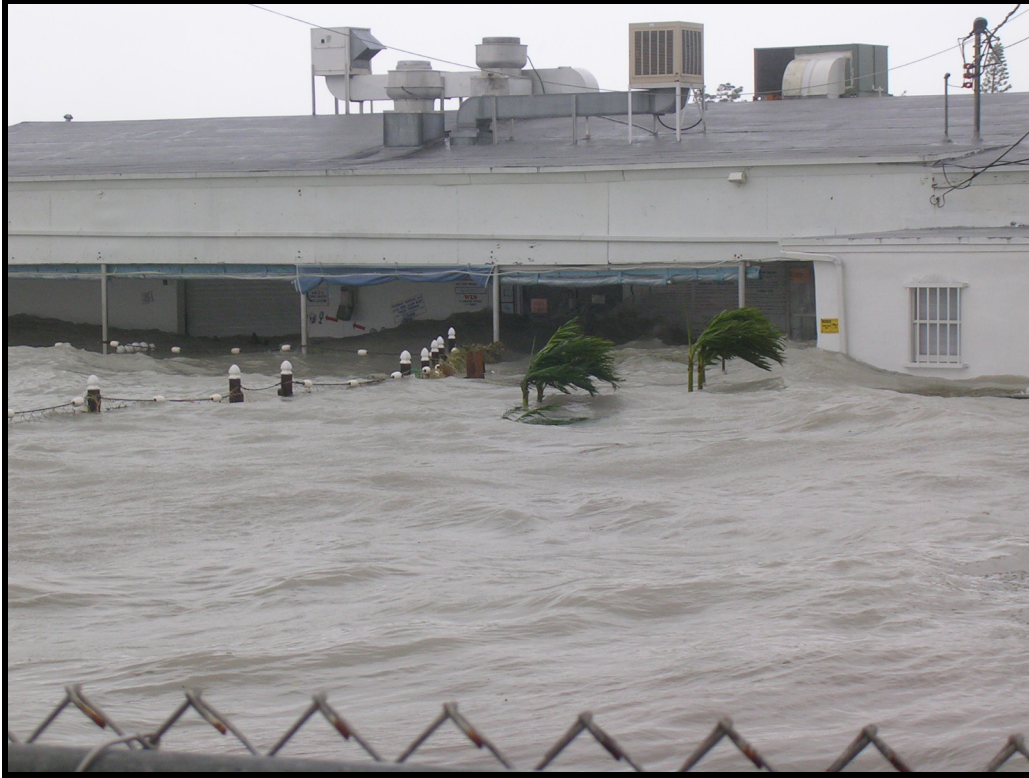
Fig. 13. Storm surge flooding around 1100 EDT, 24 October, Keys Fisheries on Gulf View Avenue in Marathon, FL (photograph by Carmen Watmuff, image courtesy of Keynoter Publishing Company, Inc.)

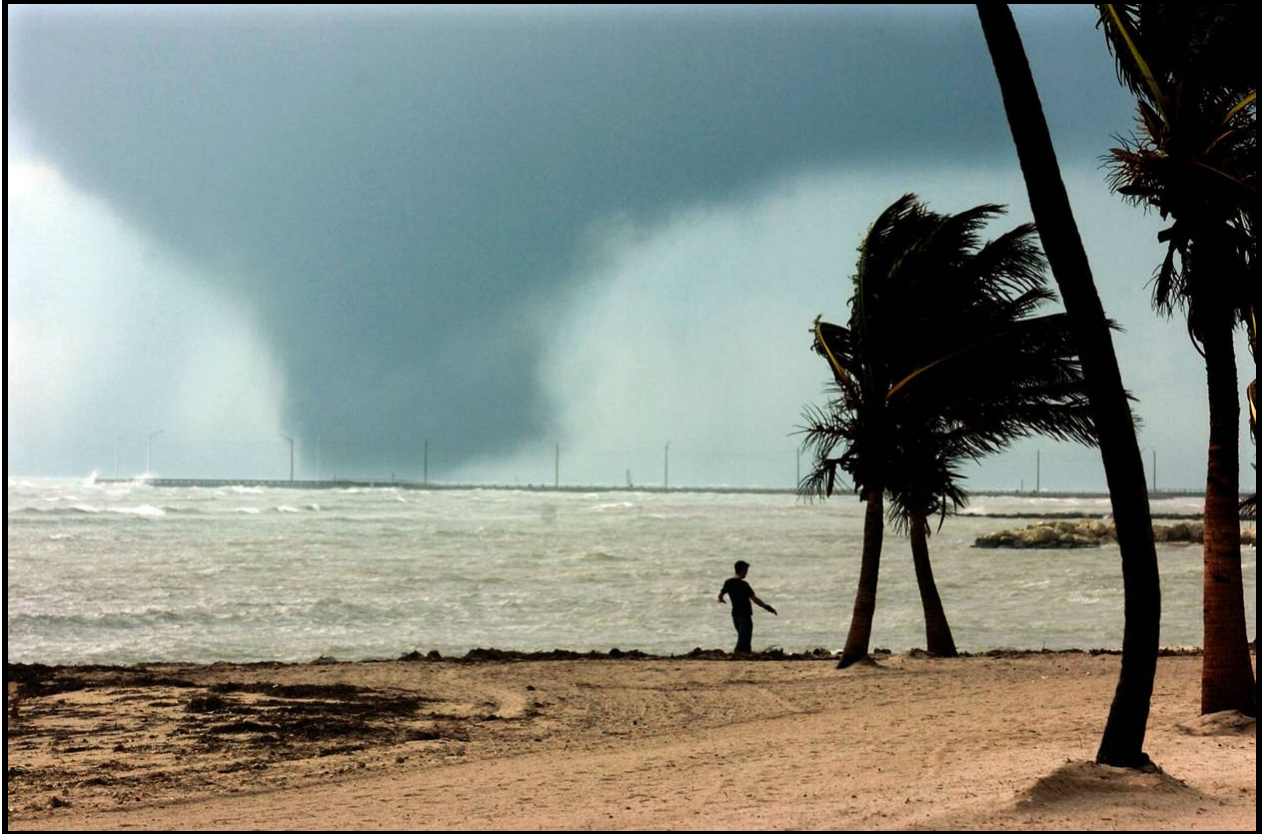
Fig. 14. Photograph of a violent waterspout, located over Hawk Channel about four miles southwest of Key West, FL at approximately 1600 EDT, 23 October 2005. The man standing is near a seaweed patch on Smathers Beach, seaward of the coconut palm trees. White Street Pier is visible in the background, in front of the waterspout (photograph by Tim Chapman).

Hurricane Wilma produced 10 tornadoes over the Florida peninsula on 23-24 October, but there were no confirmed tornadoes in the Florida Keys. However, a long-lived, mesocyclonic waterspout associated with a supercell thunderstorm was visible from Key West by NWS forecasters and other residents during the afternoon of 23 October (Fig. 14). This violent waterspout moved within three miles of the west end of Key West at closest approach, around 1600 EDT. Waterspout movement was estimated by Doppler radar to be near 40 kt toward the north-northwest. The parent convective cell of this vortex was associated with a large outer spiral rainband of Hurricane Wilma. This waterspout would have resulted in significant property damage, had the path tracked just a few miles farther east, over Key West or an adjacent island community in the lower Florida Keys.

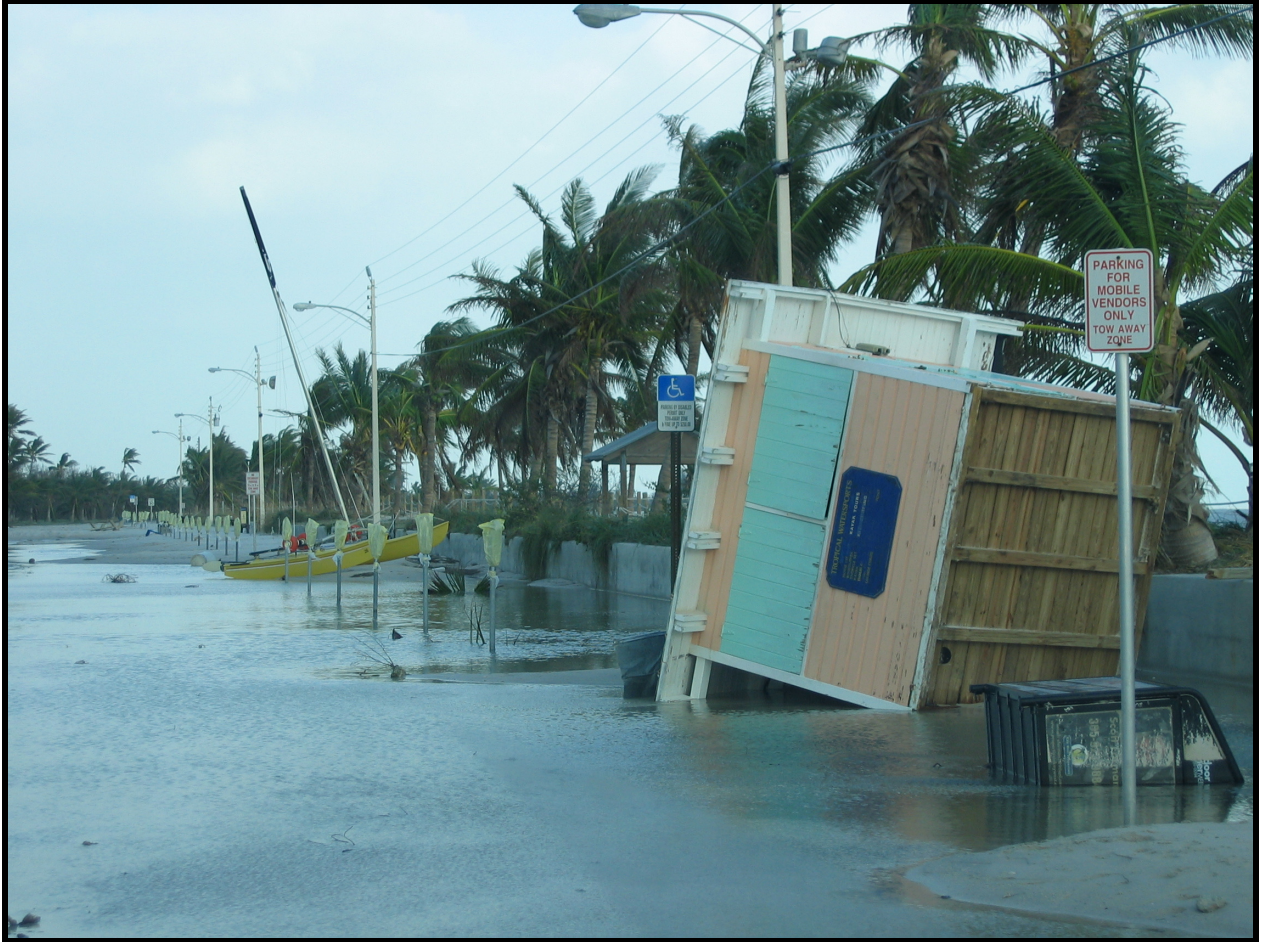
Fig. 15. Photograph of South Roosevelt Boulevard near Smathers Beach in Key West, FL during the late afternoon of 24 October 2005, looking toward the east (photograph by Jim Lee).

Severe beach erosion occurred along the Atlantic shores of the Florida Keys, with severe erosion noted on Gulf side beaches in Key West as well. Most beaches were completely inundated near time of maximum storm tide. Breaking waves of six feet were estimated along the upper Florida Keys. South Roosevelt Boulevard in Key West was closed to traffic for nearly three weeks, while crews removed tons of sand and large pieces of seawall from the road (see Fig. 15).
