The Wilmington Area Ice Jam on the Lower Kankakee River During January 2024

W. Scott Lincoln
Senior Service Hydrologist, NWS Chicago

Completed: March 27, 2024

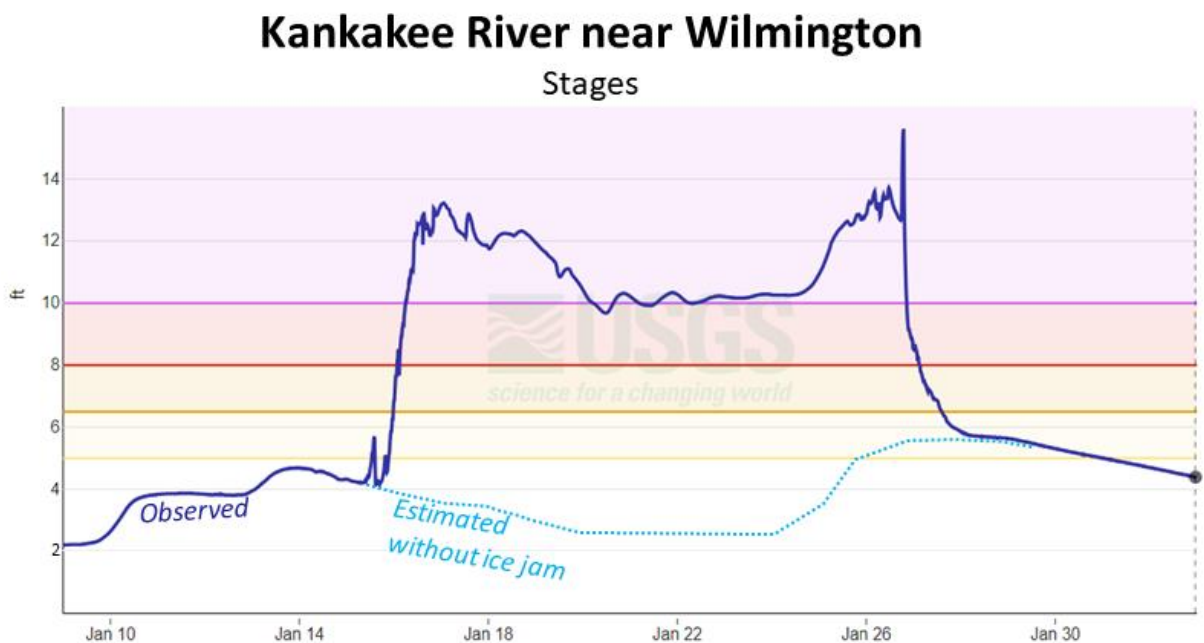
Figure 8. River stages on the Kankakee River near Wilmington during the ice jam of January 2024. The estimated stages that would have occurred without the ice jam are indicated with the dotted line. Stage measurements from the USGS.

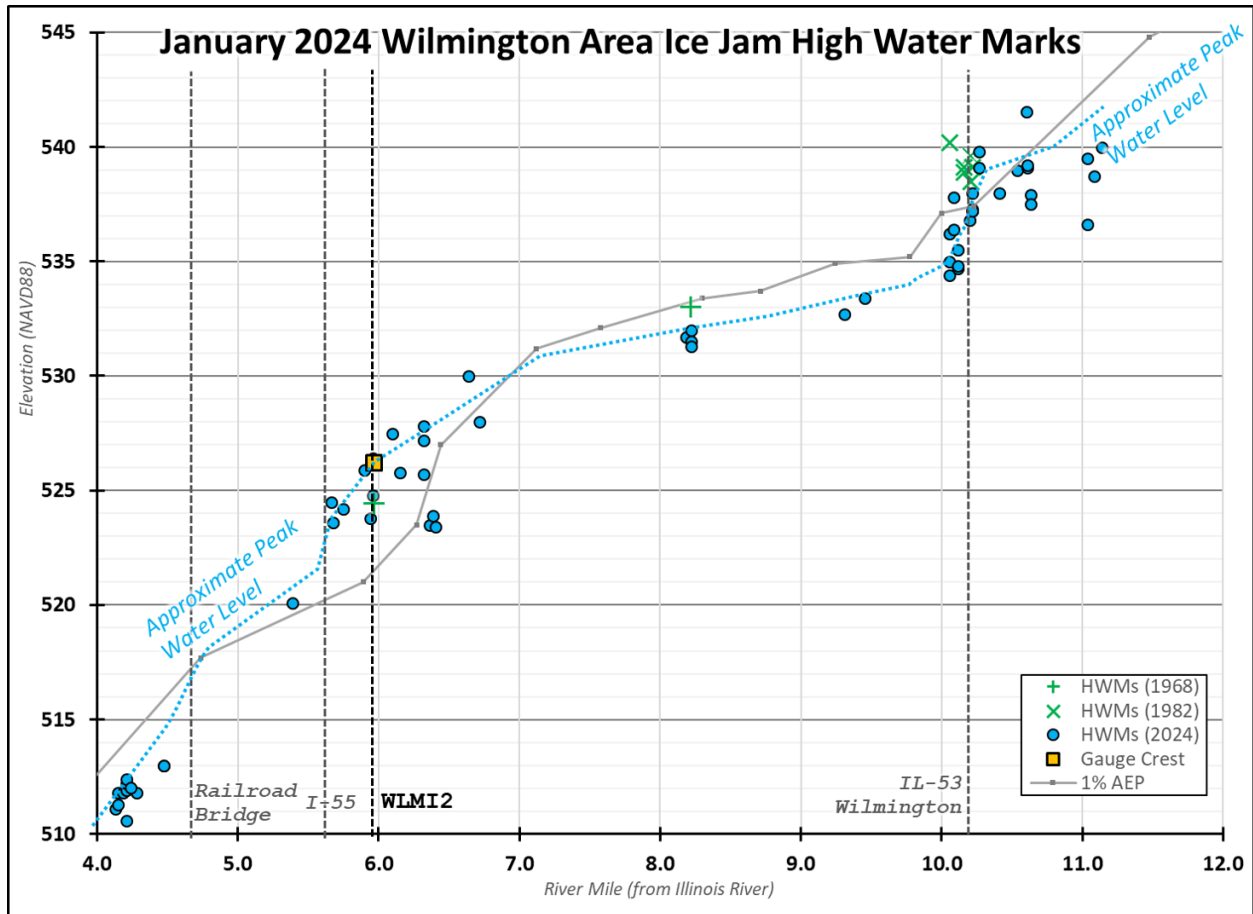
Figure 9. High water marks collected during NWS post-event surveys of the lower Kankakee River. High water marks collected for this report should be considered very approximate due to the equipment and method used to estimate elevation.

A comparison between high water marks and the 1% AEP flood event (estimated by FEMA) illustrated the flood variability occurring along the ice jam. Near and just upstream of I-55, near the start of the ice jam, water levels were several feet above the estimated 1% AEP flood, while water levels near Wilmington were near or below the 1% AEP flood (Figure 9). High water marks collected as part of the NWS survey must be used with caution and in a general sense due to limitations in the equipment and method used. Most high water marks were considered poor quality due to the very subtle mud or debris marks left behind. No survey equipment was used to determine ground elevation; latitude and longitude coordinates were determined using GPS data available to a cell phone and elevations were extracted from LiDAR elevation data for the indicated points.

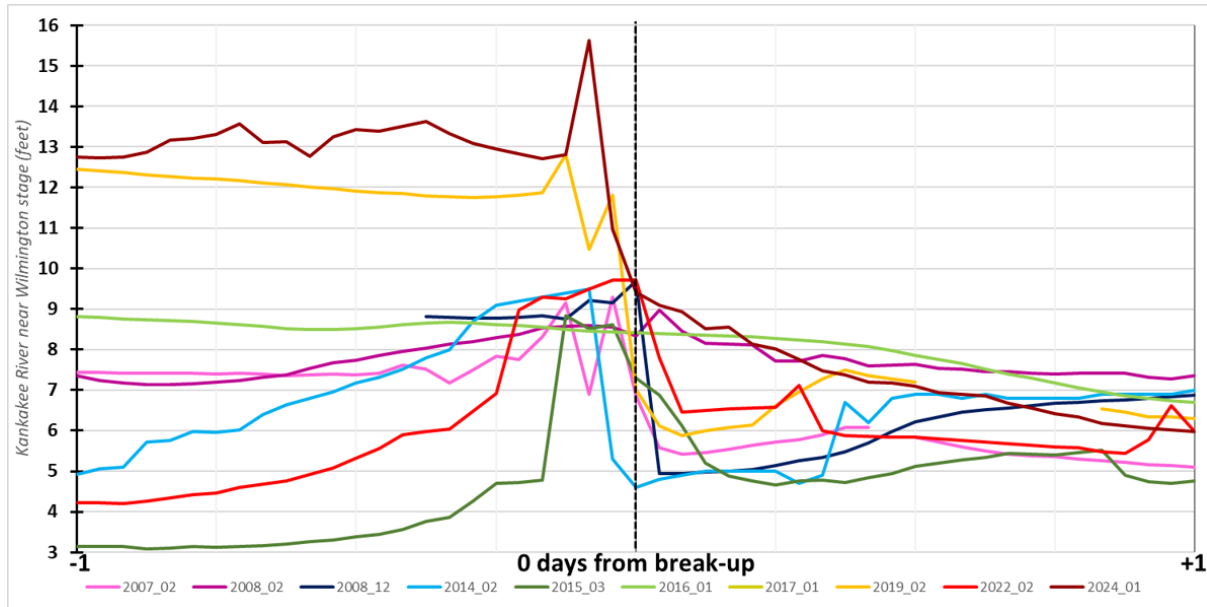
Figure 10. River stages observed by the Wilmington river gauge at the time of ice break up for ice jam events from 2007 to 2024. Note multiple events showing a jump in water levels just prior to ice break-up.

During the break-up phase of this ice jam, it was noted that stages recorded by the Wilmington river gauge showed a steep climb followed by a steep fall coincident with ice break up near the gauge location. River stage data from past ice jam events were collected to determine if this behavior was common. Data was aligned such that the time of break up coincided for each event. It was noted that the pre-break-up water level jump also occurred during events in 2022, 2019, 2015, December 2008, and 2007, with the most pronounced instances in 2024 and 2019 (Figure 10). The jump in water levels ranged from 0.9 to 3.0 feet, with an average of 1.5 feet. The ice jams of February 2008 and 2016 broke up very slowly with no sudden jump or fall in water levels. The ice jam of 2017 broke up when river gauge data was unavailable. The exact cause of the sudden jump in water levels prior to many Wilmington area ice jams is not certain, but may be due to shifting of the ice jam during the final break-up phase, with ice shifting downriver multiple times and then re-jamming, with each new instance of jamming corresponding to a localized, rapid jump in water levels. This could explain the sudden jump in water level observed at three locations in the Wilmington area in 2024 – near the central business

district, near the water treatment plant, and near the river gauge – which appeared to occur as the upper end of the jam passed a particular location.

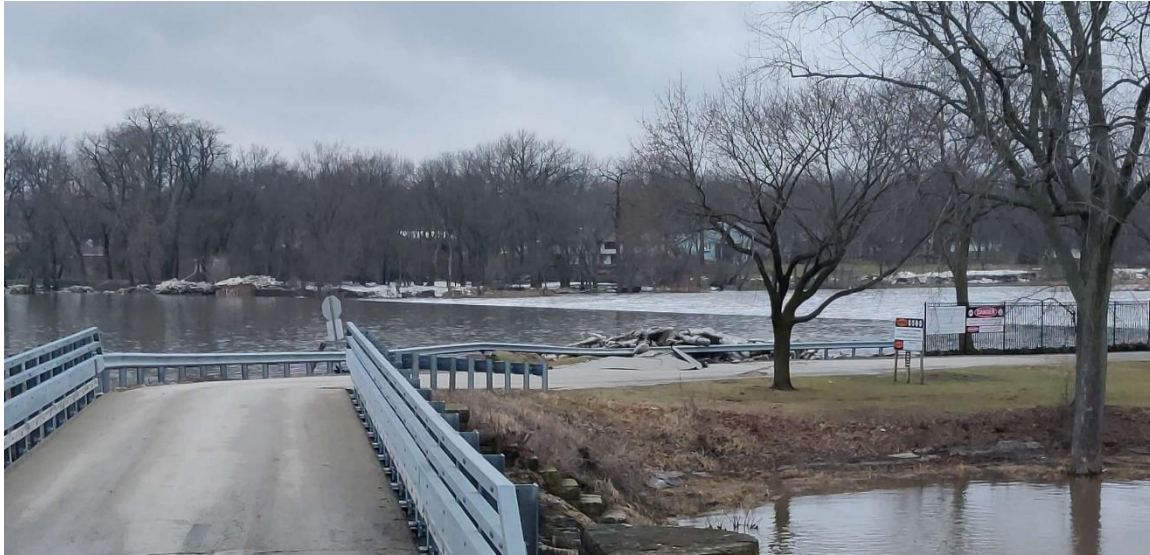
Figure 11. Damage to the roadway through Island Park in Wilmington. Note the piles of ice and shear walls on the opposite river bank still visible on January 30.

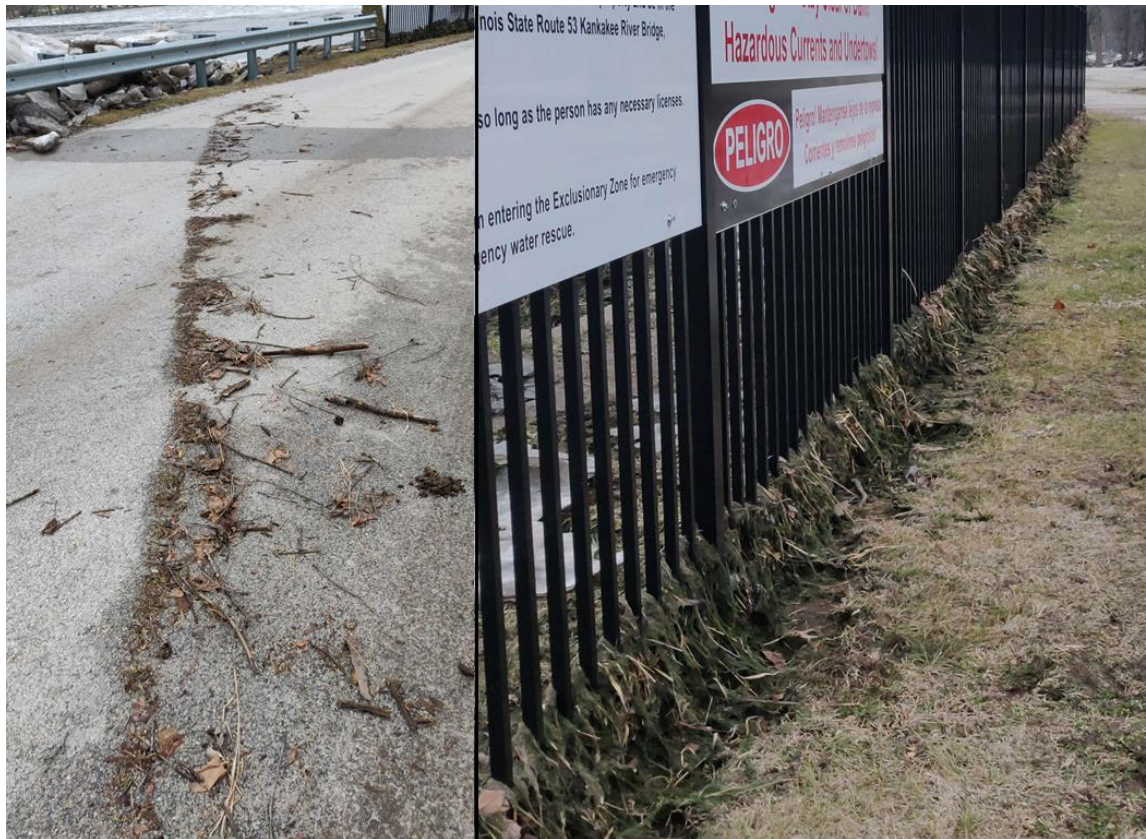
Figure 12. Vegetation debris lines on the roadway in Island Park and vegetation stuck in the fence near Wilmington Dam visible on January 30. These high water marks suggest a peak water level of about 539 feet elevation.

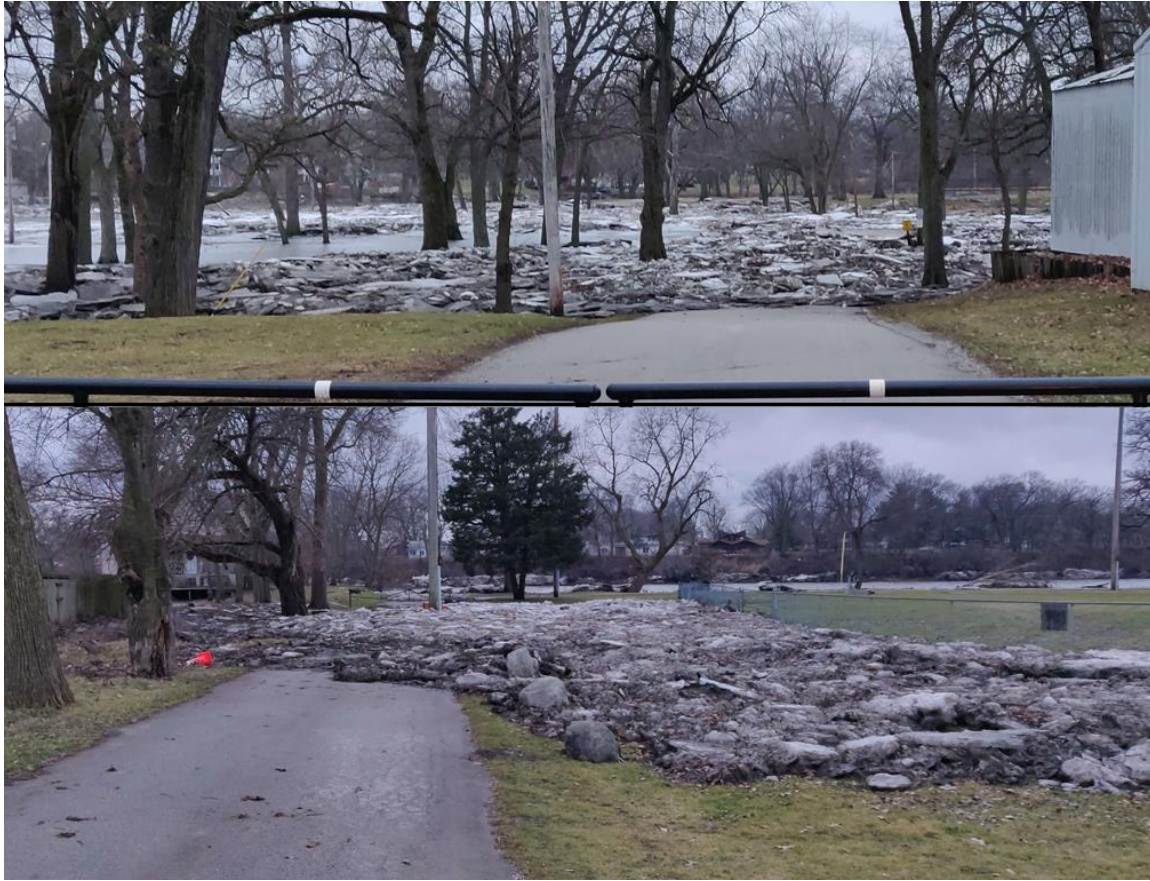
Figure 13. Large pieces of ice and flood debris cover portions South Island Park (top) and North Island Park (bottom) in Wilmington on January 30.

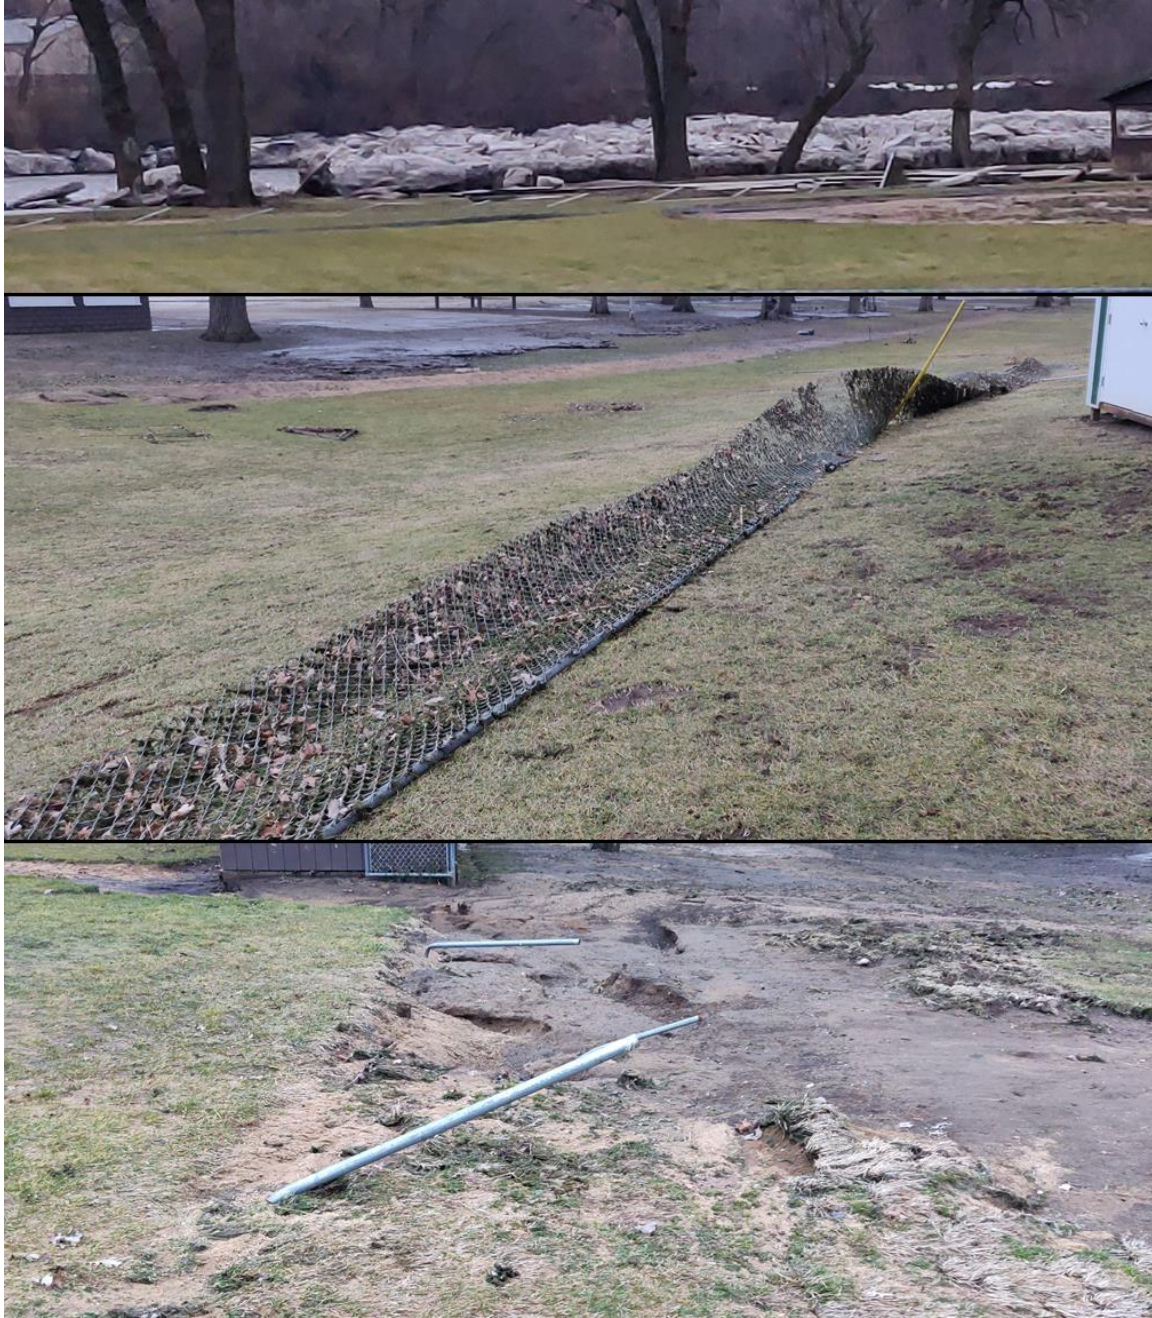
Figure 14. Chain link fencing damaged at the north (downstream) end of Island Park in Wilmington due to flooding and ice flows. Photographed on January 30.

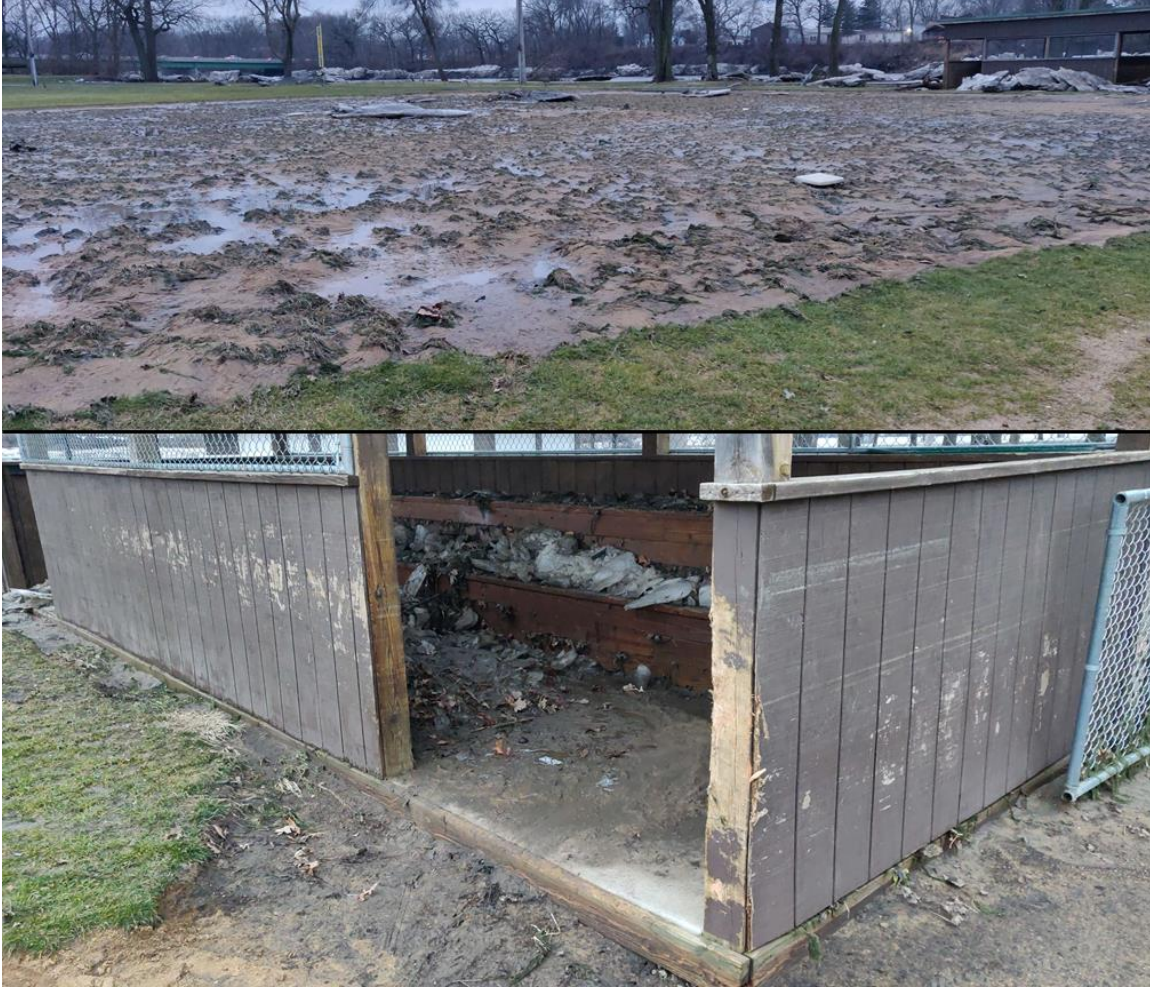
Figure 15. Damage to a baseball field at the North Island Park (downstream end) in Wilmington due to flooding and ice flows. Photographed on January 30.

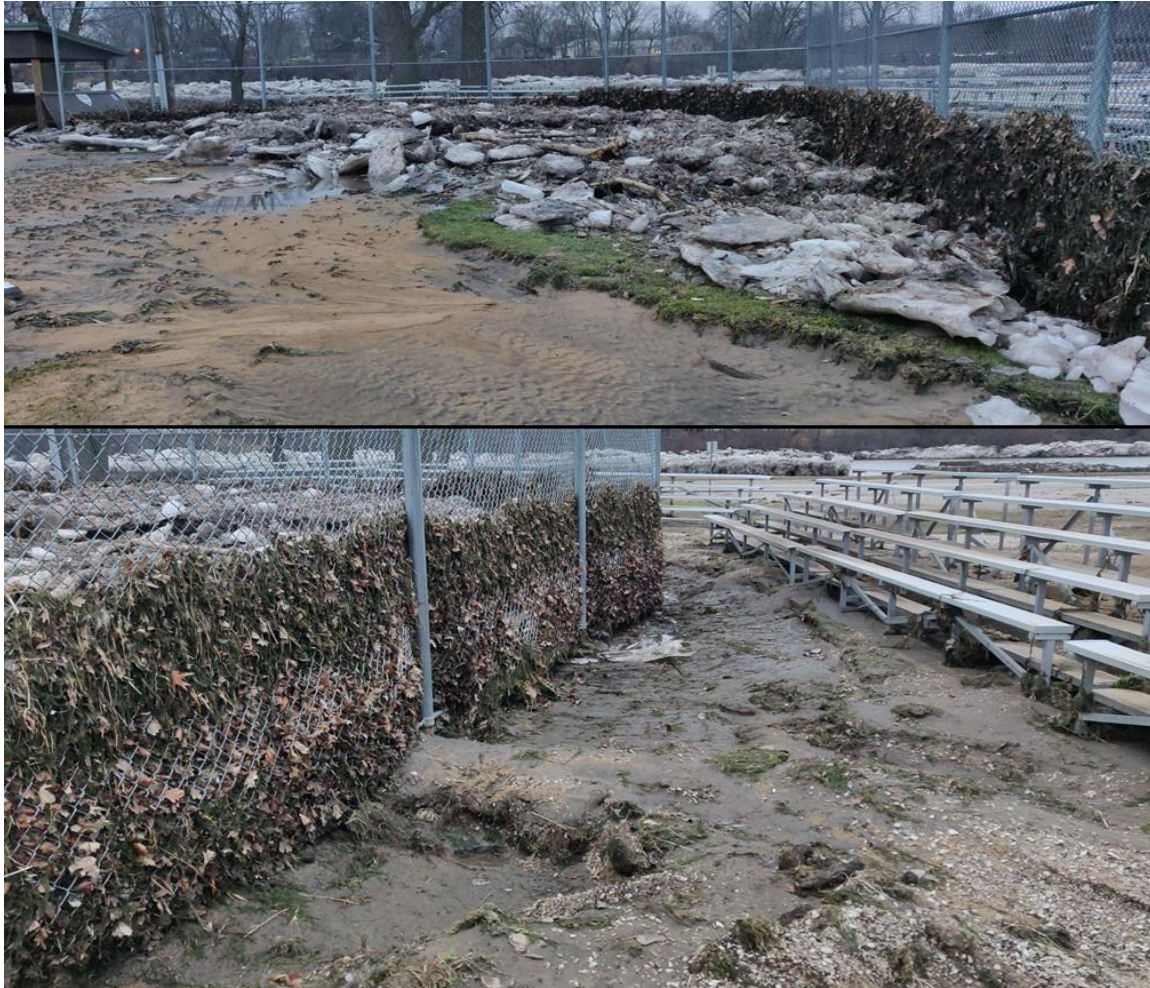
Figure 16. Vegetation stuck in the fence at baseball field at North Island Park (downstream end) in Wilmington. These high water marks suggest a peak water level of about 536 feet elevation. Photographed on January 30.

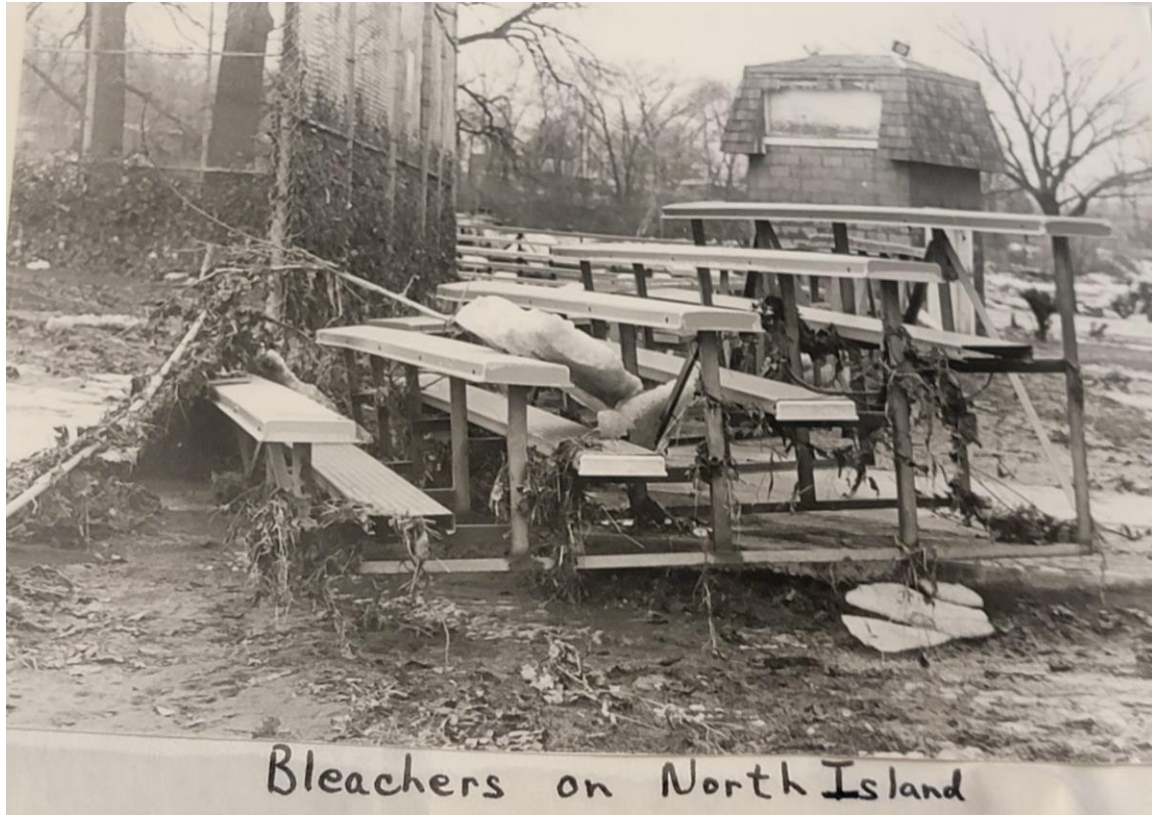
Figure 17. This photograph, taken by the family of Charles Jeffries of Wilmington, shows damage from an ice jam flood that occurred in late February 1982. This photograph is believed to have been taken from a similar vantage point as the photograph from the post-event survey from 2024, suggesting a water level multiple feet higher in 1982.

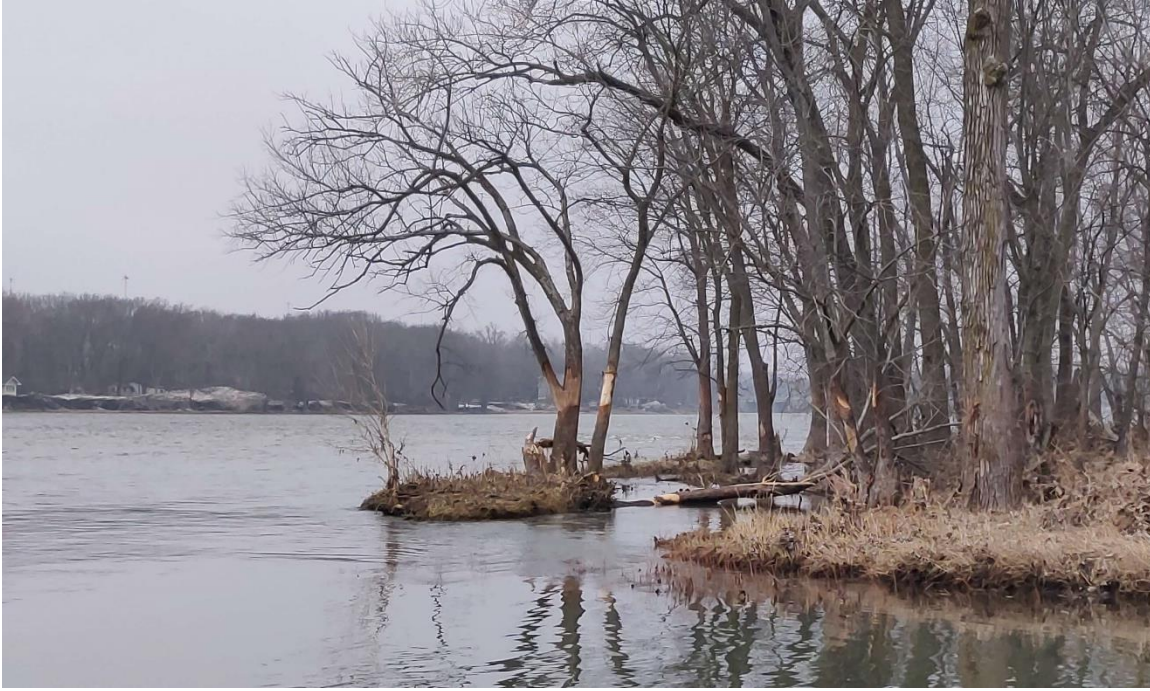
Figure 20. Multiple trees were damaged by flowing ice near Milliken Lake and the outlet of Prairie Creek. Note the shear walls on the opposite shore still visible on February 6.

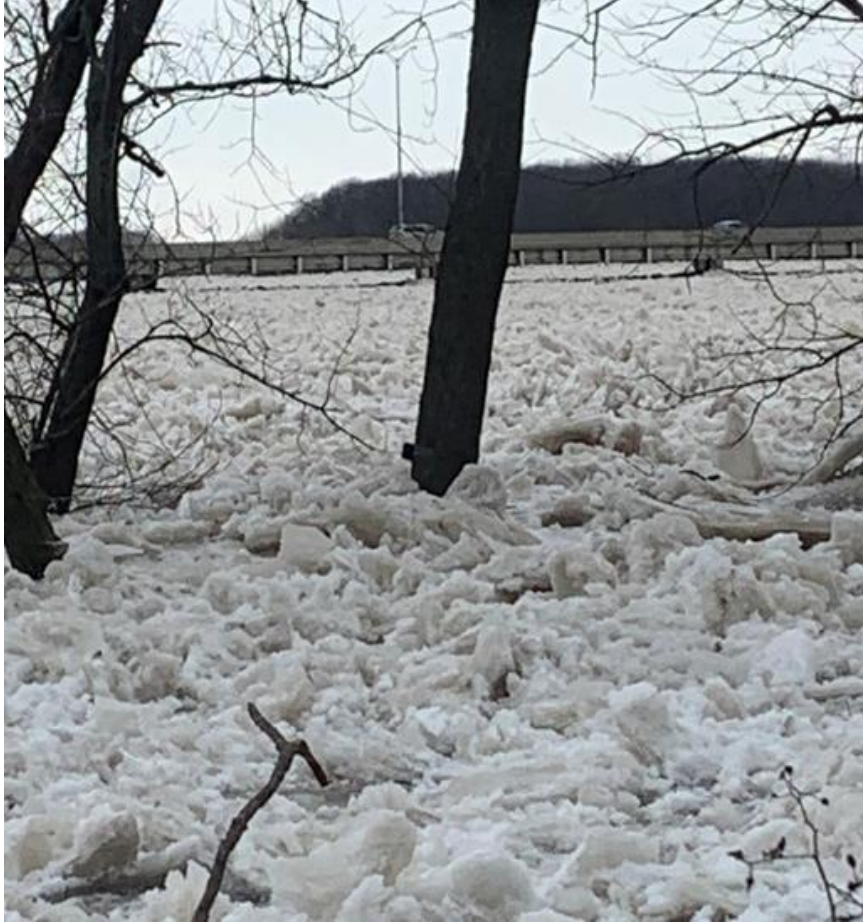
Figure 23. This photo, taken by Erin Ward of Will County EMA, shows an Ice jam in progress just upstream of I-55 at 9:33 AM CST on January 17. Note the web cam attached to the tree in the center of the photo which was installed prior to ice jam formation near the river bank at a height approximately 10 feet above ground level. The stage recorded by the nearby Wilmington river gauge was 12.3 feet at the time of this photo; the river crested over 3 feet higher at approximately 15.6 feet on January 26 and the camera was lost due the resulting ice flow.
