**WESTERN REGION TECHNICAL ATTACHMENT  
NO. 01-08  
June 19, 2001**

**FLASH FLOOD EVENT OF 6 FEBRUARY 1998: A CASE STUDY**

**Richard A. Thompson, Weather Forecast Office,  
Los Angeles/Oxnard, CA**

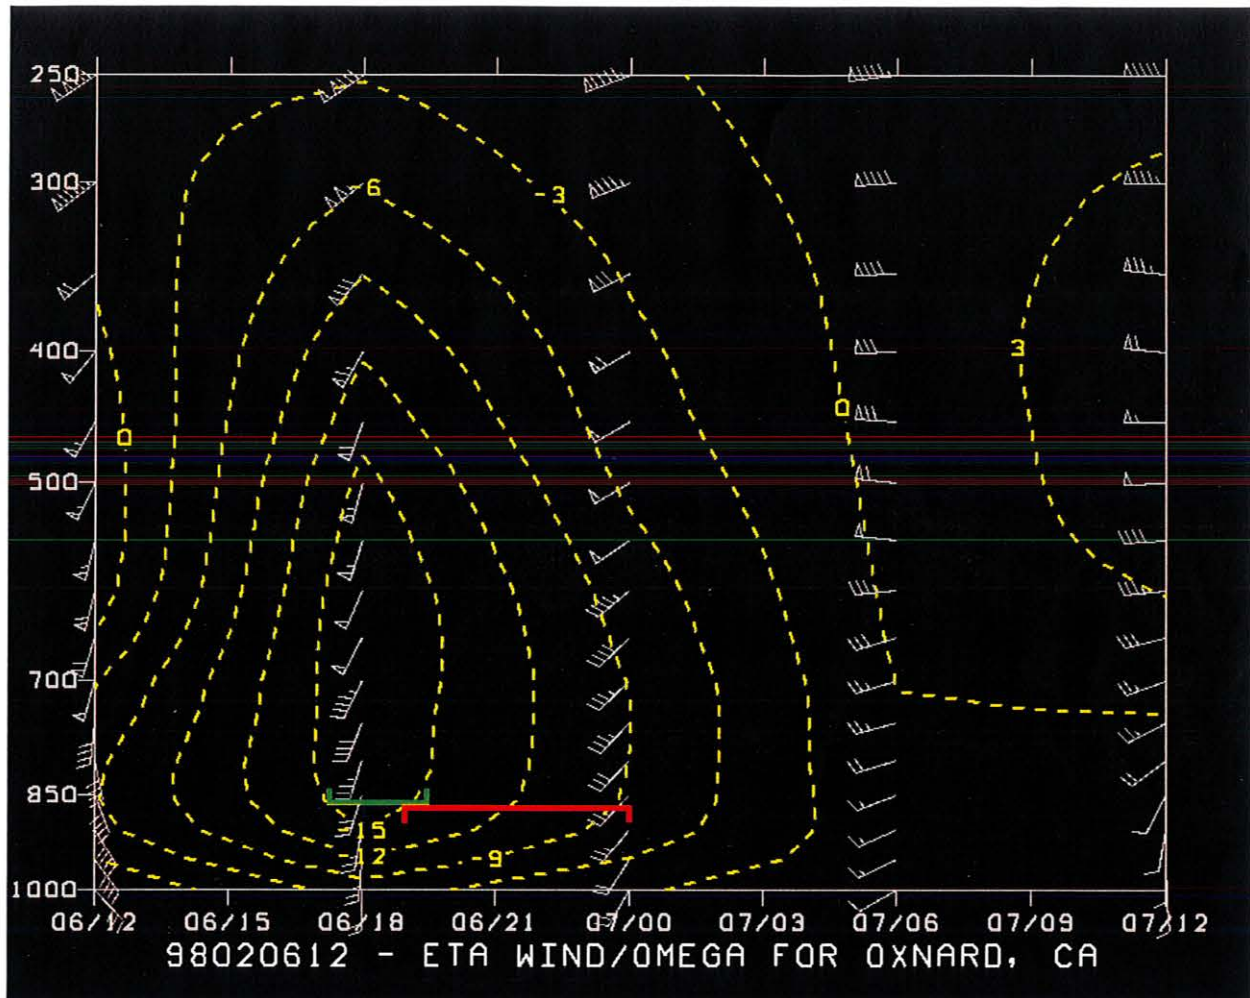
Figure 3. Time-Height Cross Section of Winds and Omega.

This figure shows the Eta forecast time-height cross section of winds and omega for Oxnard, CA from the 12Z model run. Note the area of 15  $\mu$  bars/sec upward vertical motion centered near 18Z. The green line indicates the period of the heaviest rains, while the red line indicates the period of highest flows on the Calleguas Creek.

The storm that hit southern California on the February 6 had all the earmarks of a classic El Nino event. Figure 1 shows the 500 mb pattern associated with the storm. Of particular note is the classic negatively-tilted trough aligned along the coast of southern California. Figure 2 shows a 160 knot jet approaching northern Baja—another classic El Nino feature that puts much of southern California under the favorable left exit region of the jet stream and in an area of enhanced upward vertical motion. The strength of the vertical motion can be seen in Fig. 3, a time-height cross section from the Eta model centered over the Oxnard

Plain of southern Ventura County. Note that the strongest upward vertical velocities, over 15 micro-bars per second, are centered around 06/18Z (10 PST). This is almost precisely when the heavy rains and flooding occurred.

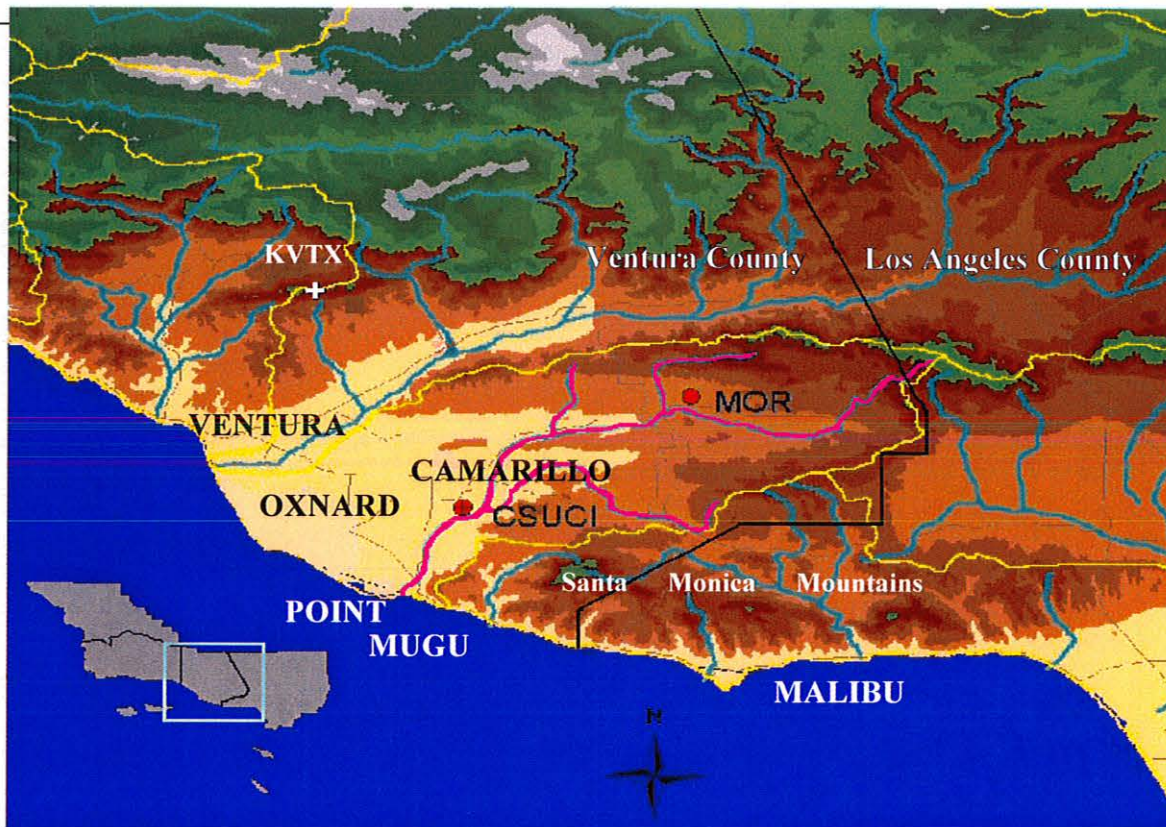
Figure 4. Calleguas Creek River Basin.

This map shows the relative positions of the Sulphur Mountain radar [KVTX], the city of Camarillo, Point Mugu, the dual rain gage and river sensor near California State University-Channel Islands [CSUCI], and the rain gage at Moorpark [MOR]. The Calleguas Creek is colored magenta. The mountain range to the south and east of the river is the Santa Monica Mountains [ $>3000$  feet]. The mountains to the north are the Topa-Topas [ $>6200$  feet].

The Calleguas Creek is not just any small creek. The Calleguas Creek River Basin is located in southeastern Ventura County at the extreme west end of the Santa Monica Mountains. Figure 4 is a topographic map of the area showing the creek (magenta) running east and south of Camarillo (C). Although it is a small basin—covering only 325 square miles with elevations running from sea level to about 2,800 feet—flooding in this basin threatens much more than just the farmlands of Oxnard and Camarillo. Located near the river's mouth is the Navy's multi-billion dollar Pacific Missile Test Center at the Point Mugu Naval Air Station (P). Other than levees on the lower reaches of the river and around the Navy Base, there are no major flood controls in the watershed. On the morning of February 6, flood waters rose rapidly to within six inches of topping the levee. The flash flood warning issued by the National Weather Service at Oxnard gave Navy personnel advanced notice on the possibility for dangerous flooding along Calleguas Creek—and they were standing by the levee at the time.

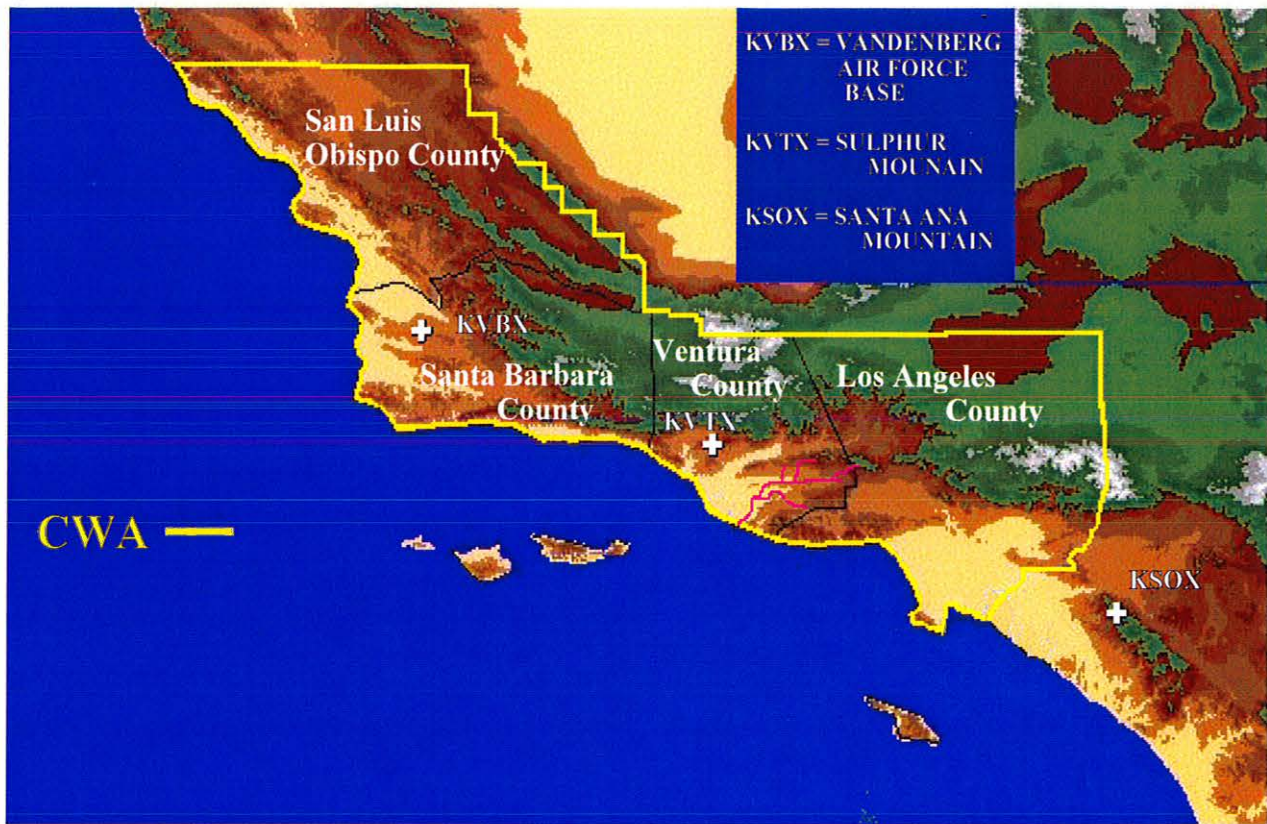
Figure 6. Next Generation Radar [NEXRAD] Sites.

This figure shows the relative positions of the three NEXRAD sites that have coverage over the area that flooded on 6 February 1998. Note the four-county, county warning area [CWA] supported by the Los Angeles/Oxnard office is outlined in yellow. The Calleguas Creek is highlighted in magenta.

There are three radars in the national Doppler network that can provide at least some coverage over southern Ventura County, the area of this flood. To the northwest, about 92 NM from Point Mugu, lies the Vandenberg AFB radar – KVBX. About 84 NM to the southeast of Point Mugu lies the Santa Ana radar – KSOX. Finally, just 23 NM to the north-northwest of the area is the Sulphur Mountain radar located near Ojai. Figure 6 shows the relative locations of these radars.
