WESTERN REGION TECHNICAL ATTACHMENT NO. 03-10 November, 26 2003

The Campo Bonito Wash Flash Flood of August 14, 2003: A Heavy Rain Event on a Recent Burn

Mike Schaffner, NOAA/NWS Weather Forecast Office, Tucson, AZ

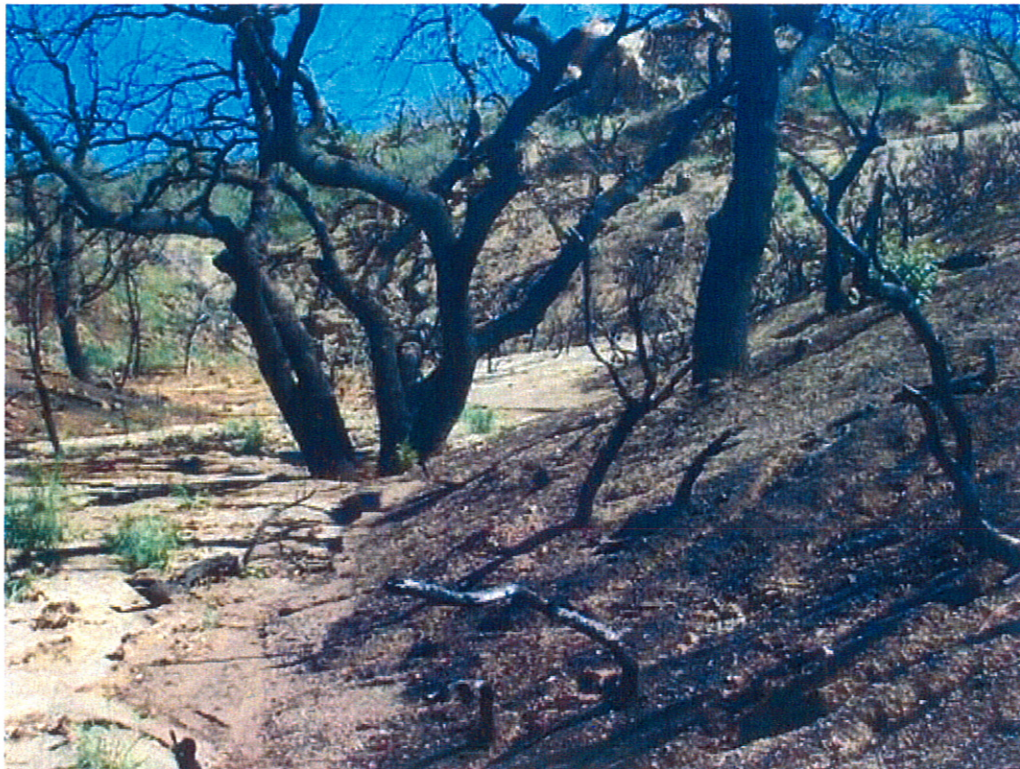
Figure 3. Image of burned oaks, scrub brush, and soil near upstream slope-area site within the Aspen Fire burn area. Road in distance acted as a fire break for both the Oracle Hill and Aspen Fires.

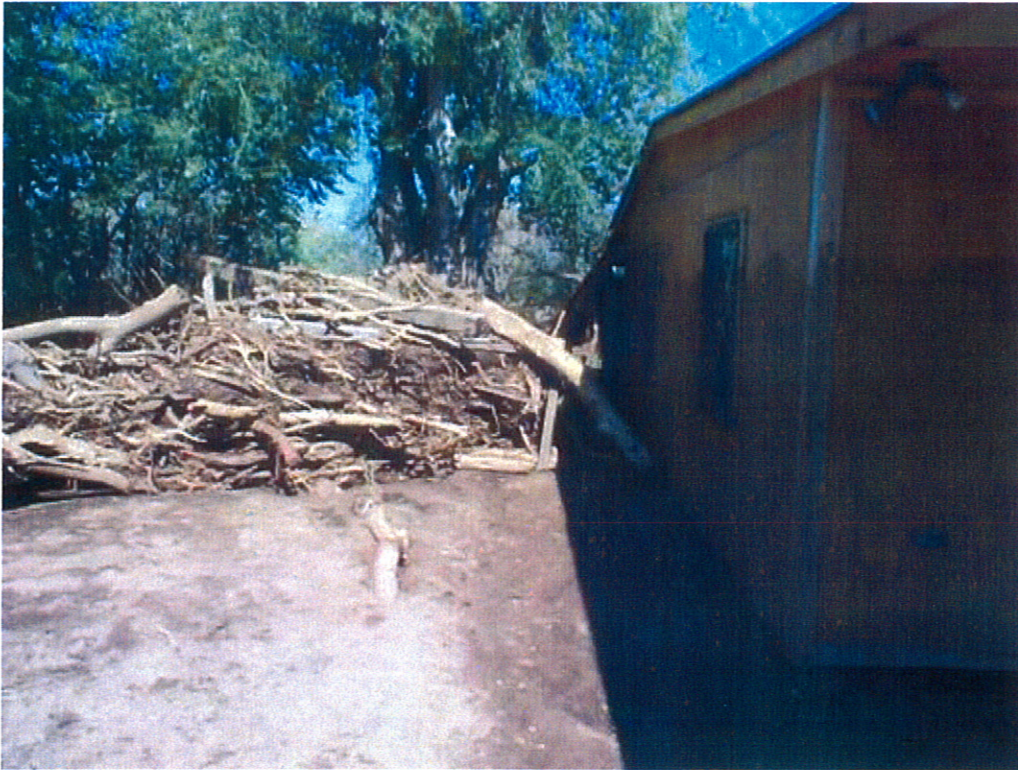
Figure 6. Large pile of debris near channel side of residence. Note highwater mark along side of residence.

A flood survey was conducted within 24 hours of the event. The NWS Tucson Hydrologist and WCM, county officials, and state division of emergency management were present. Highwater marks were approximately 5 feet high on the residence of the deceased or about 9 feet high from the pre-flood channel bottom of Campo Bonito Wash. Pre-flood channel depth was based on conversations with neighbors. Campo Bonito Wash makes a greater than 45 degree turn near the residence. A large piling of debris can be seen up against the channel side of residence ([Figure 6](#)). A culvert and wooden beam bridge belonging to a neighbor 100 yards downstream was plugged and may have caused much of the channel sedimentation near the home ([Figure 7](#)). Further evidence of man-made channel modification was noted several hundred yards downstream including walls that constricted channel flow.

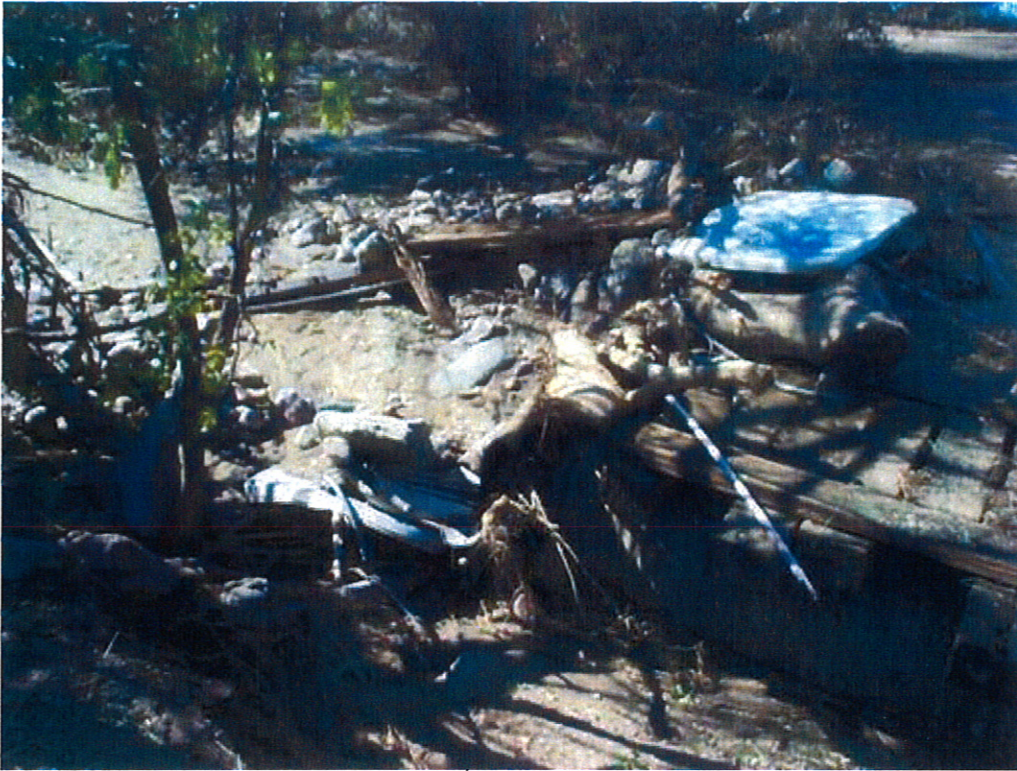
Figure 7. Culvert and wooden beam bridge 100 yards downstream of residence. Note culverts blocked and channel deposition upstream.

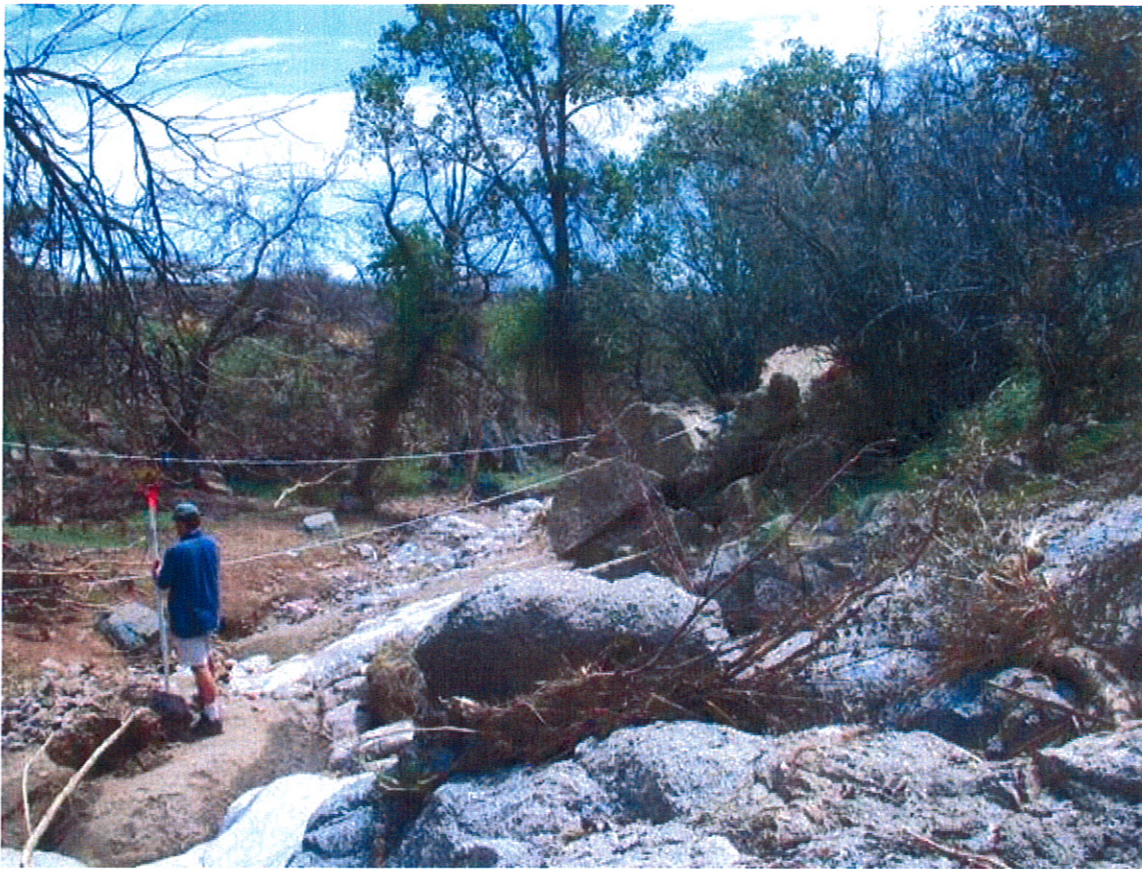
Figure 8. USGS conducting slope-area survey in upper reach. Photo is taken looking downstream. Steve Wiele, a fluvial geomorphologist with the USGS in Tucson, is pictured in the foreground. Photo courtesy of the USGS.

The NWS Tucson hydrologist worked with the USGS Tucson water resources field office to make a slope-area measurement for the event. Two slope-area reaches were flagged and surveyed within less than a week of the event ([Figure 8](#), [9](#), and [10](#)). The upstream reach has an area of 1.25 square miles and the downstream reach an area of 2.0 square miles. The majority of the area burned is within the drainage area for the upstream reach. See

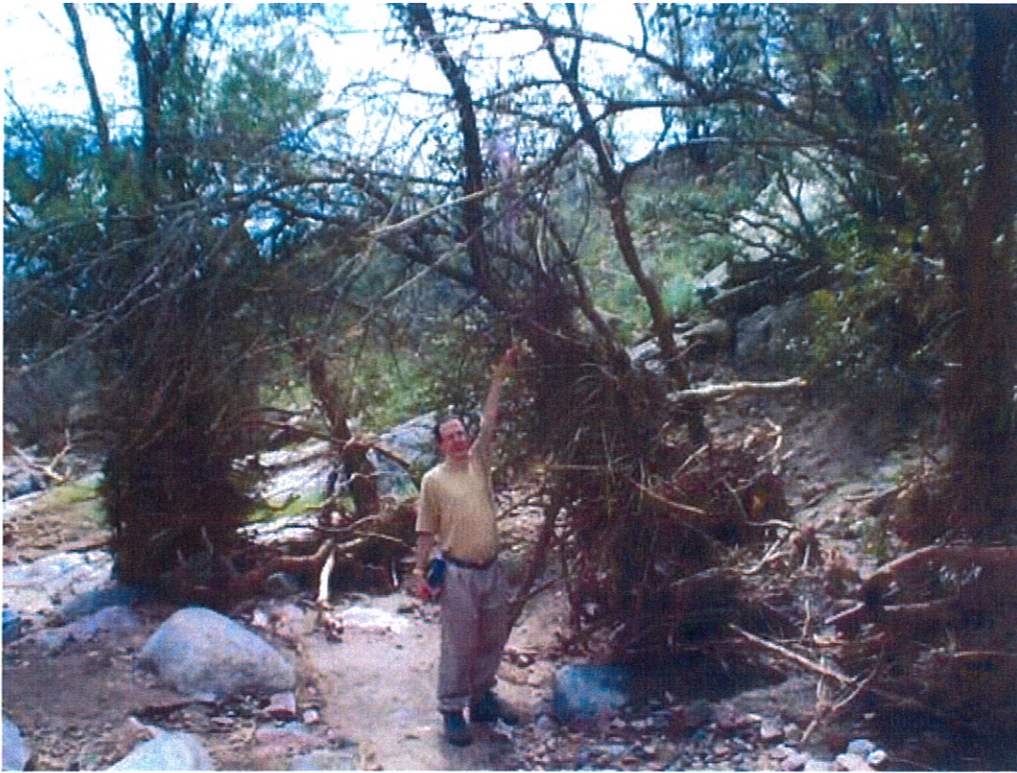
Figure 9. NWS hydrologist Mike Schaffner pointing out a debris line in a tree located in the upper slope-area reach.

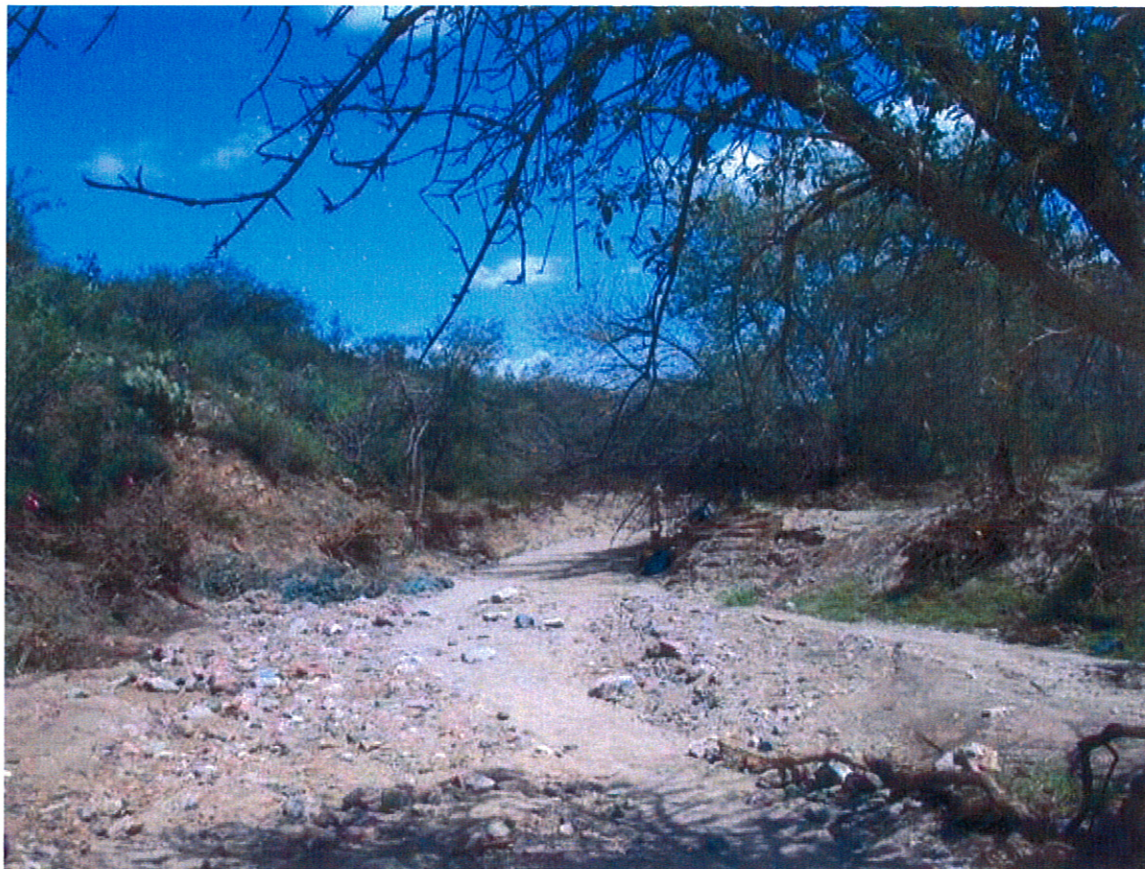
Figure 10. Image of lower slope-area reach looking downstream. Notice pink flagging on left bank indicating high water marks to be surveyed in. Photo courtesy of USGS.
