# The April 27, 2014 Windstorm

## Summary

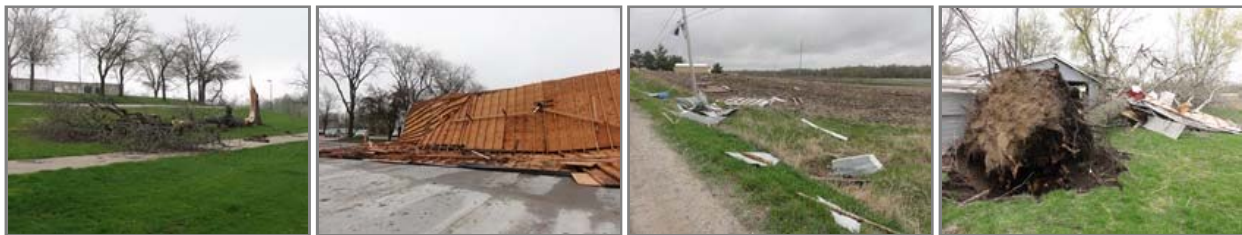
## Lovilia to Oskaloosa

A survey team from the NWS in Des Moines assessed the damage path from Lovilia to Oskaloosa and concluded that it was all the result of downbursts/straight-line winds. Contrary to initial reports, there was no evidence of a tornado touchdown in Lovilia. The only damage found in town was three broken tree sections and light siding damage to one building. This intermittent and weak straight-line wind damage trail continued northeastward through southwestern Mahaska County before strengthening to the southwest of Beacon at 3:10pm CDT. This increase in intensity is supported by data from the Des Moines WSR-88D radar. These winds snapped 4-5 large wooden power lines to the west of town, with winds estimated at 80 to 90 mph. Two large sheds/small outbuildings were destroyed just southwest of Beacon, with the debris thrown into power lines and a trailer park just across the road to the northeast. The wind removed sections of roofs from at least two trailers and tossed the debris almost 200 yards to the northeast. Other intermittent tree and roof damage took place on the southern and eastern sides of Beacon. Estimated winds in the town were between 70 and 75 mph.

These straight-line winds progressed rapidly into southwest Oskaloosa just after 3:15pm CDT. Dozens of trees were snapped or uprooted in the town, with the greatest concentration of damage running from Edmundson Park on the southwest corner of the city northeast to the city hospital on the town's eastern side. While trees suffered the bulk of the damage there was light shingle damage to some roofs and several pole lines were snapped. The Oskaloosa Family Medical Center had its roof peeled back and draped over the northern side of the building. Despite the severity of the damage to the building, the roof decking remained in one piece and there was no damage to surrounding buildings and trees. Wind speeds in this area were estimated to be around 85 mph.

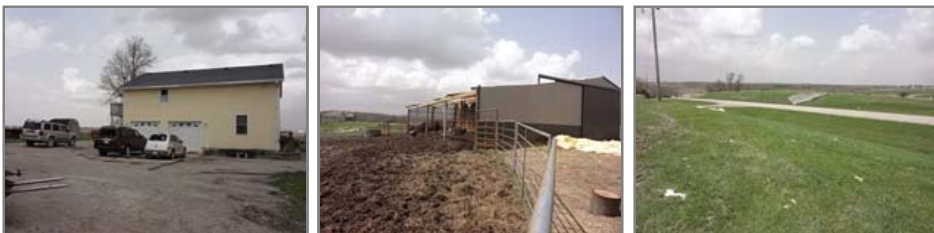
## Cincinnati to Northern Ottumwa

Straight-line winds along the leading edge of the squall line were also responsible for a broad and intermittent path of damage from southern Appanoose County to northern Ottumwa. Trees and farm outbuildings sustained the most damage from the winds, with the resultant flying debris damaging houses and cars. This flying debris also resulted in one injury to a homeowner southwest of Udell in the eastern part of the county.

The coverage and intensity of the winds lessened as the storm shifted into southwestern Wapello County, but there were still isolated pockets of heavier damage. The storm strengthened as it approached the western end of Ottumwa with the strongest winds grazing the western and northern sides of the city. Once again, damage was almost exclusively to trees and outbuildings with house damage generally due to trees or other debris striking the roofs/sides.

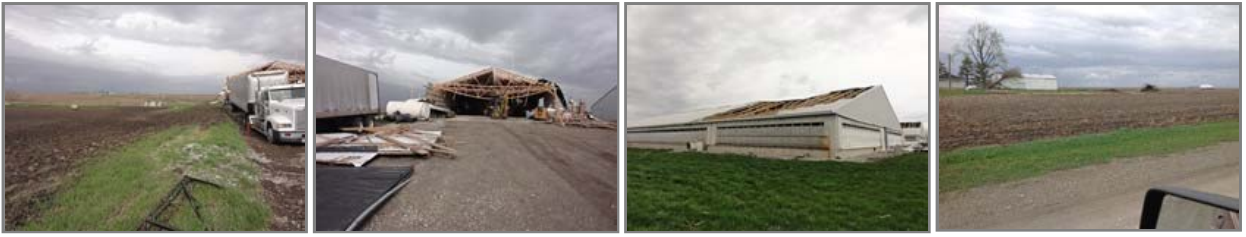
## Far Northern Wapello County

There was little to no damage for five miles to the northeast of Ottumwa. However, the storm strengthened 3 miles south of the Keokuk

County line with damage to multiple farm buildings, trees and power lines. This damage exhibited some characteristics of a broad, cyclonic circulation. It is believed that an EF1 tornado formed 2 miles south of the county line, west of Agency-Hedrick Road, and tracked northeastward out of Wapello County and into the town of Martinsburg.
