Bow Echo Event

July 10th, 2003

Dupo, Illinois Tornado

Caseyville, Illinois Tornado

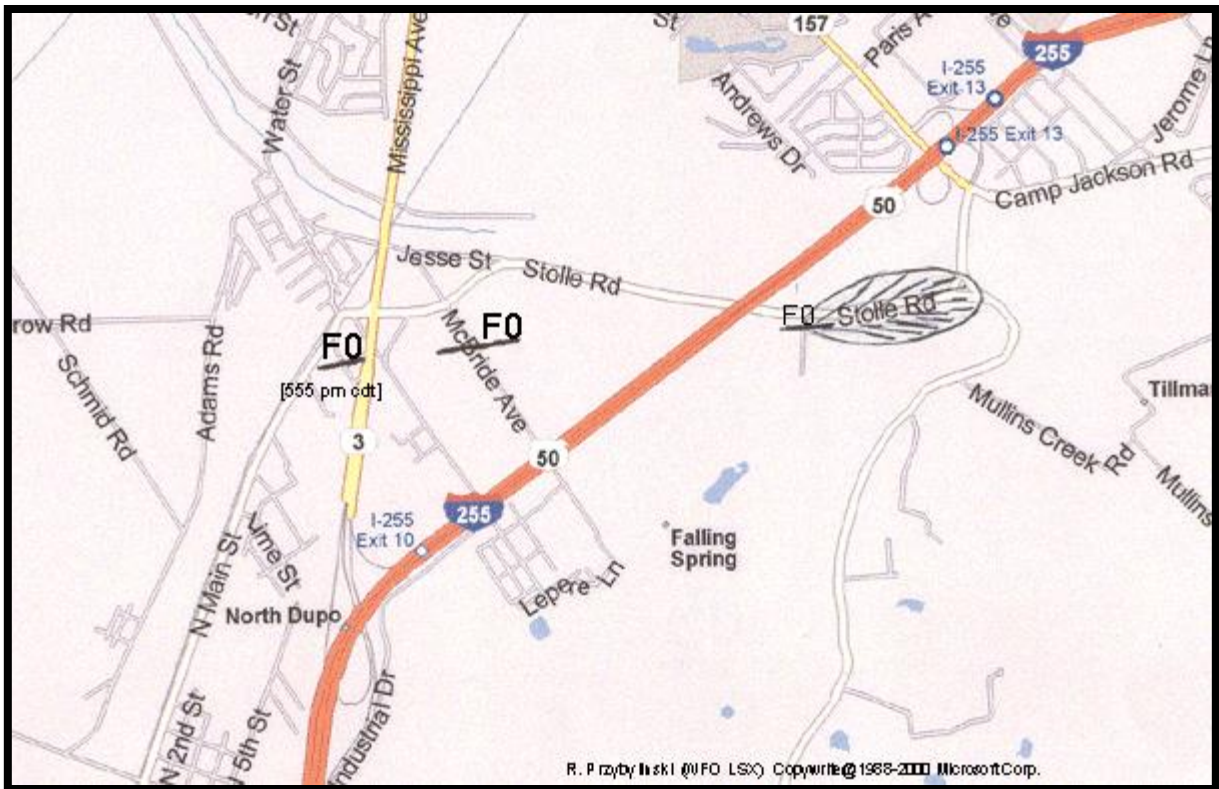
Map of the Dupo, Illinois Tornadoic Damage Track (St. Clair County, Illinois)

The first tornado touchdown occurred around 5:55 PM CDT and just west of Highway 3 - 1.5 miles north of Dupo, Illinois. The roof of one home was partially lifted while several large trees were severed or uprooted. The roof of a nearby garage was also lifted and tossed 80 yards across Highway 3. The tornado touched down a second time on McBride Ave between Highway 3 and Interstate 255 and damaged four homes and four house trailers. Parts of the roof of each home were tossed 50 to 70 yards to the east. Two of the four house trailers sustained considerable damage. Small 2 x 2 missiles of debris were driven into two of the four house trailers. Several large trees were severed or snapped at the base of the trunk. Along Interstate 255, one tractor trailer was overturned. On Stolle Road (1/2 mile east of Interstate 255, several large trees were either uprooted or snapped at the base. The damage was suggestive of both a small tornado and downburst winds. Total length of the tornadic damage path was approximately 1/2 mile long while the width of the damage path varied from 50 to 75 yards. The tornadic damage was rated F0 over these areas.

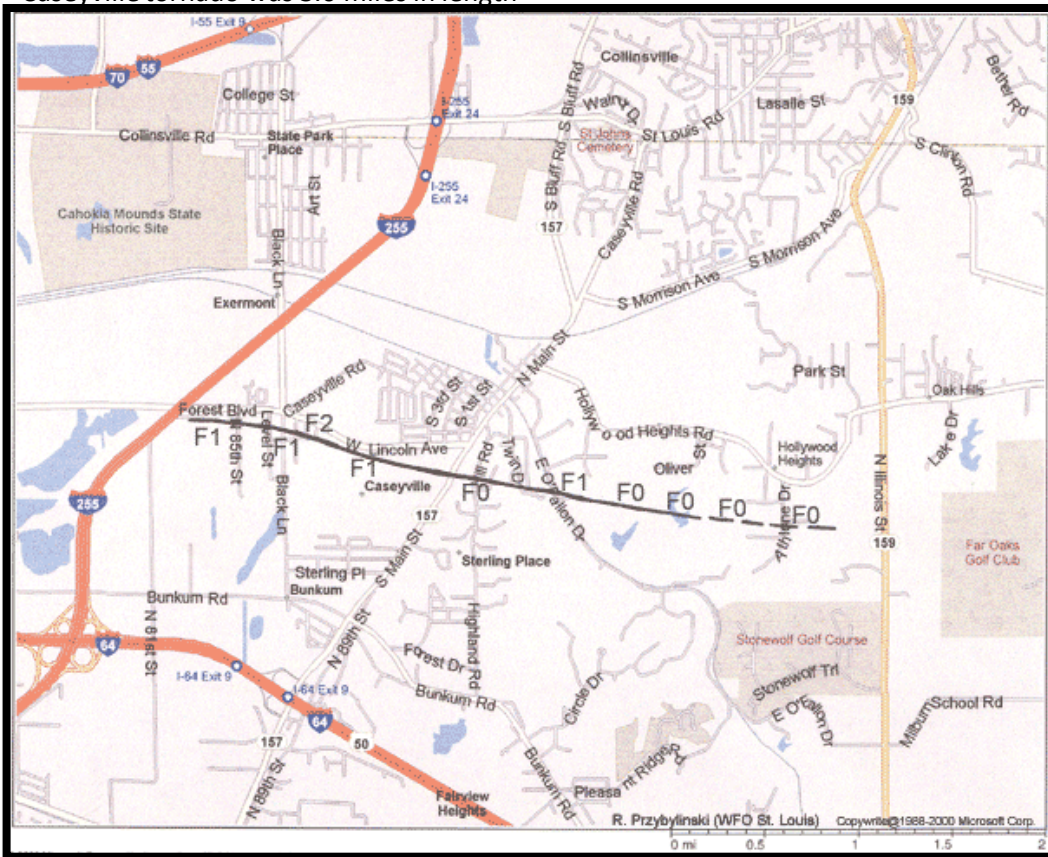
Map of the Caseyville, Illinois Tornadoic Damage Track (St. Clair County, Illinois)

The second tornado touchdown occurred along the southwest and south sides of the town of Caseyville, Illinois. The tornado initially touched down at approximately 6:05 pm CDT along Forest Blvd 1/5 mile east of Interstate 255. Over twelve witnesses observed the tornado along the leading edge of the bowing squall line as they saw debris tossed several hundred feet into the air. The tornado traveled east slightly southeast along Forest Blvd and West Lincoln Avenue. Three house trailers were severely damaged by the tornado between 85th and Black Lane. Two injuries occurred in two of the three house trailers. Numerous large trees were severed or downed by the tornado. The roof of a large machine shed on Black Lane was uplifted and displaced several hundred yards to the east. The tornado then ripped through a auto salvage area where several vehicles were over-turned, damaged or destroyed. The width of this damage area was 50 to 100 yards wide while damage intensity was rated F1. The tornado continued to travel eastward causing damage to two homes and a camper and completely destroying another house trailer. Some of the remains of this house trailer were observed 3/4 mile to the east just west of Highway 157. Pieces of metal were wrapped around snapped power poles while one 2 x 4 was driven into the front windshield of a pickup truck. The width of this damage area varied from 50 to 75 yards while the damage intensity was rated high-end F1 - low-end F2.

The tornado continued eastward and caused showed a convergence pattern in a nearby wheat field south of West Lincoln Ave. The tornado then caused minor damage to six new homes 100 to 300 yards south of West Lincoln Ave and 1/4 to 1/2 mile west of Highway 159. Roofs from five homes were partially uplifted and tossed 200 to 400 yards downwind to the east. One home under construction was completely destroyed. The width of the damage area varied from 75 to 150 yards. The damage intensity was rated the lower end of F1.

The tornado continued eastward up the ridge east of Highway 157. Several large trees were snapped or uprooted just east of 157. Additional tree damage was found along Hill Road east of Highway 157. One home on Hill Road sustained minor roof damage. The tornado crossed East O'Fallon Drive and severed or uprooted several large trees. One home sustained minor roof damage while machine shed and garage near a second home was severely damaged. The tornadic damage track ending just west of Highway 159. Width of the damage area again varied from 75 to 100 yards while the damage intensity was rated between F0 and lower end of F1. Total damage track of the Caseyville tornado was 3.0 miles in length

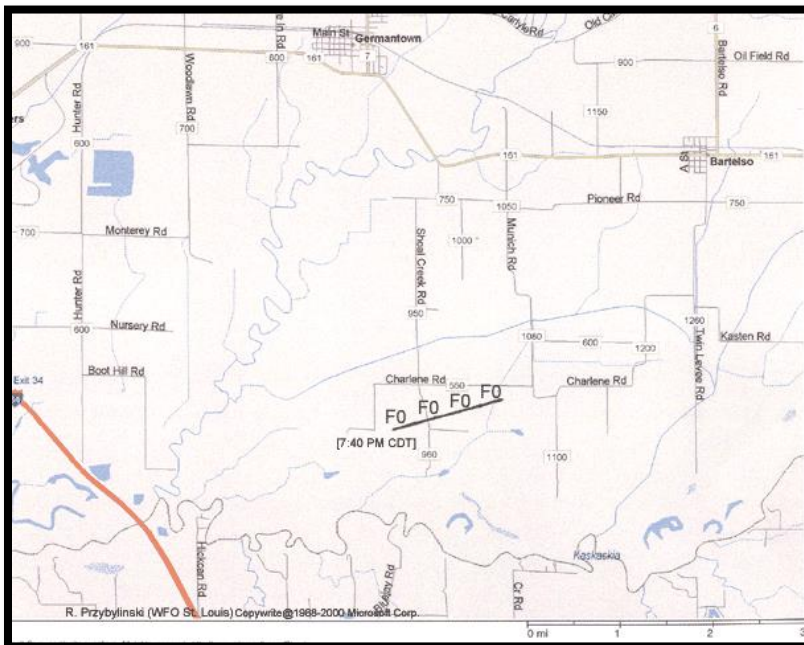
Map of Kaskaskia River Valley Tornadoic Damage Track

Another tornado caused brief damage to a farmstead over south-central Clinton County Illinois. The tornado occurred 4 miles south of Germantown , Illinois at 6:30 PM CDT. The farmstead was located in the Santa Fe flood plain along and north of the Kaskaskia River. A barn, machine shed, and silo sustained the greatest degree of damage while there was minor damage to the farm home. Debris from the farmstead was thrown 200 yards to 1/4 mile to the northeast. The tornadic damage track was 40 yards wide and 1.25 miles long. The tornadic damage was rated F0.

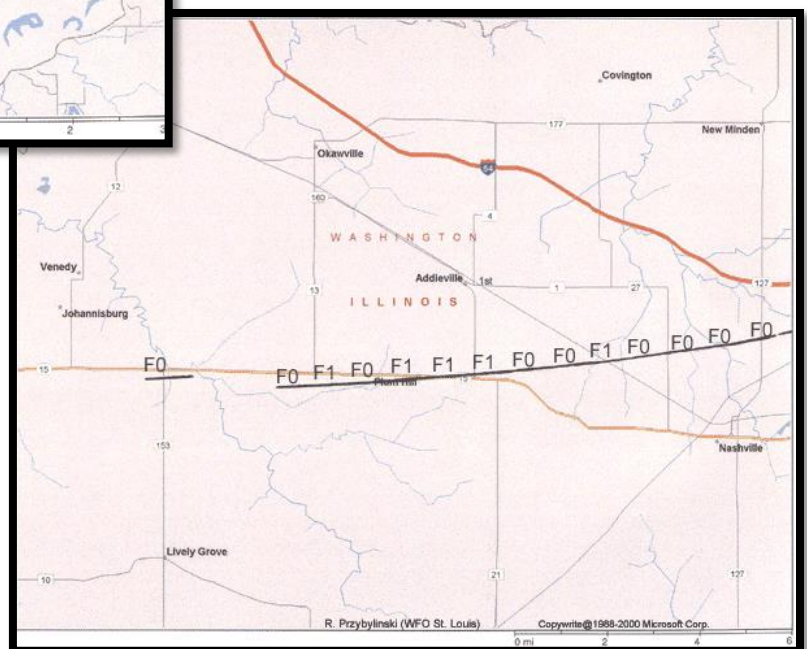
Map of Plum Hill, Illinois Tornadoic Damage Track

The bow echo system on June 10, 2003 spawned another tornado over parts of west-central Washington county Illinois. This tornadic damage track was relatively long (14 miles in length) compared to the other tornadic damage tracks on this day. Twelve machine sheds, barns, homes, other type of out-buildings sustained varying degrees of damage while numerous trees were along the tornado's path were either severed or uprooted. Debris at several locations along the damage path were driven into the ground 1 to 2 feet deep at 45 to 60 degree angles. A satellite tornadic damage track was observed approximately 100 yards north of the primary track approximately 1 mile south of Addieville, Illinois. The damage track of the satellite tornado was 1/4 mile long and 20 yards wide. In contrast to the other tornadoes on this day, this tornado occurred south of the apex of the bow echo. The tornado initially touched down at 635 PM CDT. The width of the damage track varied from 40 to 60 yards while the total length of the damage track was 7.0 miles. The damage was rated F1 intensity.
