Storm Survey for Severe Weather Event May 22-26, 2014

A damage assessment was conducted on Tuesday, May 27, 2014 by National Weather Service Midland, TX meteorologists. The survey was conducted in areas that reported widespread damage from either straight line winds or from a tornado. In addition, there were numerous reports of large hail where car windows were destroyed, mainly in Eddy County, New Mexico during this event. It appears that the greatest amount of hail, some of it the size of baseballs was in the White City and Carlsbad area. Based on NWS warnings and calls from WFO Midland, several outdoor activities were cancelled at Carlsbad Caverns National Park; with the National Park being evacuated before the thunderstorms arrived. This potentially saved significant amount of damage to vehicles. A damage survey was not conducted in this area due to the lack of any widespread structural damage. Vehicle damage was from vehicles travelling through the area.

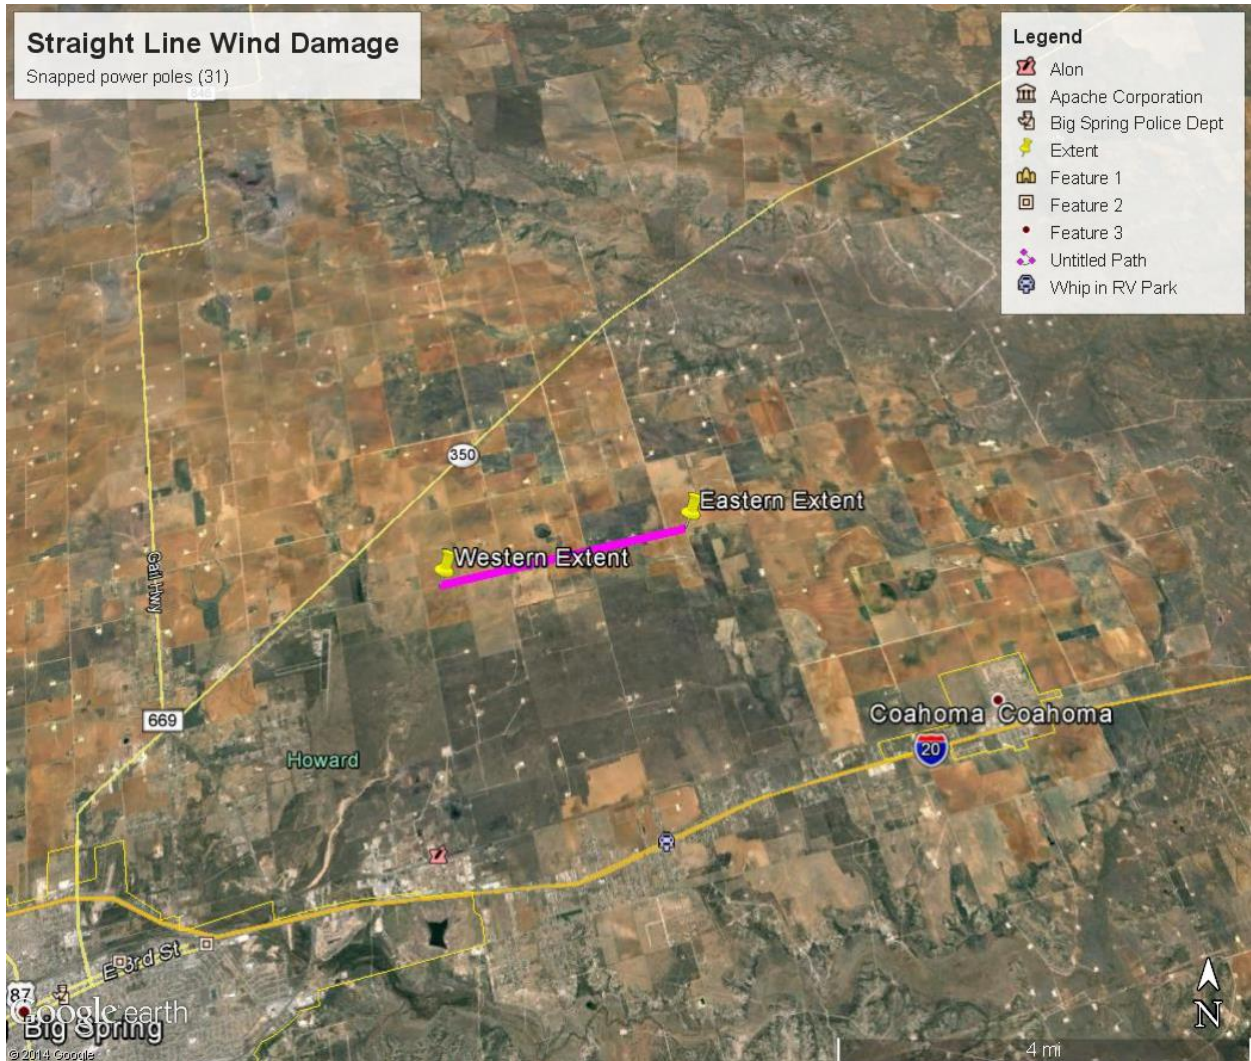
In Howard County near Big Spring and Coahoma there was a three mile long stretch of Centerpoint Road where there were 31 power poles snapped. This was most likely the result of a Rear Flank Downdraft from a severe thunderstorm. Based on damage indicators the estimated wind speed was likely between 85-100 mph (EF-1 equivalent). The map below shows the stretch of road.
