March 28, 2017 Severe Weather Event

During the afternoon and evening hours of Tuesday, March 28, severe thunderstorms developed over a large portion of the Texas Permian Basin. On Wednesday, March 29, two teams from the National Weather Service in Midland surveyed the damage from these storms. The following are the results.

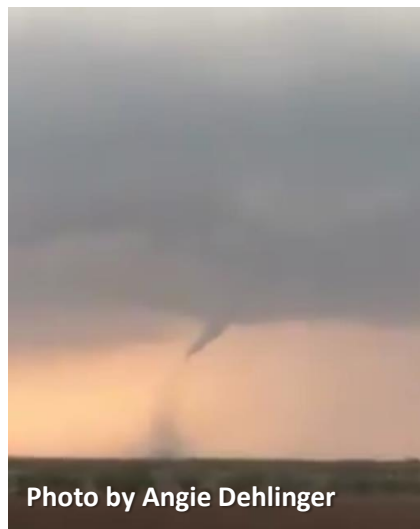
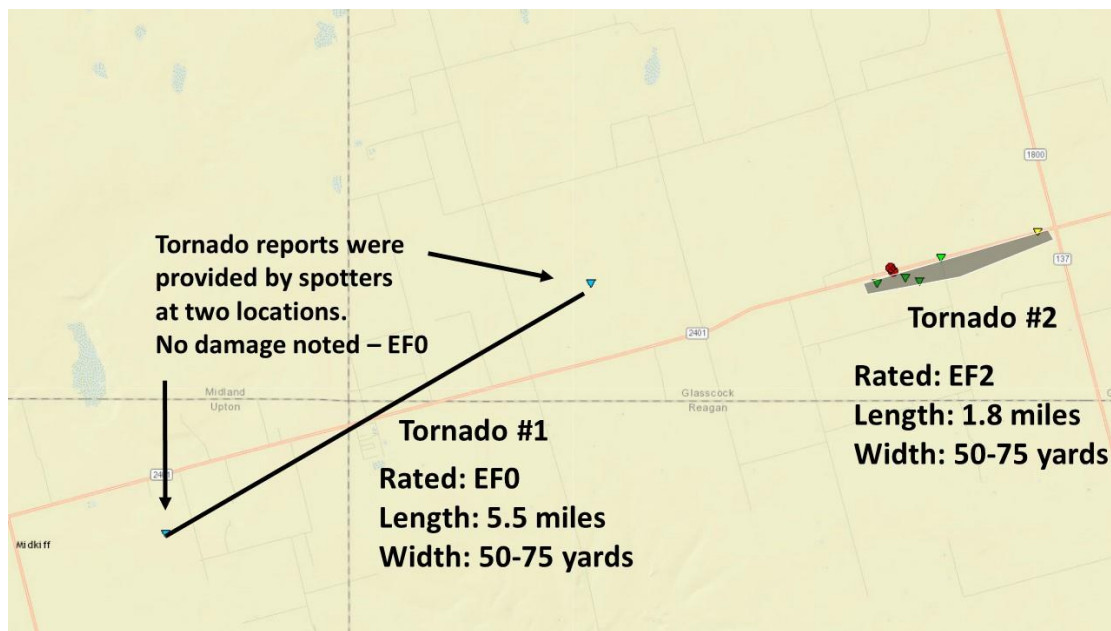
Tornado #1 – EF0 NE Upton County to SW Glasscock County (7:21-7:25 pm CDT)

Trained spotters viewed and took images of a tornado that developed 2 miles east of the community of Midkiff along Farm to Market Road 2401 and continued northeastward into open fields in extreme southwest portions of Glasscock County. The tornado was narrow, perhaps 50-75 yards in width. No damage was found with this tornado, which travelled along a path for approximately 5 ½ miles.

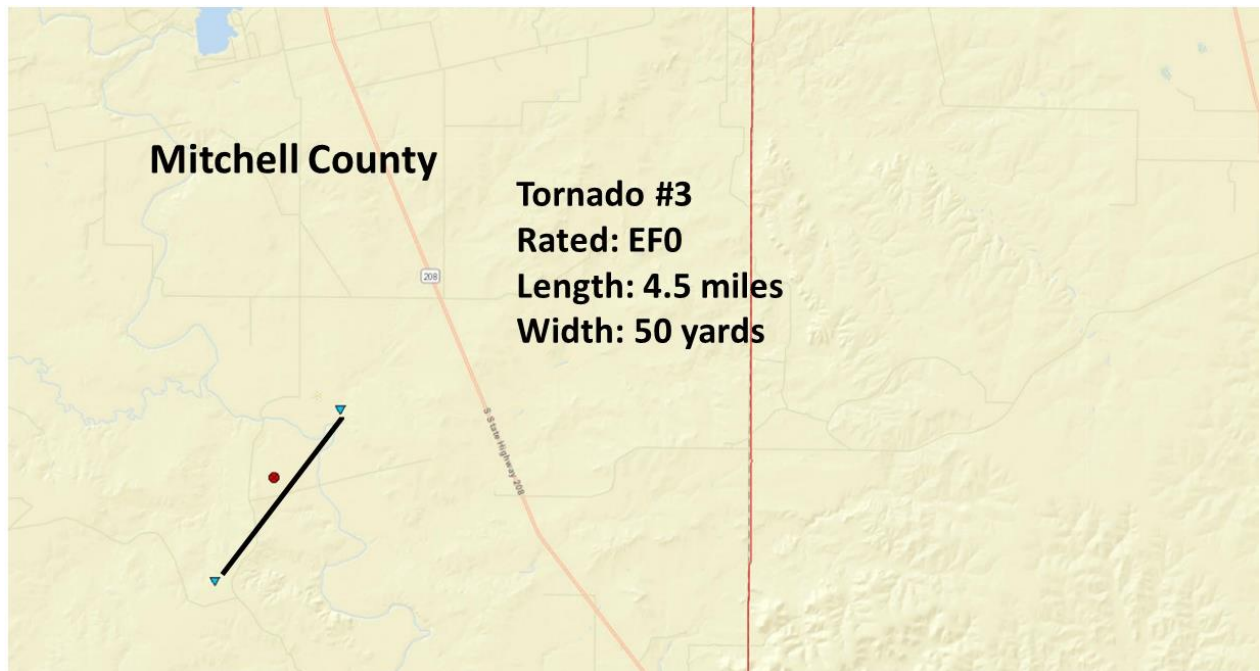
Tornado #3 – EF0 Southeast Mitchell County – approximately 20 miles southeast of Colorado City. (8:50-8:56 pm CDT)

While a damage survey team could not locate any damage, trained spotters did provide reliable reports of the existence of a low-end tornado located just west of Highway 208. Based on radar data, the image below gives a best guess of the life cycle for that tornado.

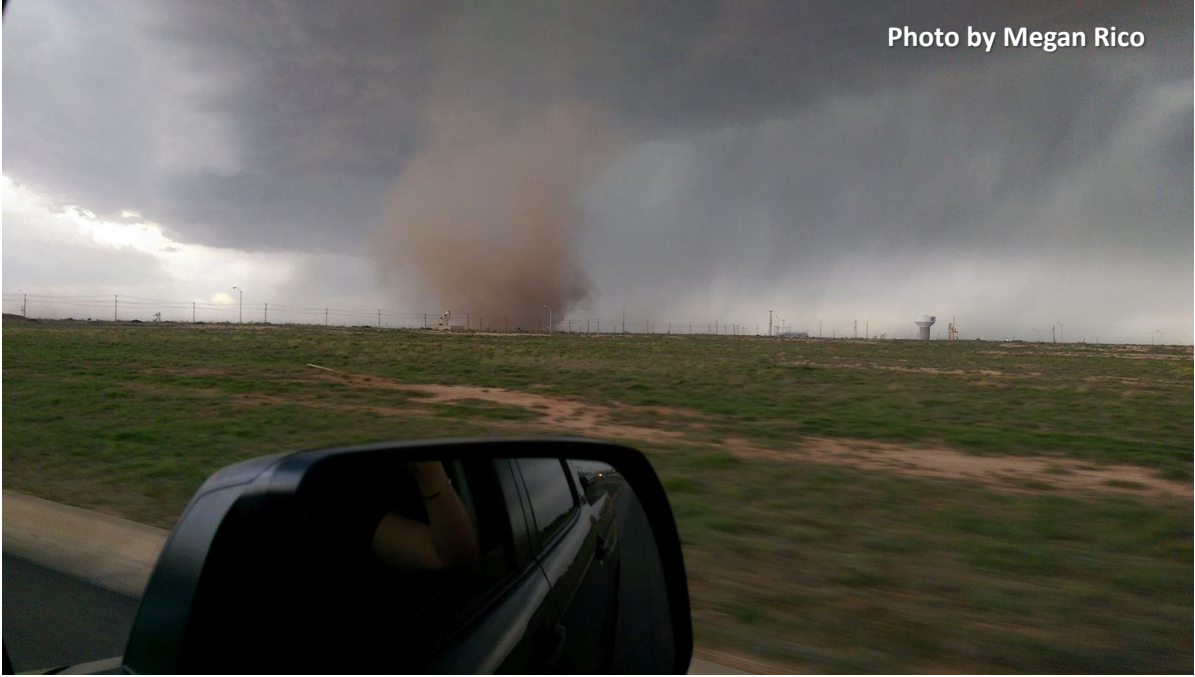
Photo by Megan Rico

In addition to the tornadoes and straight line winds across the region, there were several sightings of gustnadoes across Odessa and Midland as the storms moved through. The gustnadoes were very photogenic due to the amount of dust they generated. These typically form within an outflow along the leading edge of a line of thunderstorms, as was the case on March 28th. Gustnadoes are short lived and typically do not cause serious damage.
