Severe Weather Impacts from Tuesday March 12, 2019

On Thursday, March 14, the National Weather Service in Midland conducted damage surveys at 3 locations that were impacted by severe weather on Tuesday evening and very early Wednesday morning. The following are the determinations of those teams:

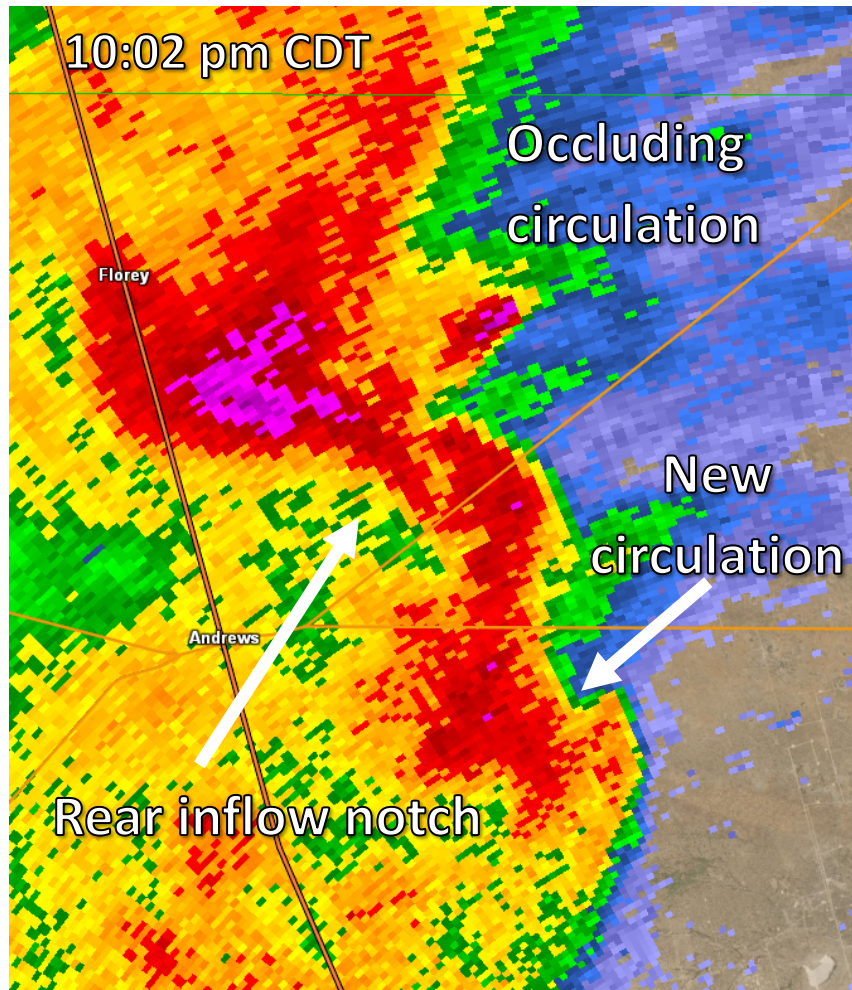
With the close correlation of the meso-circulation with observed damage, the survey team determined that damage was the result of a tornado. Damage to outbuildings, residential structures, power poles, and to a 300-foot transmission tower (image to the right) suggest that the most significant damage is indicative of a moderate to high end EF-1 tornado, with wind speeds estimated at 80-100 mph. The tornado was estimated to be 1/5 mile wide and traveled northeast along a path approximately 3.5 miles long. Based on radar and damage information, it is believed that the tornado had a life span of 6 minutes, from approximately 9:55 pm to 10:01 pm. The radar image below, from 10:02 pm CDT, shows the pronounced rear inflow notch, a weakened and occluding circulation, and a newly developing circulation further south.

The image on the left shows a rolled manufactured trailer on SE 650 Rd. On the right is a destroyed outbuilding on SE 2601 Rd.

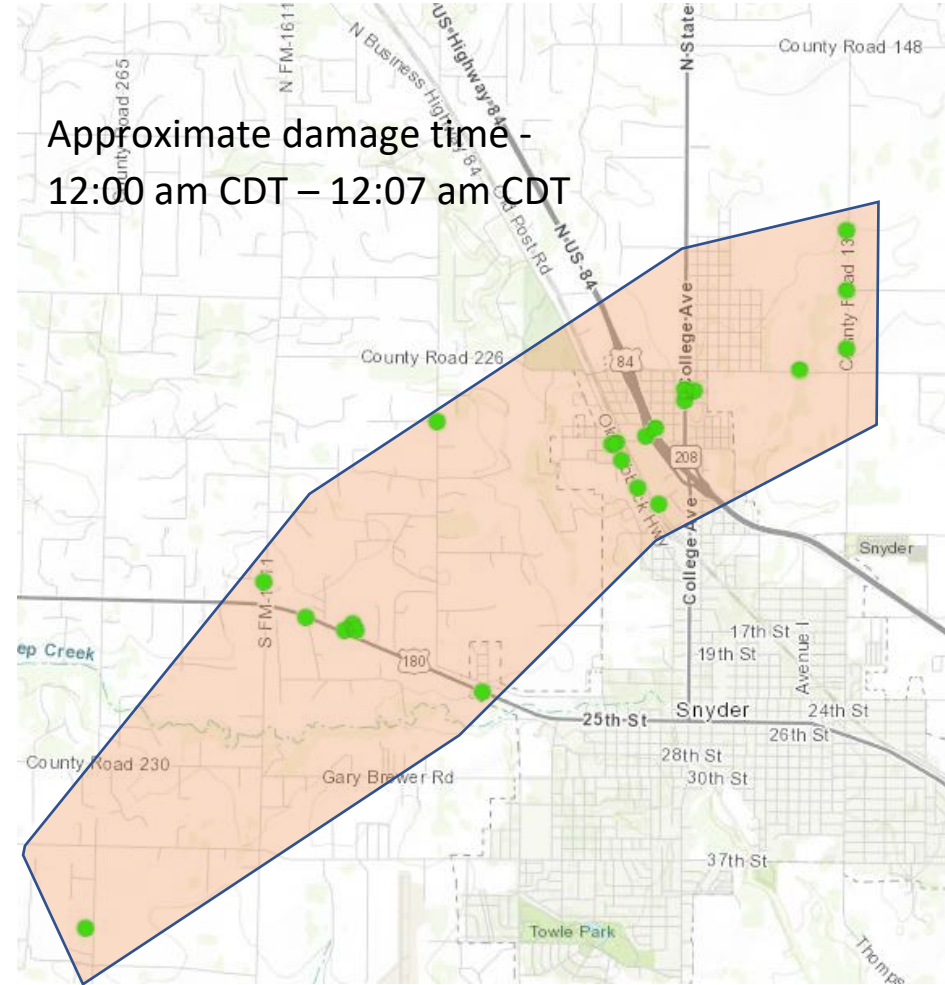
Approximate damage time -
12:00 am CDT – 12:07 am CDT

The survey team found the first indications of damage southwest of Snyder, just west of Highway 351 and approximately 2 miles south of Highway 180. From this location, the swath of damage extended northeastward across the city of Snyder for nearly 4 miles. The NWS survey team found the damage to residential and business structures indicative of that produced by winds of 85 to 100 mph. With no circulations evident, the event has been determined to be a straight-line wind event. This weather event provided an excellent example of how significant damage can occur without the presence of a tornado. The following image shows the swath of damage for this event.

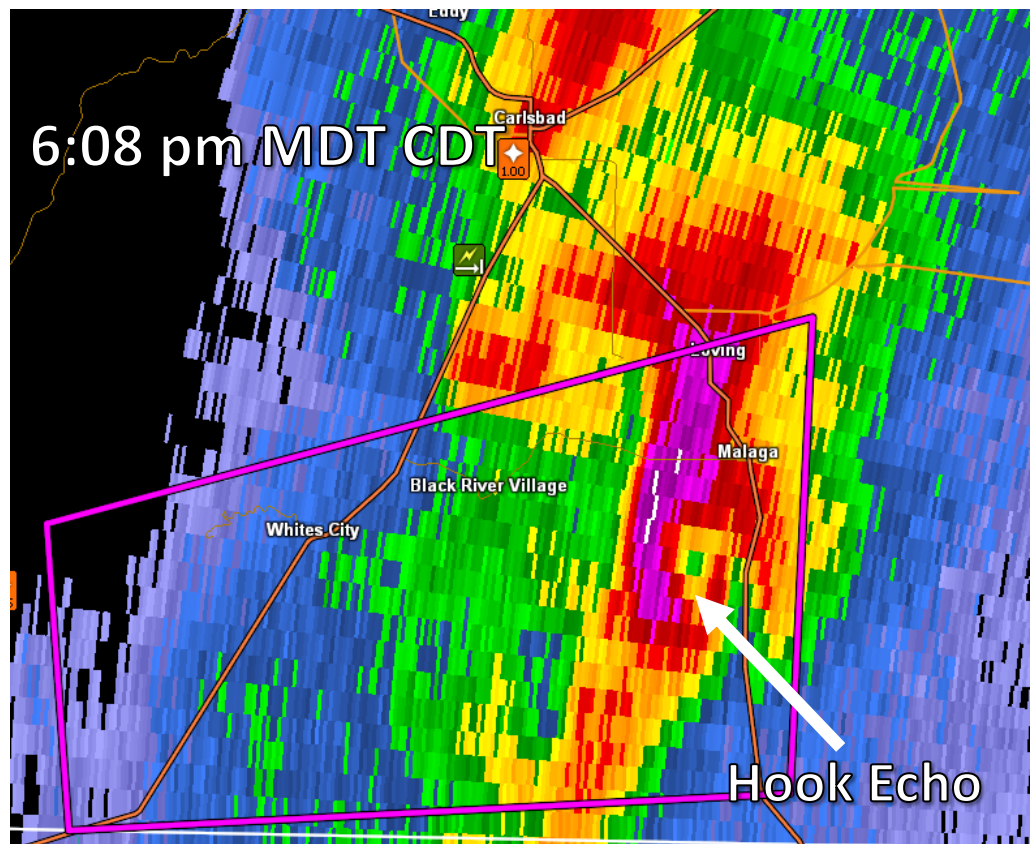
Damaged power poles (image to the right, provided by Malaga Volunteer Fire Dept.) along Highway 285 were located slightly further south than was indicated on radar, 3.75 miles to 4.05 miles south of Malaga. This was used as a starting point. With the tornado crossing the power poles at approximately a 45-degree angle, the width of the tornado was estimated at 1/5 mile.

Approximately 10 power poles that were damaged to some degree as the tornado crossed Highway 285. Poles on the north and south limits were snapped at 1/2 to 2/3 height from the ground, while near the center-line of the tornado's path, poles were snapped close to ground level. The observed damage is consistent with damage of an EF2 tornado, with winds estimated at approximately 112 mph.
