## December 16, 2007 Land O' Lakes Tornado Damage Survey

**Anthony Reynes, Daniel Noah - NWS Tampa Bay**

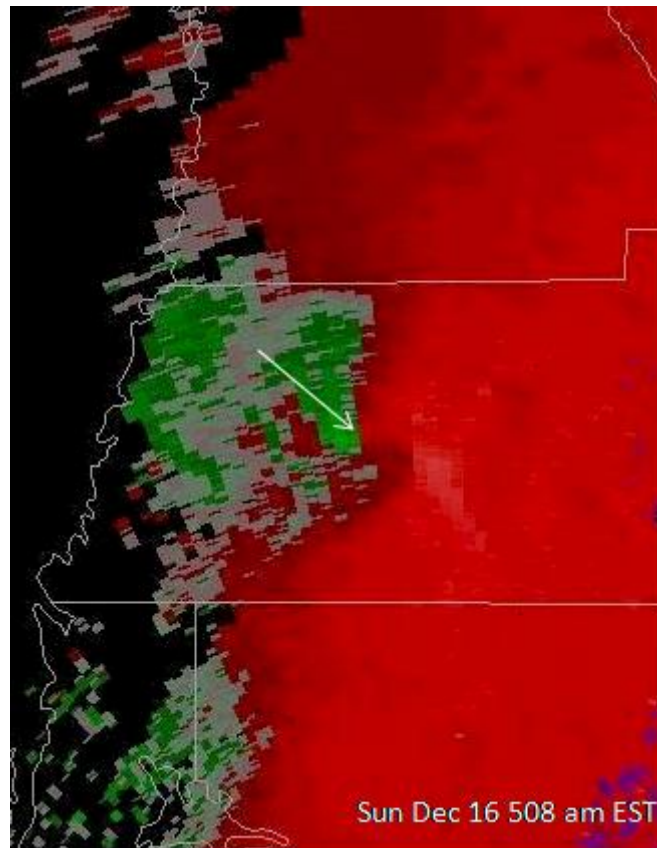
**Figure 1.** Base Velocity from NWSTBW Radar at 5:05 am EST showing a well defined rotation couplet at 0.5 degrees of elevation.

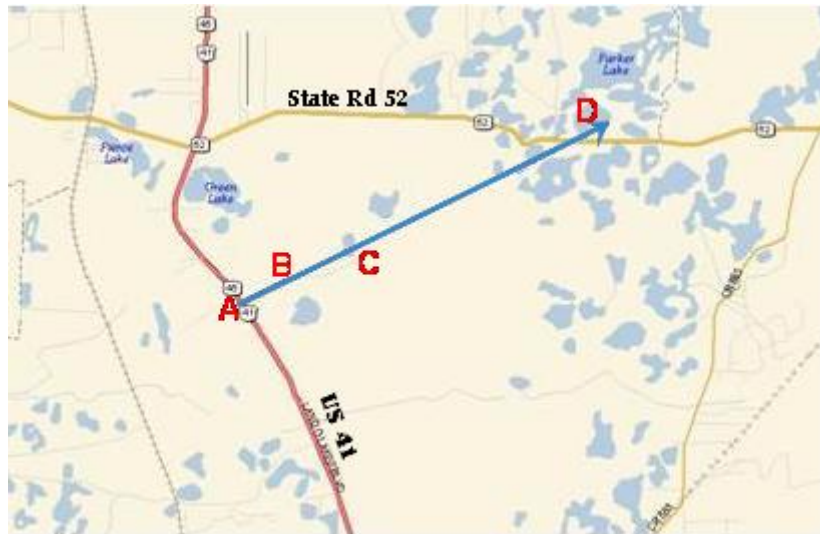
Figure 2 shows the map with the general area and estimated path of the tornado, depicted by a blue arrow, whose main target was the Pasco County Jail near Land O' Lakes, Fl.

The length of the tornado path was about 3.2 miles long from Site A to Site D (Figure 2). As mentioned before, there is compelling evidence that the tornado may have temporarily lifted between Sites and did not remain on the ground along

Figure 2. General map showing impacted area and estimated tornado path.
