### Overview

During the early morning of March 1<sup>st</sup>, 2007, a bow echo system over central Missouri moved east-northeast through parts of northeast Missouri and west-central Illinois during the early morning hours. The bow echo was responsible for producing damaging winds, small hail and three weak tornadoes over western Monroe county while a supercell along the southern part of the bow echo produced some wind damage and hail over northern Ralls County. The bow echo was north of a warm front which extended from a deep low pressure system west of Columbia, Missouri to just south of St. Louis and across southern Illinois. Unseasonably warm, moist and unstable air was moving north towards central Missouri while cooler moist air was present north of the warm front. Damage assessments were conducted over parts of northeast Missouri. The damage was caused by both straight-line winds and 3 tornadoes. The tornadoes occurred over parts of Monroe and Shelby counties.

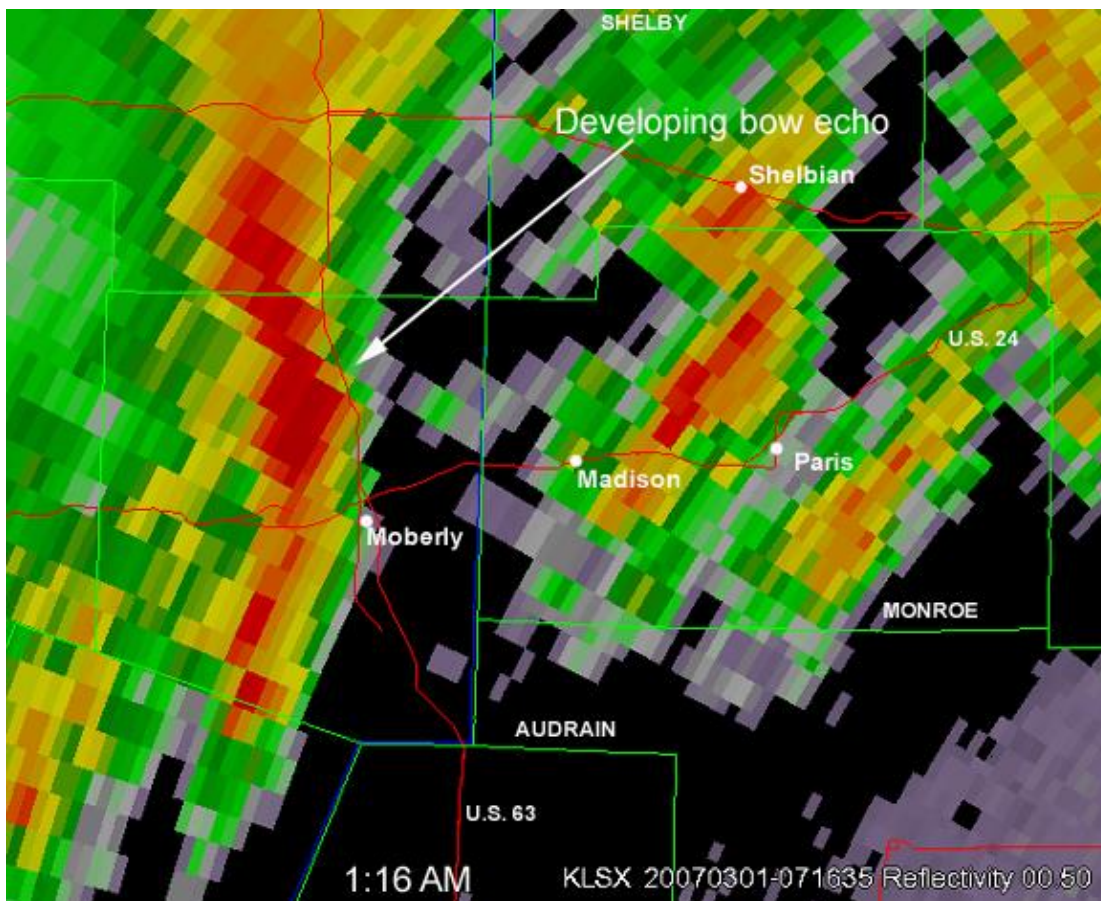
Radar image taken at 1:16 AM. Note the developing bow echo over central Randolph county.

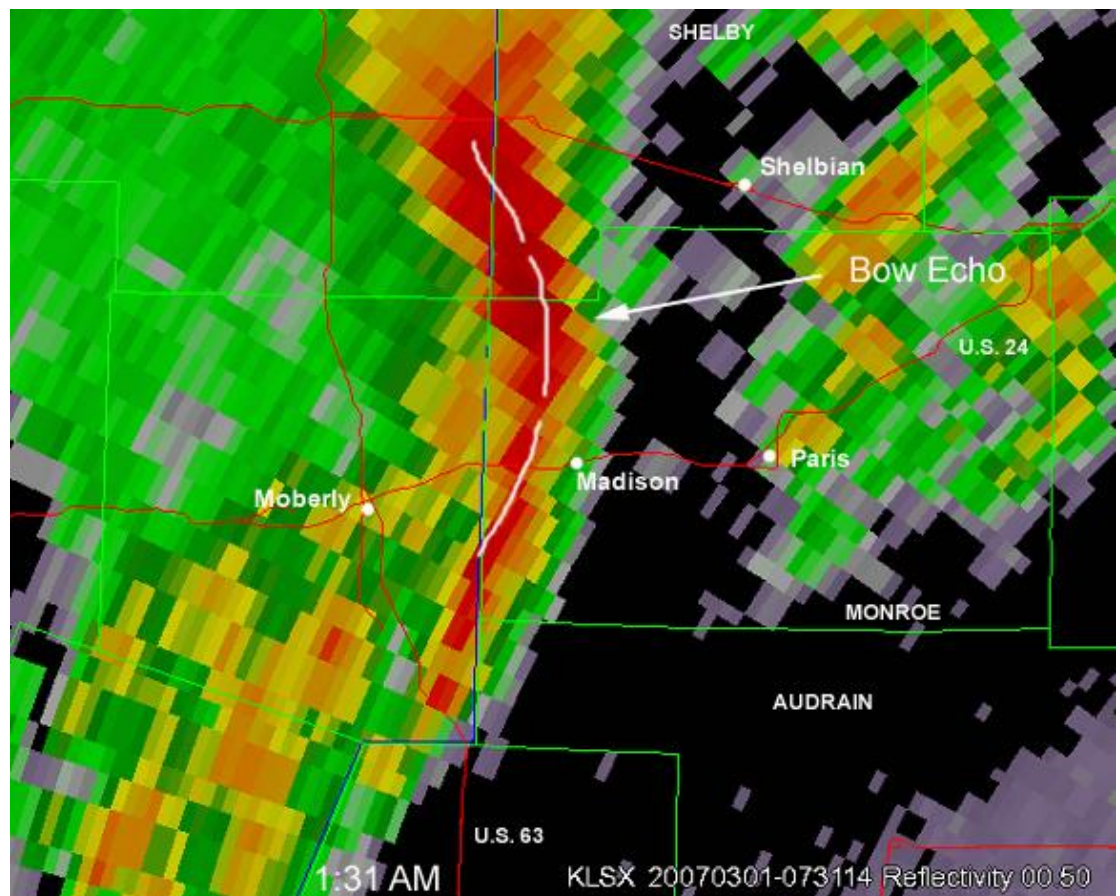
Radar image taken at 1:31 AM. Note the bow echo has moved into western Monroe county. Three non-supercell tornadoes occurred along the leading edge of the bowing segment over parts of west and north central Monroe County.
