Storm Data and Unusual Weather Phenomena - July 2010

TEXAS, South

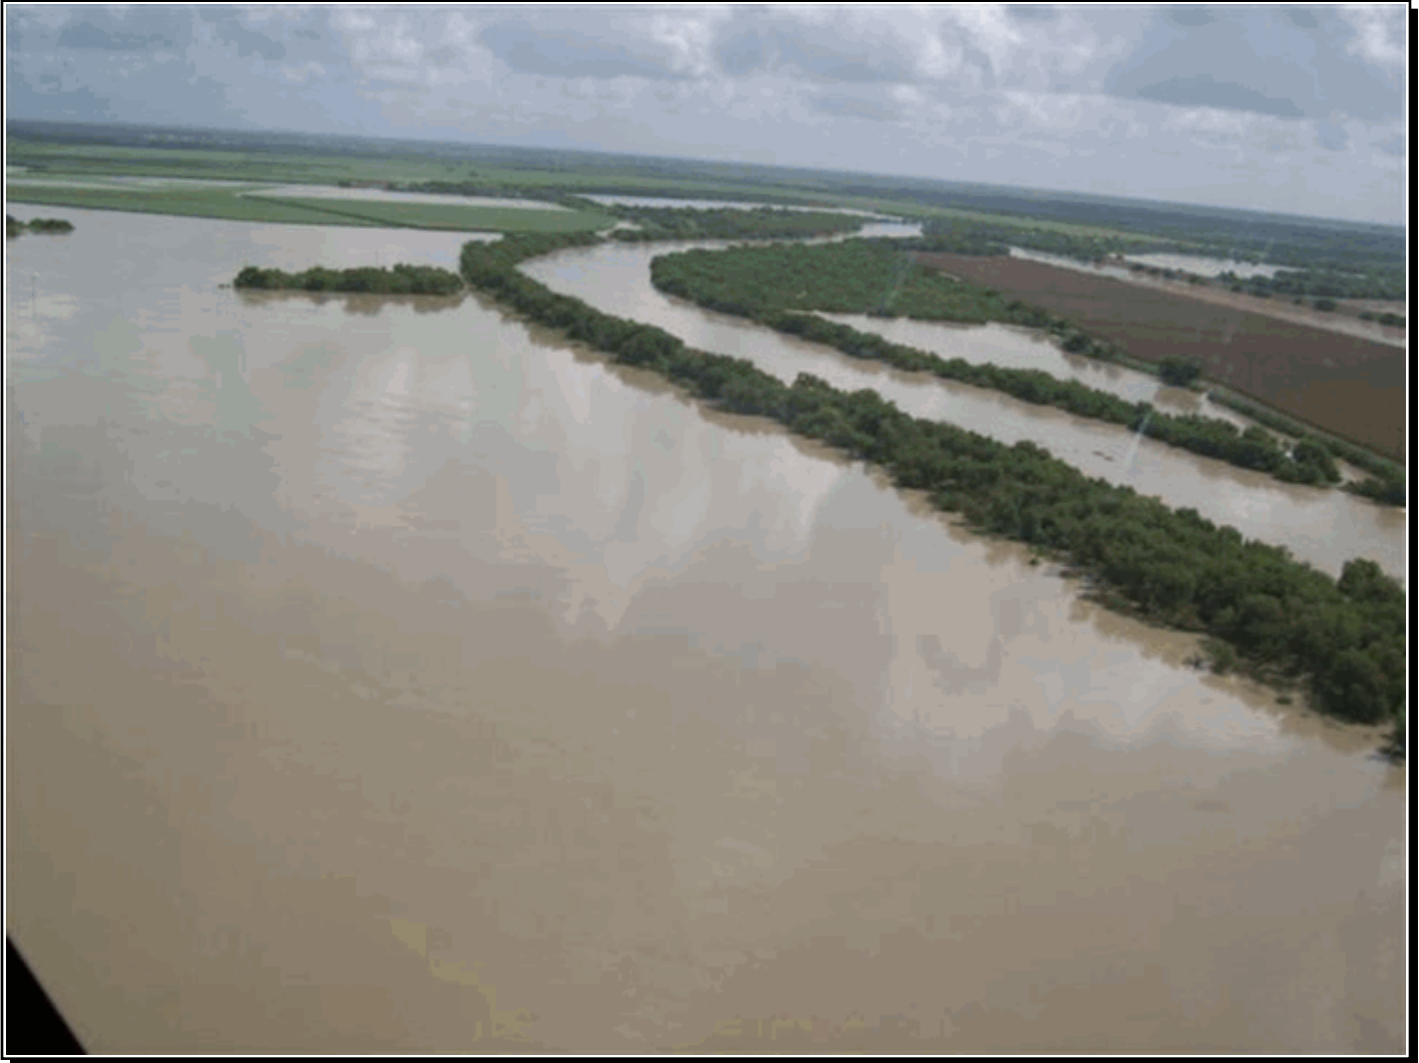
Flooding along the Rio Grande Between Starr County, TX, and Tamaulipas State in northeastern Mexico. Photo courtesy of Starr County Emergency Management

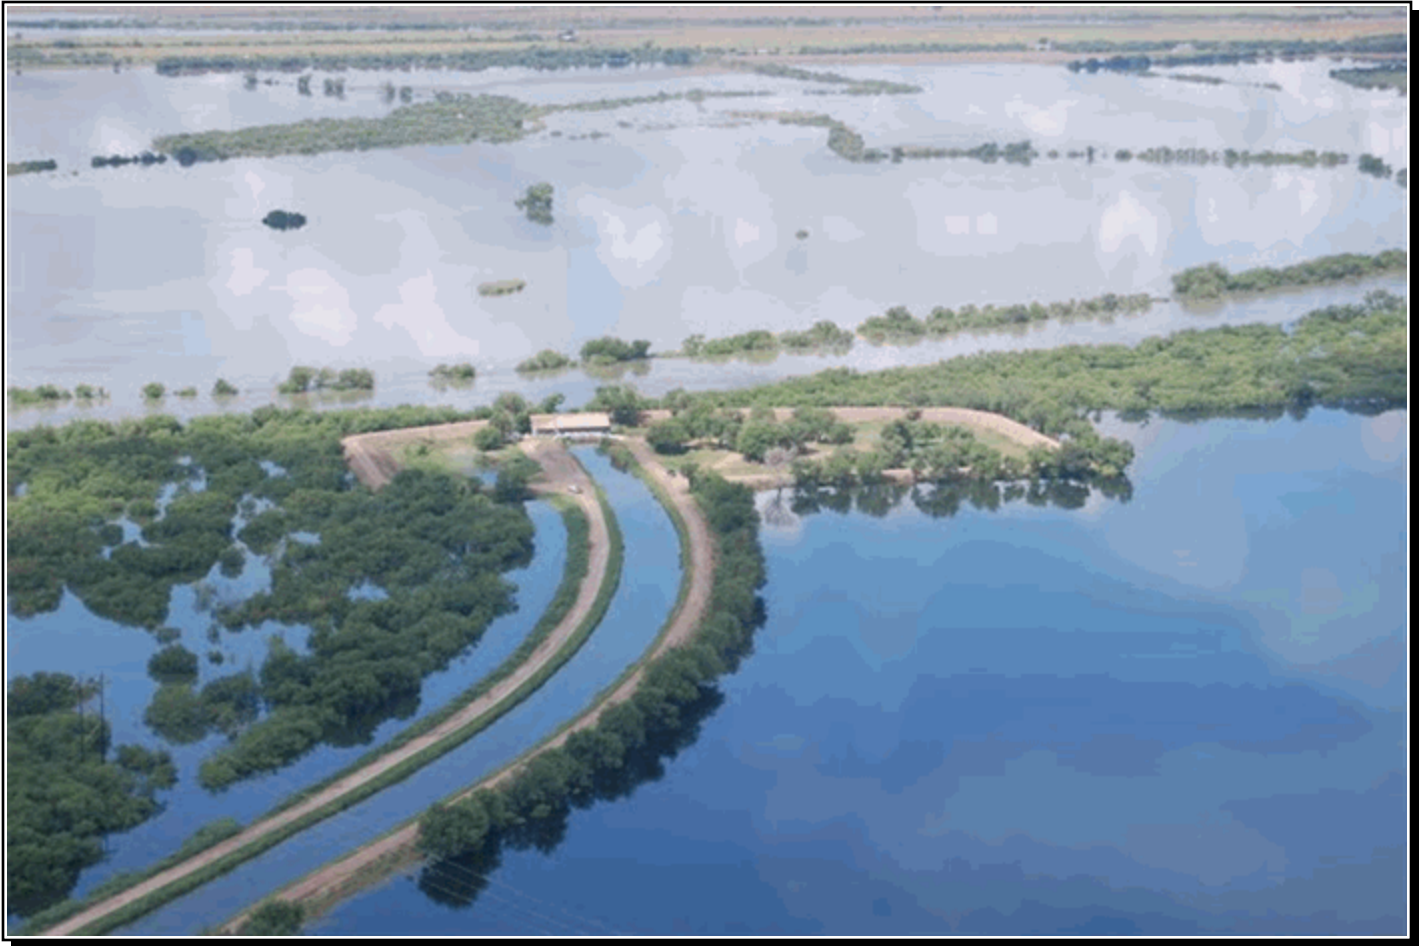
Flooding on the Rio Grande, extreme southwestern Hidalgo County between Los Ebanos and Penitas (unimproved river banks), July 9th, 2010. Photo courtesy of Hidalgo County Emergency Management
