# Tornadoes and Strong Gradient Winds

February 20<sup>th</sup>, 2014

## Damage Surveys

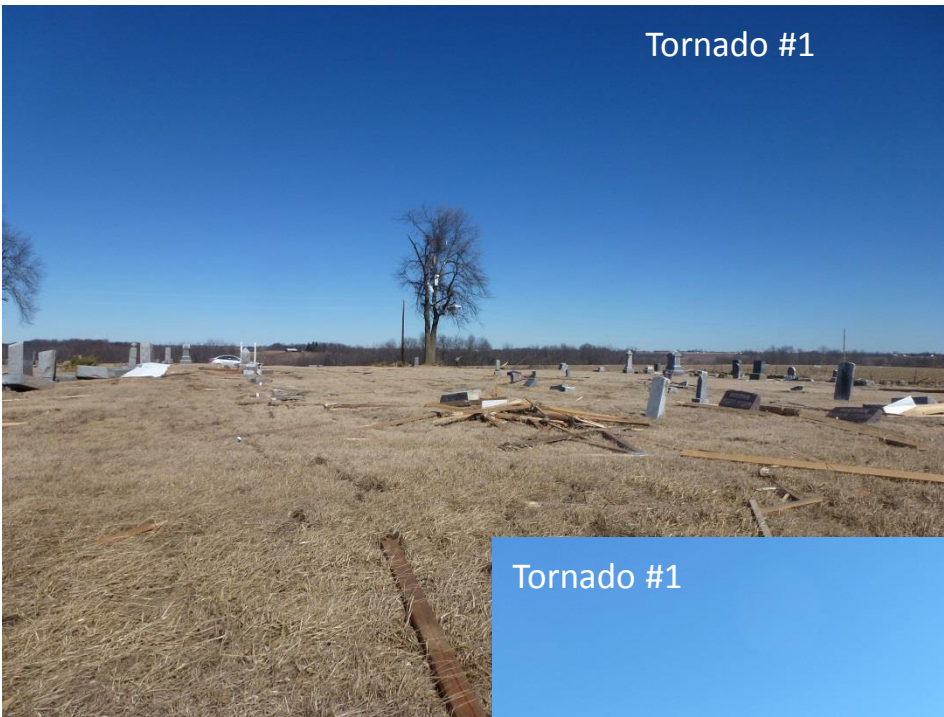
Tornado #1

Watson Cemetery had a few tombstones blown over. Also, several large tree limbs snapped were snapped at cemetery.

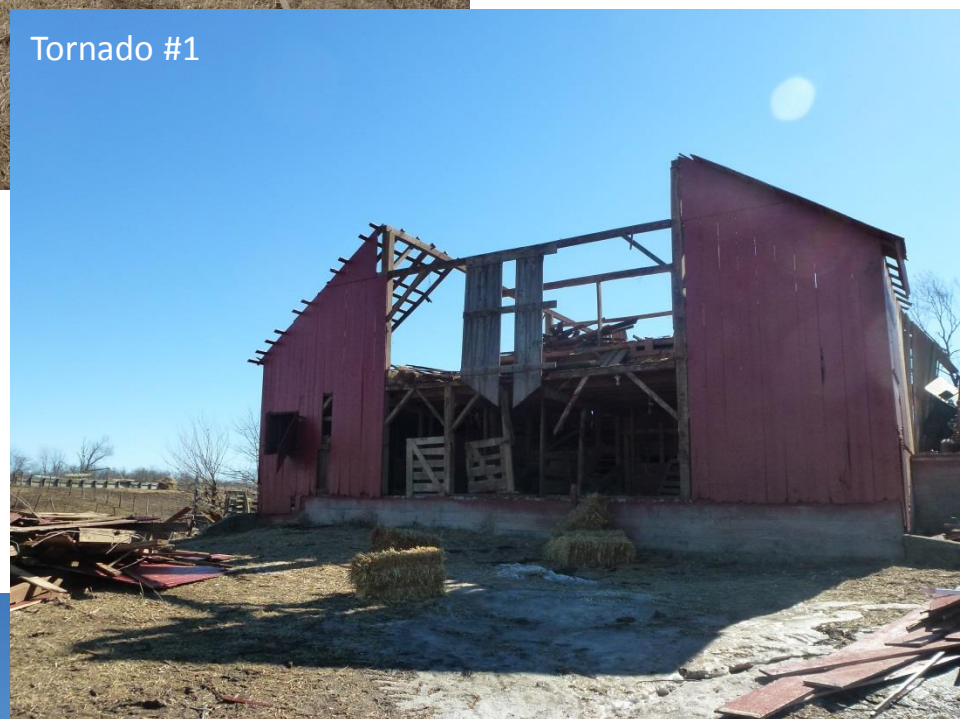
Tornado #1

The tornado developed over the north side of Martinsburg, Illinois. One home sustained minor roof and fascia damage and one window was damaged along the south side of the home. A few large trees and several large branches were downed by the tornado. The tornado then traveled east-northeast and sheared a path of large pine trees 30 to 40 feet tall half a mile north of Martinsburg along and west of County Road 11. Many of the pine trees were snapped from near the base to half way up the trunk. The width of this damage area was 80 yards. The next damage was found approximately 300 yards south of the intersection of County Road 7 and 205th Avenue. A one story residence home sustained minor fascia damage and a few pine trees were snapped at the bases. The tornado then totally destroyed a medium size machine shed on the south side of Watsons Cemetery east of the intersection. Several tomb stones were damaged. Approximately 300 yards east of the cemetery another farmstead sustained damage. Two empty medium size grain bins were destroyed while another machine shed was destroyed. Damage was found again at another farmstead located 1 mile west of Detroit, Illinois. The east side of a two story farm house was moved off its foundation by 5 inches while part of the east side of the roof was tossed to the east. The upper half of a large barn was removed and tossed to the east. One old machine shed was completely destroyed while two canvas hoop sheds were completely destroyed. Debris from the machine sheds were tossed a quarter of a mile to the east. The tornado crossed Illinois Route 106 about a mile west of Detroit and damaged several large trees. The tornado then directly hit a hog building which was supported by steel I-beams. The southern part of the structure was pushed to the north and northeast. Debris from the roof of this structure was tossed over half a mile to the northeast. The damage width over this area was 80 yards wide. Damage to this structure was rated EF-2. The tornado continued to the northeast before lifting and dissipating about a mile north northeast of Detroit on the east side of County Road 14.

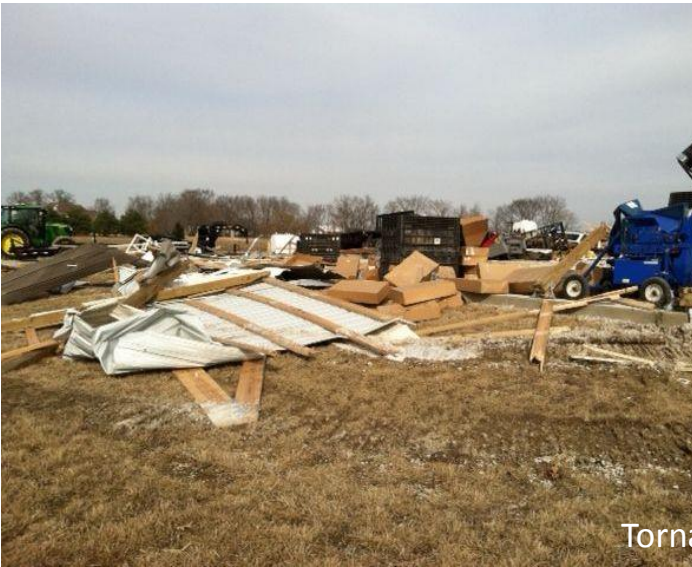
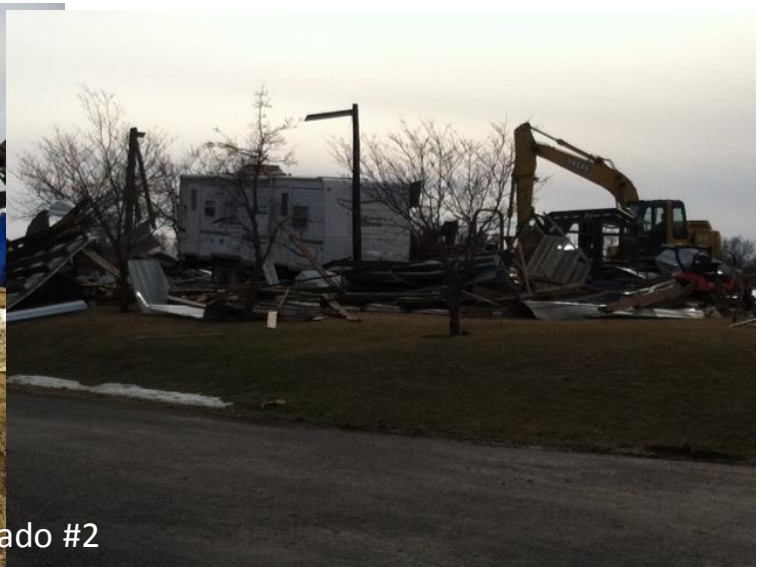
Tornado #2

The tornado touched down about 3.4 miles northeast of Highland, in Madison County, on Trestle Road causing window, roof and tree damage to a home, and then totally destroyed a large commercial metal storage building just northeast of the home. The tornado then crossed the county line into Bond County. The tornado continued to produce intermittent tree damage as it headed northeast and crossed Illinois Route 143 and then totally destroyed a farm outbuilding along Pokey Road. Another farmstead was struck northeast of the farm outbuilding, where the tornado totally destroyed a pole barn and produced extensive damage to a home from a falling oak tree. The tornado continued to produce damage to trees and outbuildings as it moved northeast with roof and siding damage also occurring to a home on Millersburg Road. It lifted and dissipated just southwest of the intersection of Airport Avenue and Dudleyville Road, three miles south of Greenville.

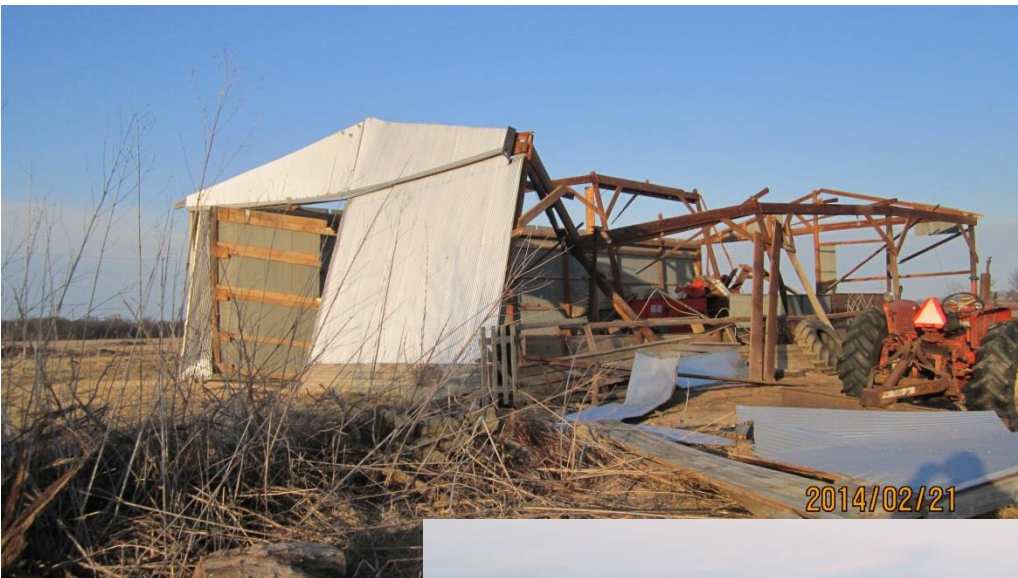
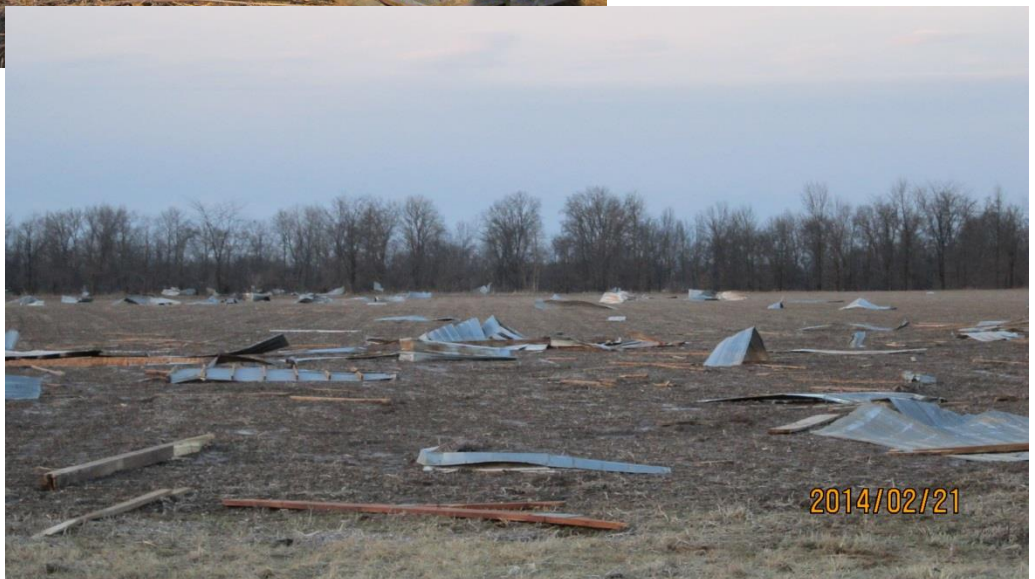
Tornado #3

The tornado developed 2.8 miles northwest of Brownstown or 0.3 miles north of the intersection of County Roads 1900N and 1375E. One large old tree was down while several large branches along a row of trees were snapped two thirds up the trunk. The damage path was approximately 40 yards wide and damage intensity was rated EF0. Two witnesses observed the tornado near the intersection of County Roads 2000 N and 1450 E. The tornado was rain wrapped and skipped over this area. One large machine shed was damaged about 150 yards southwest of this intersection while the southern part of another barn southeast of the intersection was severely damaged. Debris from both structures were tossed about one third mile to the northeast. At the intersection of 2100 N and 1600 E three tall wooden transmission line poles were snapped two thirds up the pole at the intersection. Approximately 50 yards to the southeast of this intersection a medium size machine shed was severely damaged with the east and south sides of the shed shredded and tossed one third mile to the northeast. The tornado continued northeast and destroyed a large machine shed housing farm equipment. The tornado totally shredded the metal panels and tossed them over one third mile to the north. A medium size machine shed approximately one half mile to the northeast of the large machine shed lost a few metal roof panels.

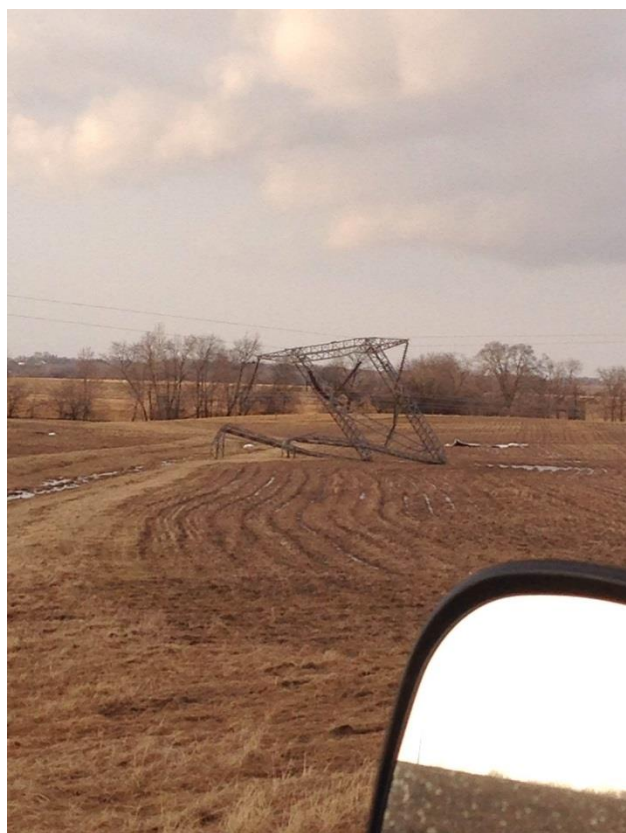
Tornado #4

The tornado touched down 4 miles south southeast of Nokomis at the intersection of E 25th Road and Mt. Zion Trail. In this location it took a large section of shingles off of a garage roof and twisted the entire structure slightly off its foundation. A little further to the northeast it took a large section of roof off of a barn. Some of the metal panels from the roof were thrown about half a mile to the northeast of the structure. Just northeast of the barn, a double trussed metal transmission tower was blown down. Damage in this area was rated EF1. The tornado continued to the northeast. Just north of the intersection of Oconee Avenue and E 28th Road, a two foot diameter oak tree was uprooted. Also, in this location there was a 50yard wide path of major tree damage. Several trees were uprooted on the west side of Litz Road, about six tenths of a mile north of the intersection of Litz Road and CR 2050N. From there the tornado continued to the northeast and crossed into Shelby County (WFO Lincoln's county warning area), about a third of a mile south of the intersection of E 30th Road and N 22nd Avenue. For Montgomery County portion of the tornado, the maximum intensity was EF1 with a max wind speed of 100 mph. The path length of this segment was 6.3 miles and a max width of 50 yards. (This portion of the tornado information is from the survey done by WFO Lincoln for Christian and Shelby Counties) The initial path through Shelby County consisted mainly of tree damage. However, the tornado damaged several properties to the south and east of Pana, before crossing back into Shelby County 3 miles east of Pana. The tornado increased in intensity after it crossed into western Shelby County, doing significant damage to the roof of a house and causing one minor injury, about 3 miles north-northwest of Tower Hill. The tornado continued to the northeast, dissipating near the intersection of county roads 1700 North and 1200 East, or roughly 3 miles west-southwest of Westerveldt. Overall the maximum intensity was EF2 (in Shelby County about 3.5 miles north northwest of Tower Hill). The total path length was 22.2 miles with a max path width of 200 yards.
