Storm Data and Unusual Weather Phenomena - May 2024

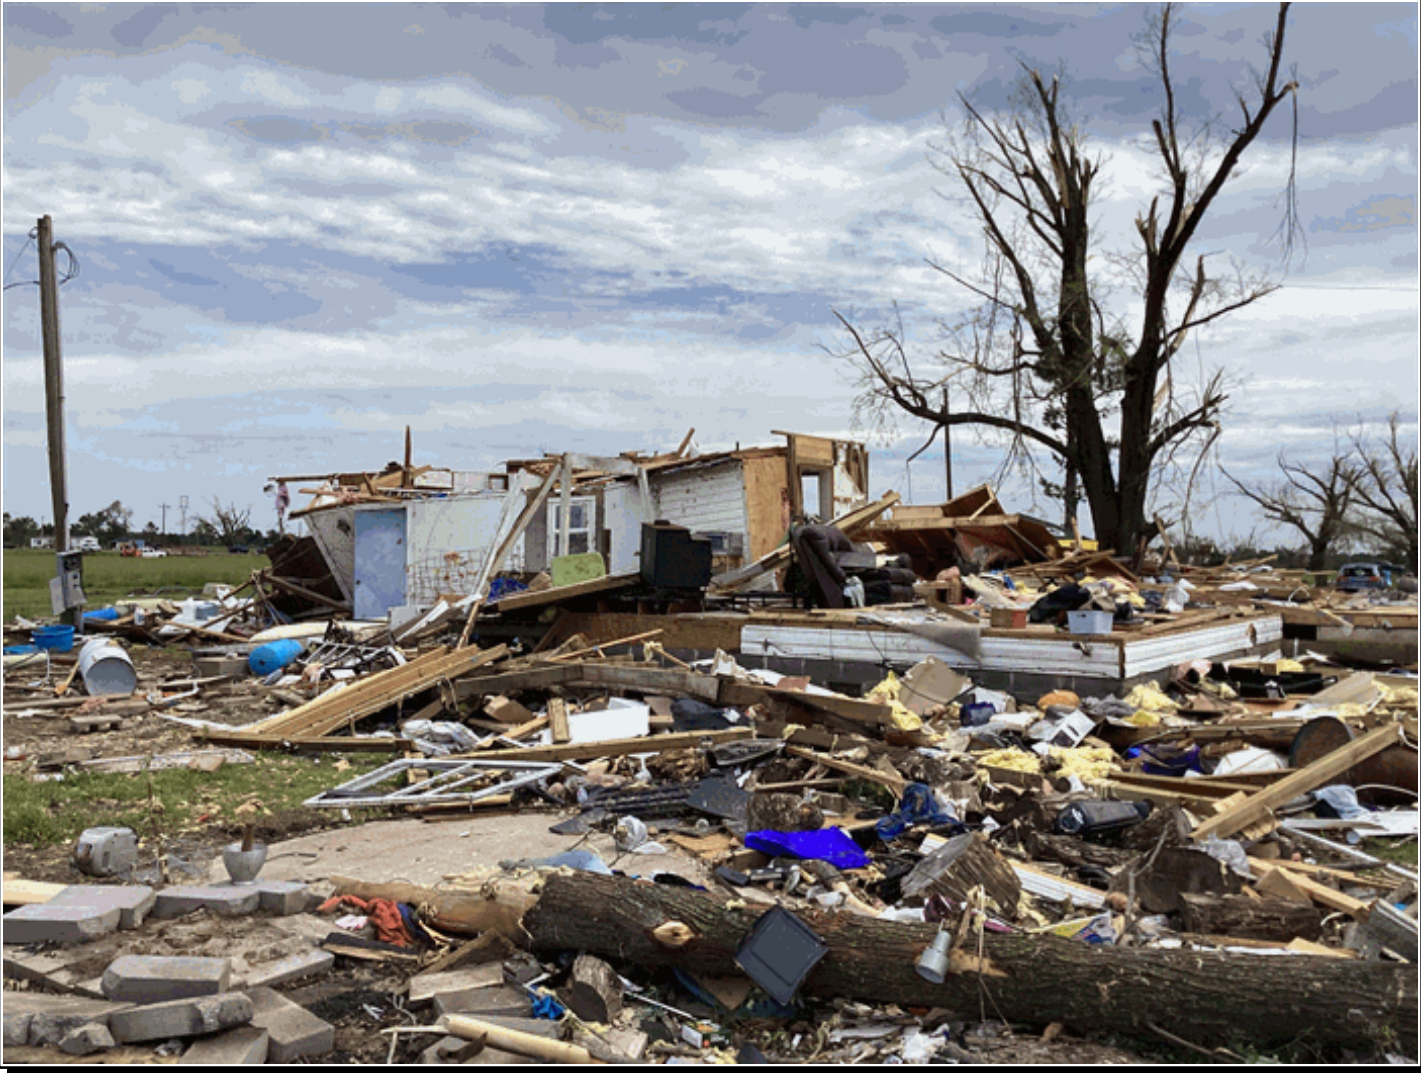
An EF-3 tornado damaged or destroyed more than 60 homes and businesses near Decatur, Arkansas, and severely injured at least two people during the early morning hours of May 26, 2024. The damage path was about 1.8 miles wide at times, and resulted in extensive tree damage. Many power poles were snapped, and numerous outbuildings were also destroyed. Photo by Ed Calianese, WCM, NWS Tulsa Oklahoma.

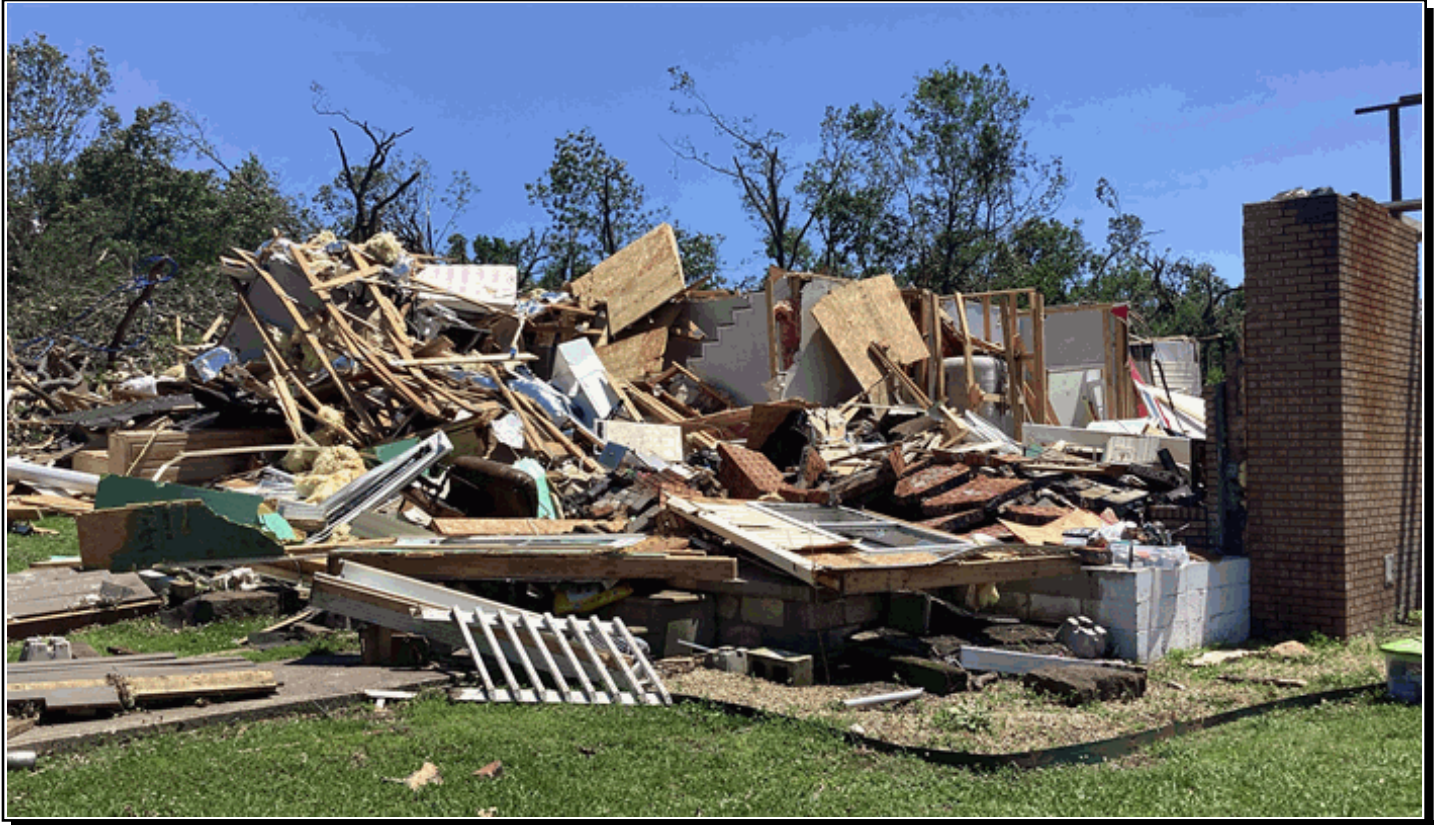
An EF-3 tornado destroyed more than 70 homes and businesses, and damaged at least 1200 others, in Rogers and Mayes Counties, during the late evening of May 25, 2024. Two people were killed by the tornado, and at least 23 others were injured. Damage to trees and power poles was extensive. Photo by Ed Callanese, WCM, NWS Tulsa Oklahoma.
